Pit, Closed-Loop System, Below-Grade Tank, or  
Proposed Alternative Method Permit or Closure Plan Application

1.  
Operator: SIMCOE LLC OGRID #: 329736  
Address: 1199 Main Ave., Suite 101, Durango, CO 81301  
Facility or well name: GALLEGOS CANYON UNIT #356  
APPNumber: 30-045-26365 OCD Permit Number: \_\_\_\_\_  
U/L or Qtr/Qtr G Section 19 Township 29N Range 12W County: San Juan County  
Center of Proposed Design: Latitude 36.715189° Longitude -108.136077° NAD: ☐ 1927 ☒ 1983  
Surface Owner: ☐ Federal ☐ State ☒ Private ☐ Tribal Trust or Indian Allotment

**RE: Notice of Proposed Below-Grade Tank (BGT) Closure**

Photo Log  
Gallegos Canyon Unit 356 – Hand Auger BGT Closure  
April 16<sup>th</sup>, 2021

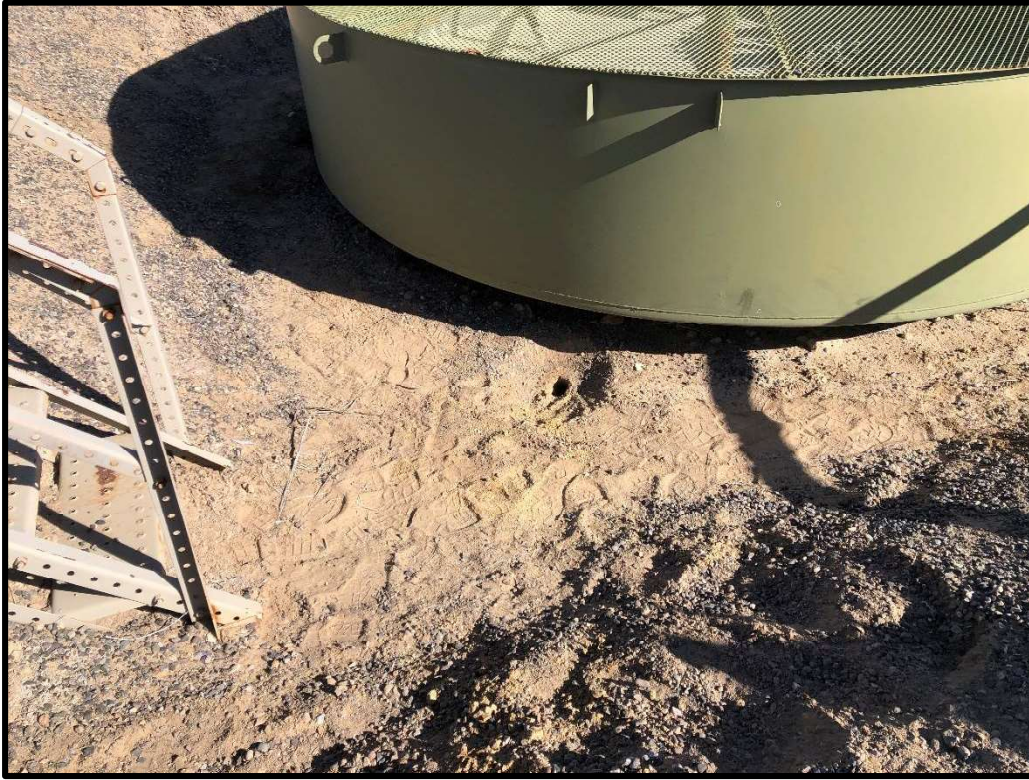
Photo 1: Above - Collection point of S-HA-40", advanced at ~ 25° via hand auger from beneath the above-ground tank.

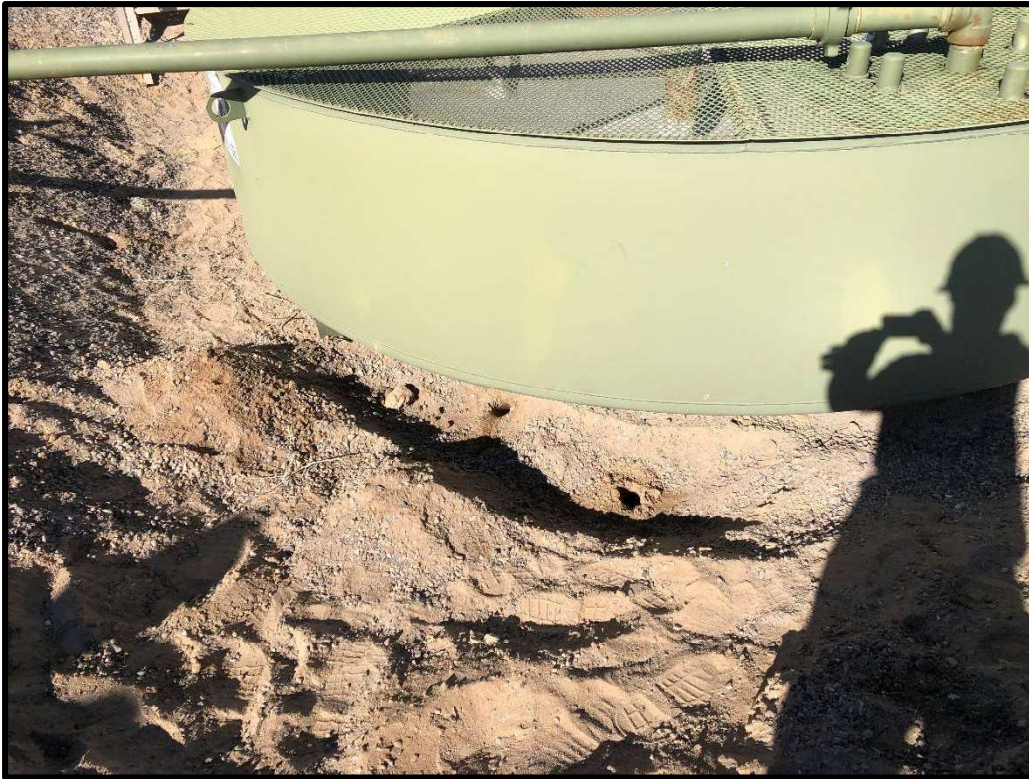
Photo 2: Above - Collection point of E-HA-34" (left) advanced at ~ 25° and Center-HA-35" (right) advanced at ~45° via hand auger from beneath the above-ground tank.

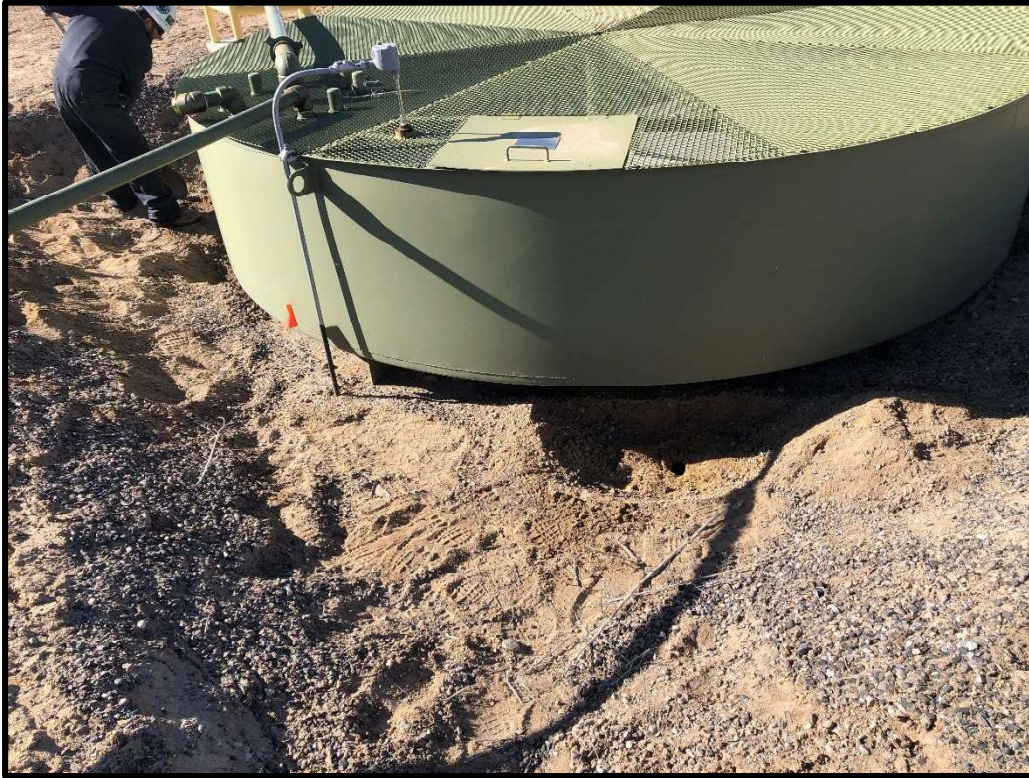
Photo 3: Above - Collection point of N-HA-30", advanced at  $\sim 25^\circ$  via hand auger from beneath the above-ground tank.

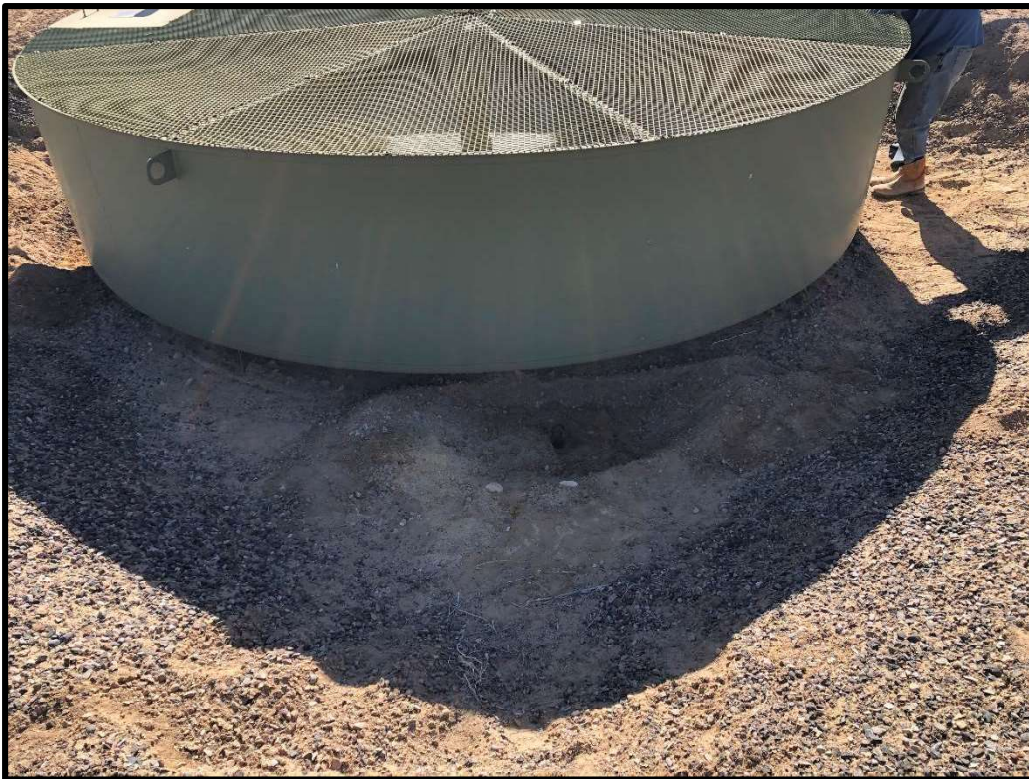
Photo 4: Above - Collection point of W-HA-32", advanced at  $\sim 25^\circ$  via hand auger from beneath the above-ground tank.
