Pit, Below-Grade Tank, or
Proposed Alternative Method Permit or Closure Plan Application

1.
Operator: Hilcorp Energy Company OGRID #: 372171
Address: 382 Road 3100 Aztec, NM 87410
Facility or well name: STEDJE GAS COM 3
API Number: 3004531329 OCD Permit Number: _____
U/L or Qtr/Qtr F Section 27 Township 30N Range 12W County: SAN JUAN
Center of Proposed Design: Latitude 36.786336 Longitude -108.087873 NAD27
Surface Owner: ☐ Federal ☐ State ☒ Private ☐ Tribal Trust or Indian Allotment

Hilcorp Energy Company
San Juan Basin
Below Grade Tank Closure Report

Lease Name: **STEDJE GAS COM 3**

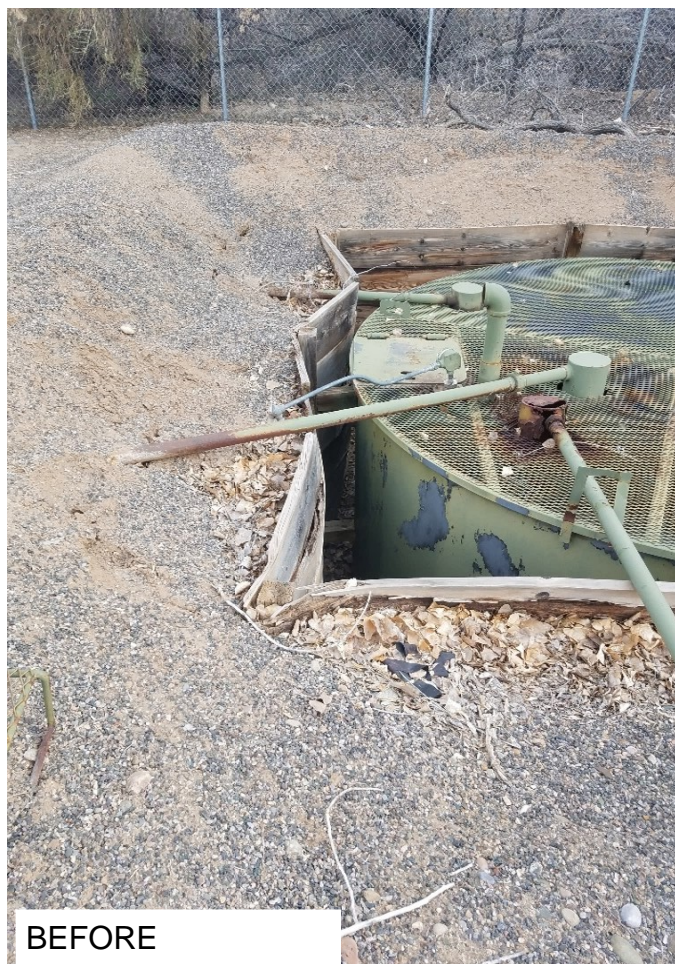
BEFORE

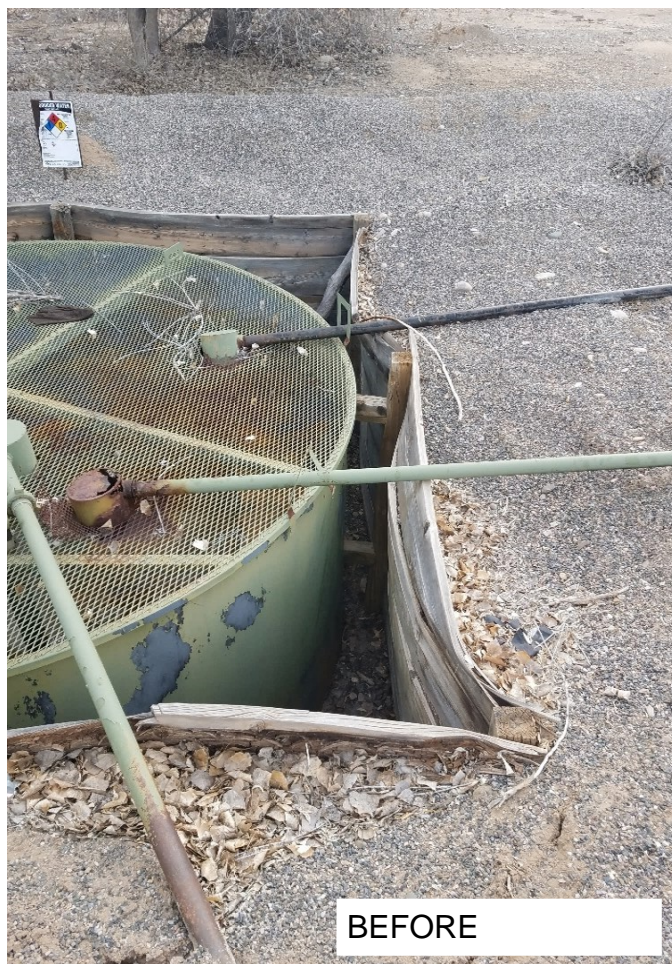
BEFORE
