Pit, Below-Grade Tank, or
Proposed Alternative Method Permit or Closure Plan Application

Hilcorp Energy Company
San Juan Basin
Below Grade Tank Closure Report

Lease Name: Tiger 6 BGT 1

API No.: 30-045-29581

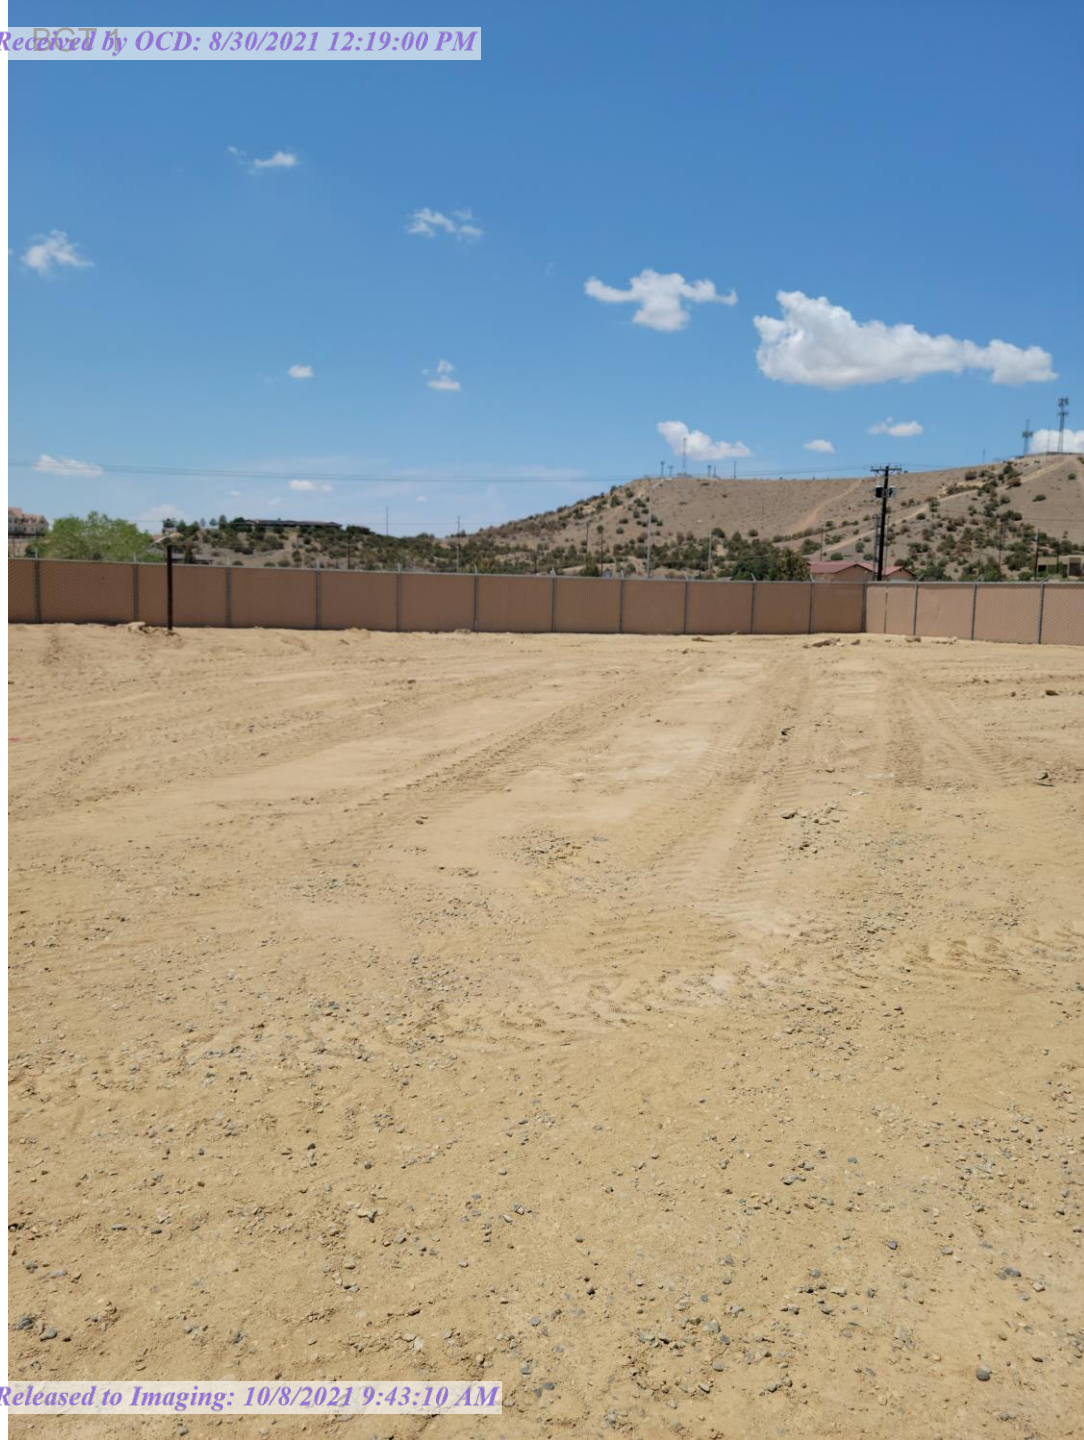
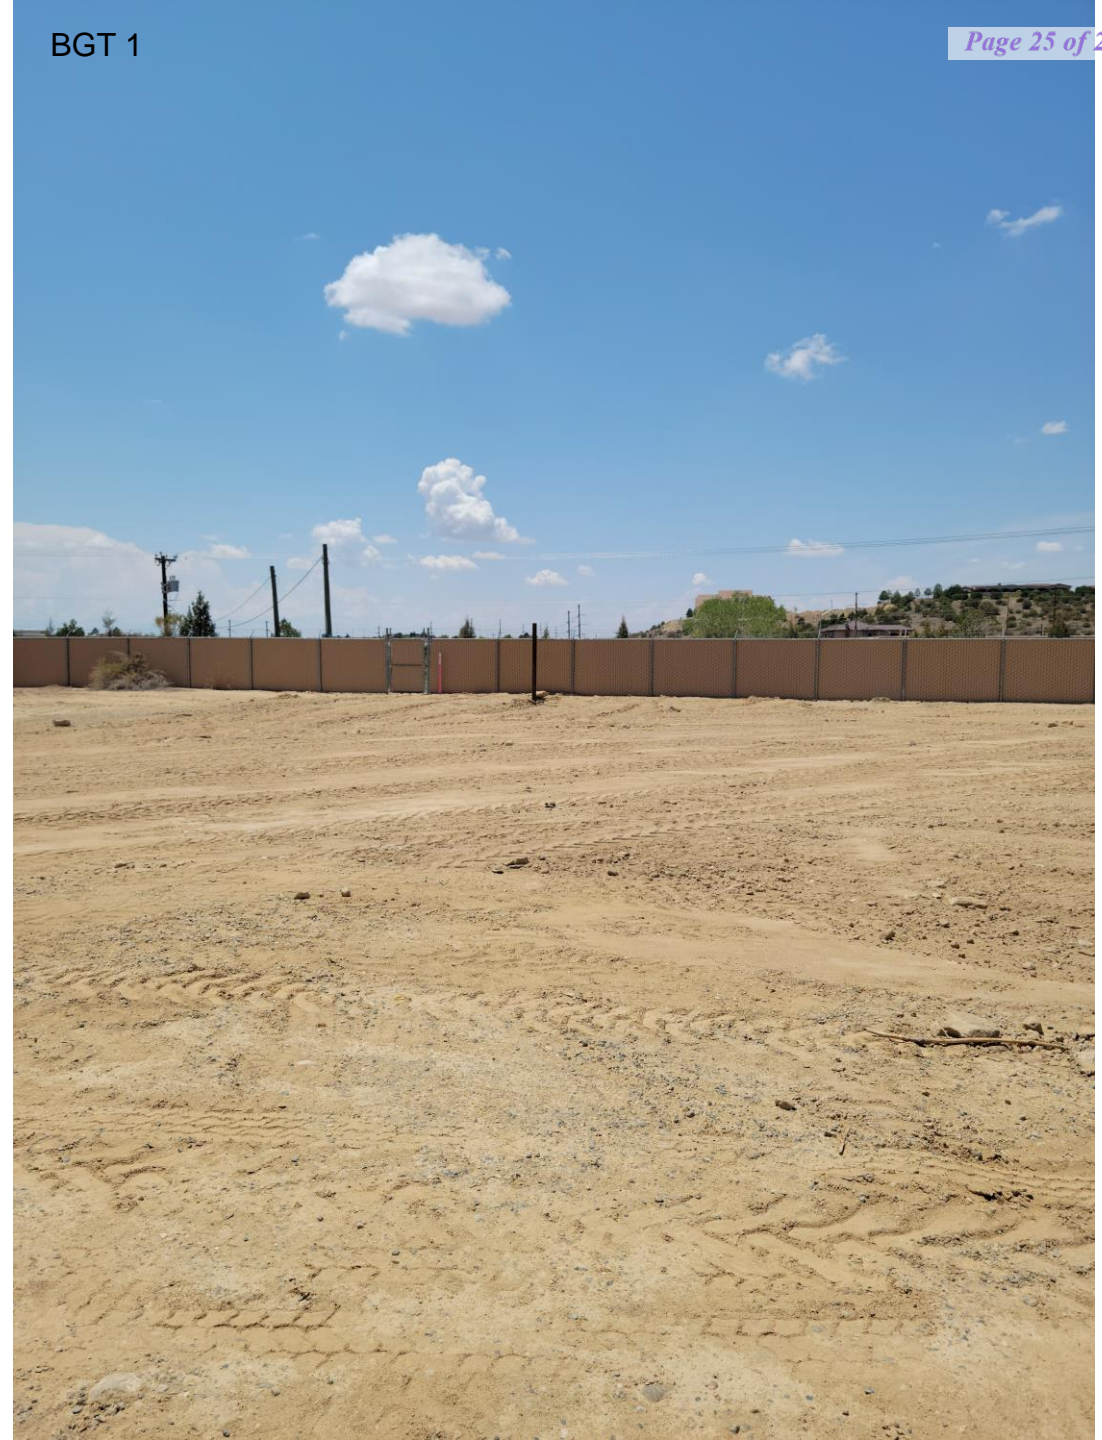
Tiger #6
07/19/21

Pit Closure Pictures.

The below-grade tank area passed all requirements of Paragraph (4) of Subsection E of 19.15.17.13 NMAC and was backfilled with compacted, non-waste containing, earthen material.
