Pit, Below-Grade Tank, or  
Proposed Alternative Method Permit or Closure Plan Application

**Hilcorp Energy Company  
San Juan Basin  
Below Grade Tank Closure Report**

**Lease Name: San Juan 28-6 Unit 162**

**API No.: 30-039-20492**

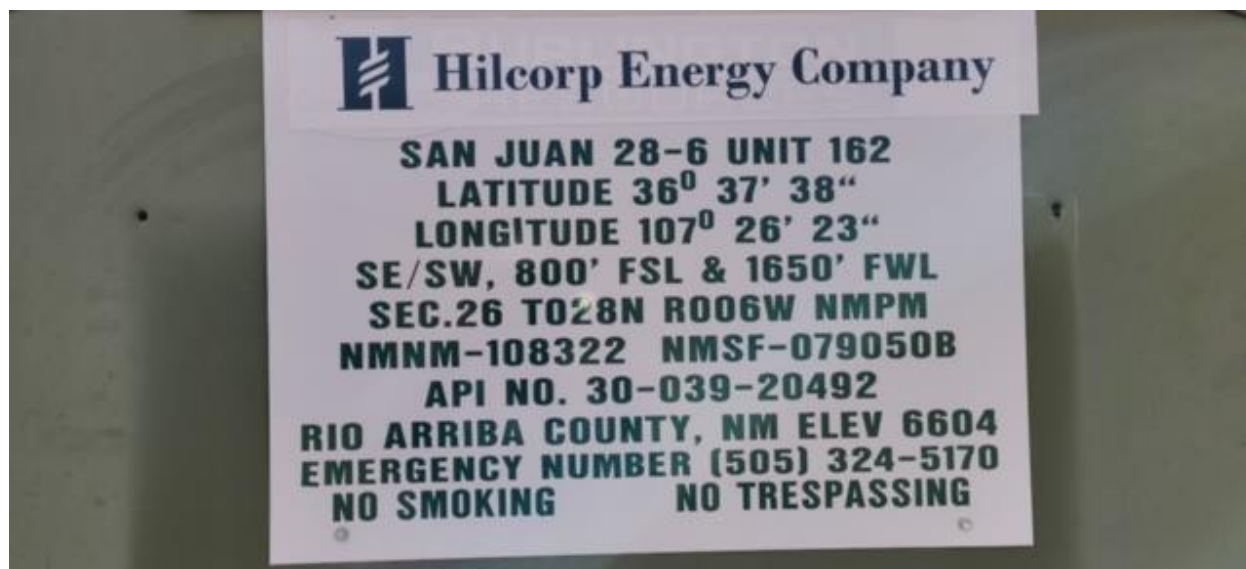
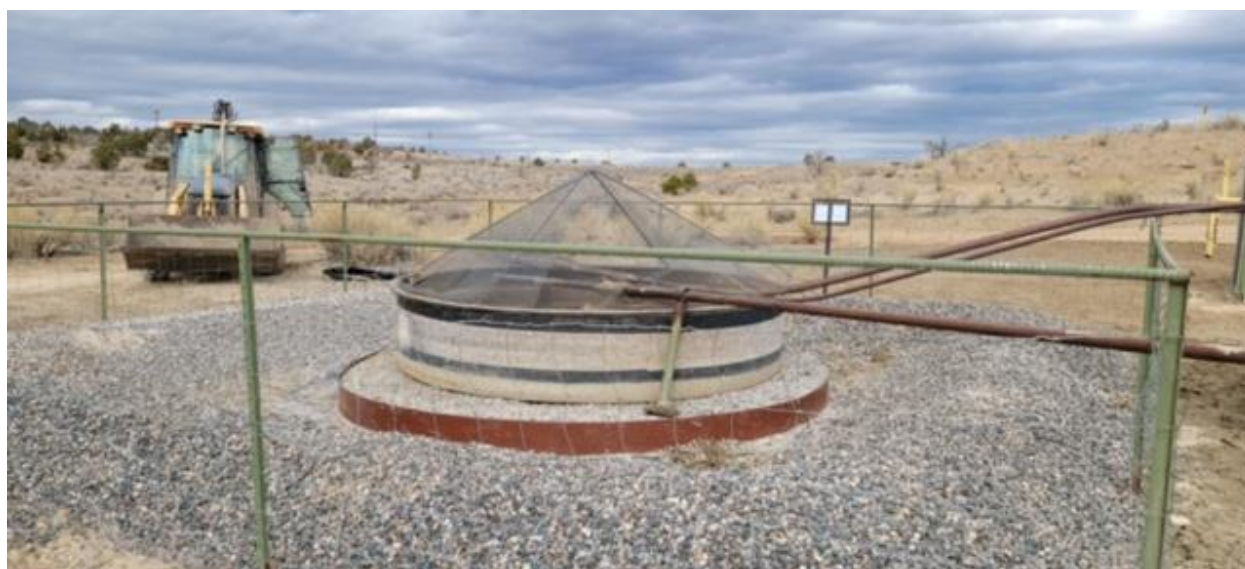
30-039-20492

Tied to INC# cJK2032155311. BGT was closed and reset as an AGT.
