Pit, Below-Grade Tank, or  
Proposed Alternative Method Permit or Closure Plan Application

**Hilcorp Energy Company  
San Juan Basin  
Below Grade Tank Closure Report**

**Lease Name: San Juan 28-7 Unit 56 BGT 1**

**API No.: 30-039-07401**

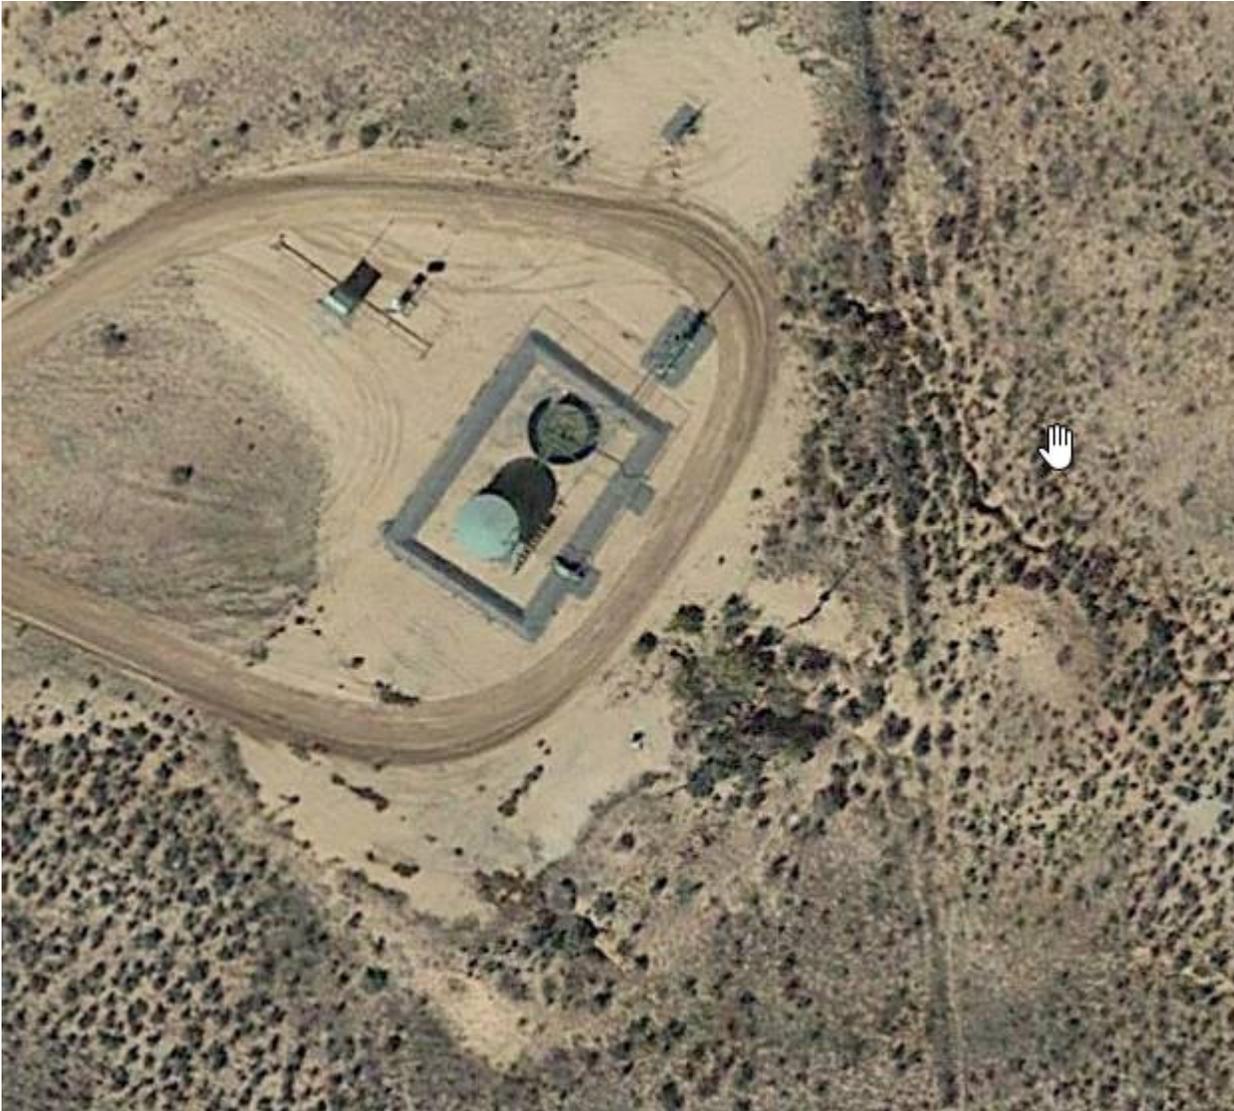
Current View

<b>Today's Date:</b>	1/26/2021				
<b>Well Name:</b>	SAN JUAN 28-7 UNIT 56	<b>Location:</b>	Sec: 13	Twn: 028N	Rng: 007
<b>API Number:</b>	30.039.07401	<b>Footage:</b>	980' FSL & 1000' FWL		
<b>Operator:</b>	Hilcorp Energy Company	<b>Area/Run/MSO:</b>	10	1007	Greg Vald
<b>Meter #:</b>	71-409-01		<b>Pipeline:</b>	ENT	
<b>INC Number:</b>	Verbal.JK.110220	<b>Agency:</b>	OCD	<b>Inspector:</b>	Jonathan K
<b>Type of INC:</b>	Verbal	<b>Photos Required:</b>	<b>Yes</b>	<b>Due Date:</b>	
<b>Issue of Concern:</b>	Well file has 2 C-144 below grade tank registrations in well file, only 1 bgt on location.

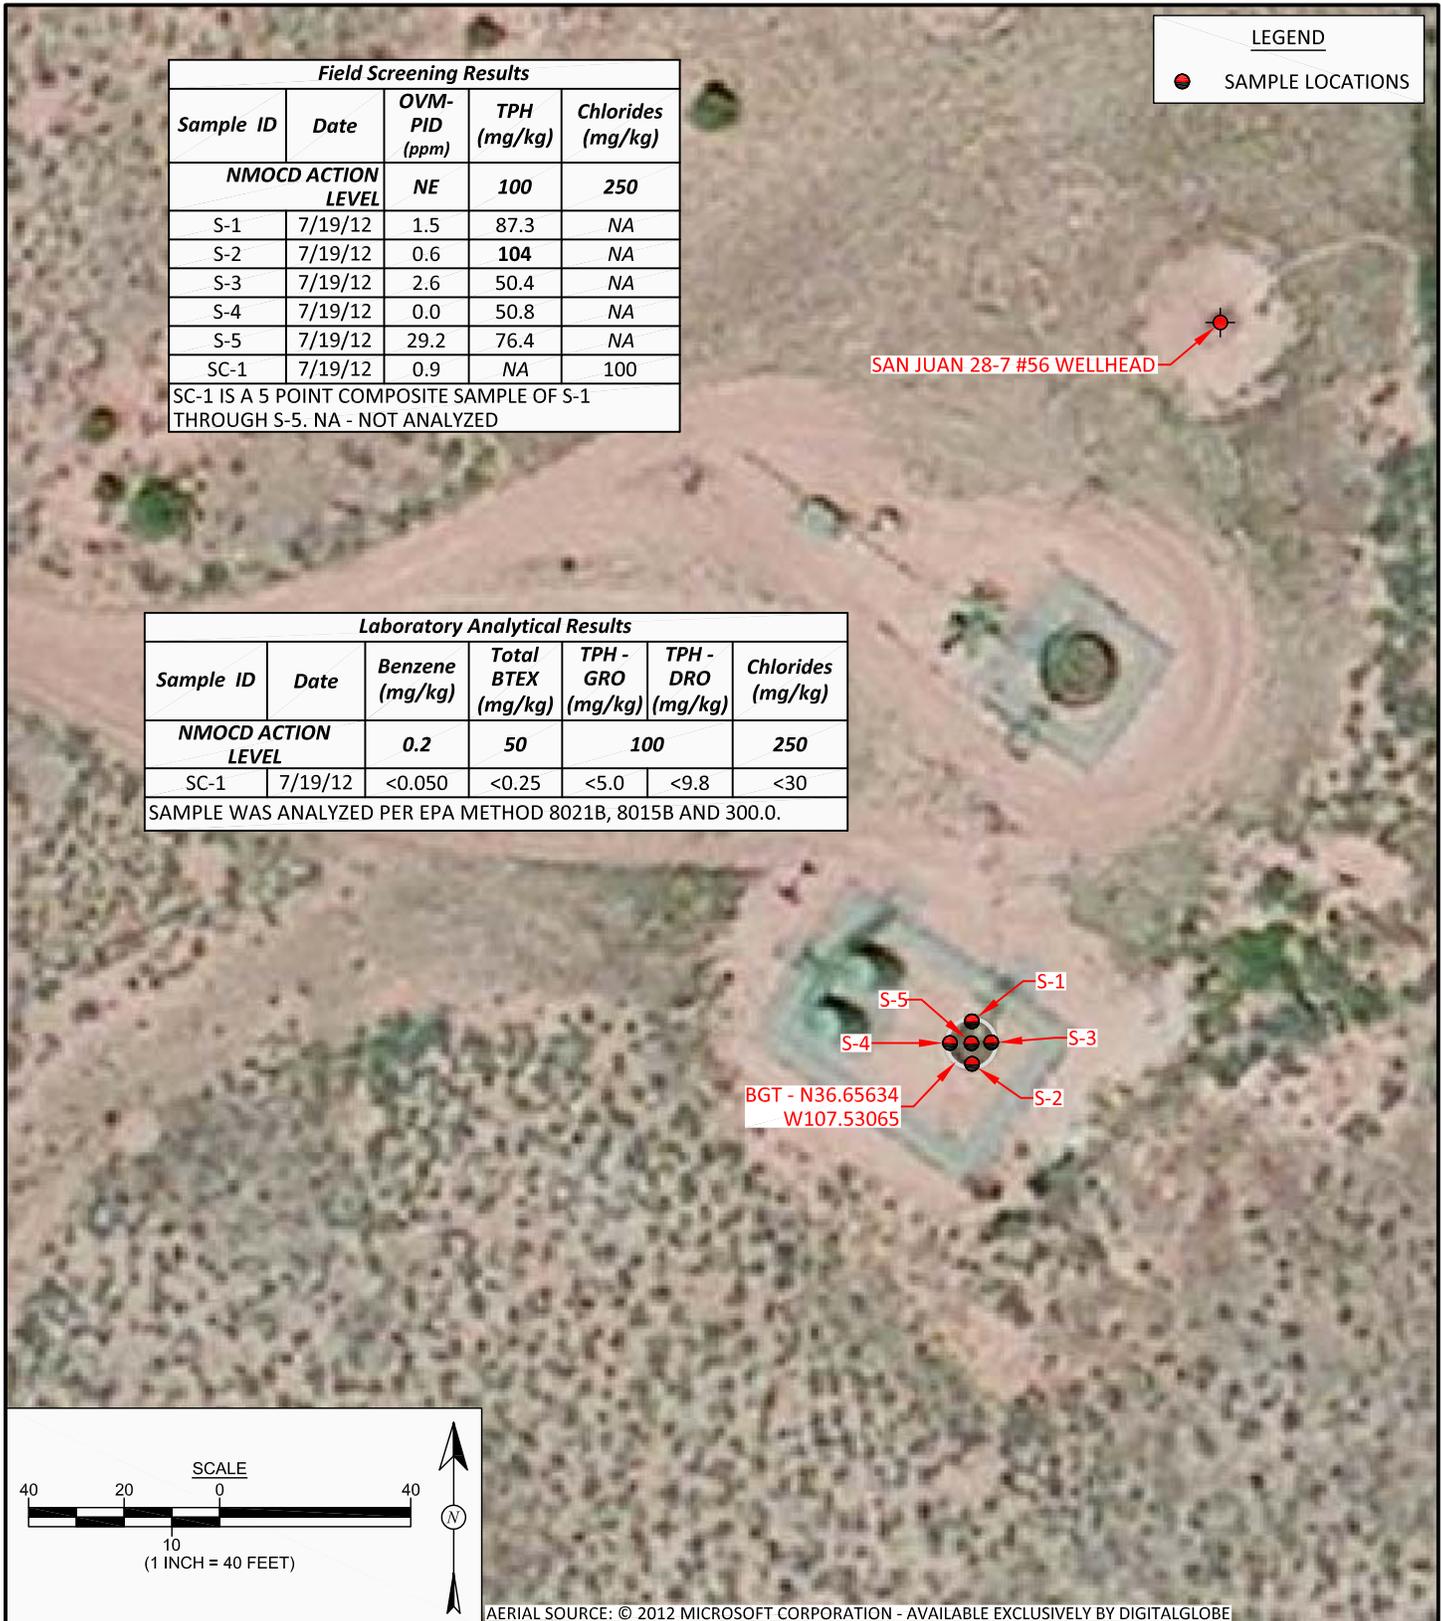
<b>DRAWN BY:</b> C. Lameman	<b>DATE DRAWN:</b> August 3, 2012	<h2 style="text-align: center;">FIGURE 2</h2> <p style="text-align: center;"><b>AERIAL SITE MAP BELOW GRADE TANK CLOSURE JULY 2012</b></p> <p style="text-align: center;">ConocoPhillips SAN JUAN 28-7 #56 RIO ARRIBA COUNTY, NEW MEXICO SW<math>\frac{1}{4}</math> SW<math>\frac{1}{4}</math>, SECTION 13, T28N, R7W N36.65672, W107.53050</p>
	<b>REVISIONS BY:</b> C. Lameman	<b>DATE REVISED:</b> August 3, 2012	
	<b>CHECKED BY:</b> D. Watson	<b>DATE CHECKED:</b> August 3, 2012	
	<b>APPROVED BY:</b> E. McNally	<b>DATE APPROVED:</b> August 3, 2012
