Pit, Below-Grade Tank, or  
Proposed Alternative Method Permit or Closure Plan Application

1.  
Operator: Enduring Resources, LLC OGRID #: 372286  
Address: 200 Energy Court, Farmington, New Mexico 87401  
Facility or well name: Marshall A 3  
API Number: 30-045-06536 OCD Permit Number: \_\_\_\_\_  
U/L or Qtr/Qtr G Section 15 Township 27N Range 9W County: San Juan  
Center of Proposed Design: Latitude 36.578597 Longitude -107.772393 NAD83  
Surface Owner: ☐ Federal ☐ State ☐ Private ☒ Tribal Trust or Indian Allotment

Enduring Resources, LLC  
BGT Closure Report  
Marshall A 3  
30-045-06536

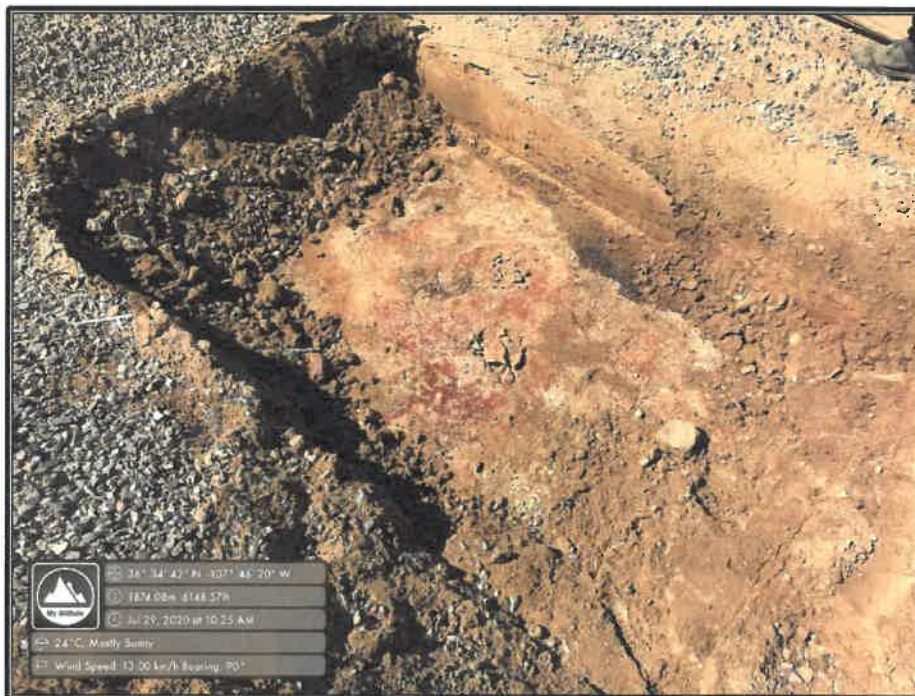
PHOTO 2: Former BGT Location after Removal (7/29/2020)

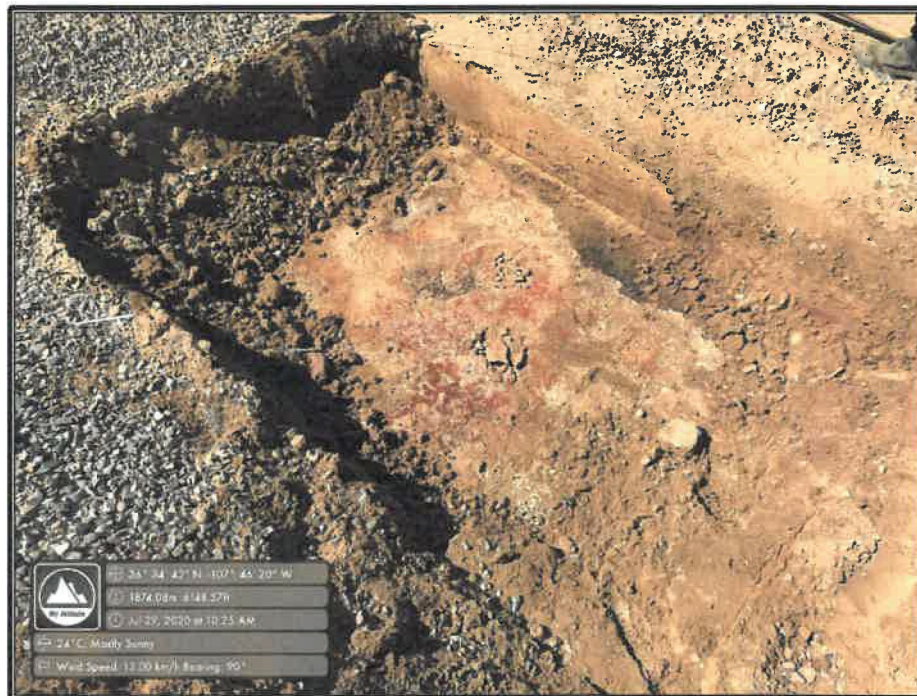
PHOTO 2: Former BGT Location after Removal (7/29/2020)

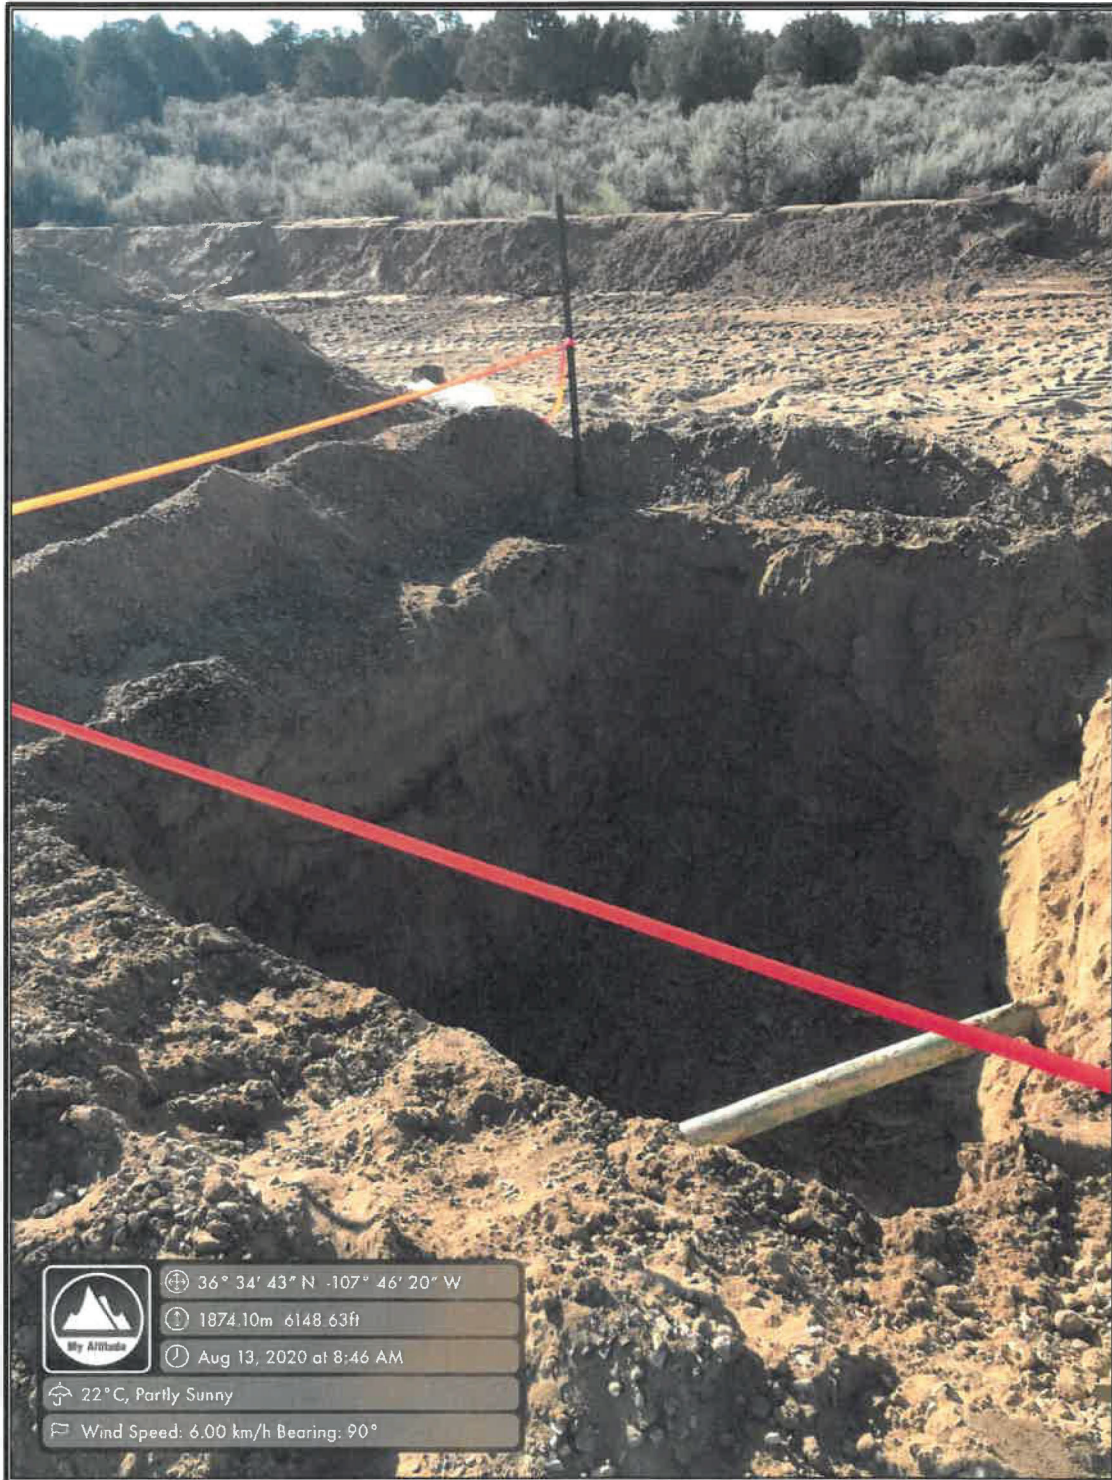
PHOTO 4: Excavated Area (8/13/2020)

Two of the samples from the Marshall A 3 failed the 100 ppm TPH standard for this location. The South Wall and the Bottom at 5' below ground surface. Additional excavation will take place on these areas on Monday, August 24, and sampling will occur on Tuesday August 25<sup>th</sup> at 9 AM. Thank you for your time in regards to this matter. Sample results are included for your reference.
