Pit, Below-Grade Tank, or
Proposed Alternative Method Permit or Closure Plan Application

1.
Operator: Hilcorp Energy Company OGRID #: 372171
Address: 382 Road 3100 Aztec, NM 87410
Facility or well name: Schwerdtfeger A 3M
API Number: 30-045-11605 OCD Permit Number: _____
U/L or Qtr/Qtr D Section 6 Township 27N Range 8W County: San Juan
Center of Proposed Design: Latitude 36.60923 Longitude -107.727739 NAD83
Surface Owner: ☒ Federal ☐ State ☐ Private ☐ Tribal Trust or Indian Allotment

On May 31, 2019 Hilcorp Energy sampled 2 – BGTs at the Schwerdtfeger A 3M for closure. The 95 bbl BGT did not pass in accordance with the approved BGT pit closure plan approved by NMOCD on 07/06/2016. Hilcorp then requested permission to backfill both BGTs with the intent of re-excavating and removing remaining contaminants of the 95 bbl BGT once the re-fracing was completed at that site (email included).

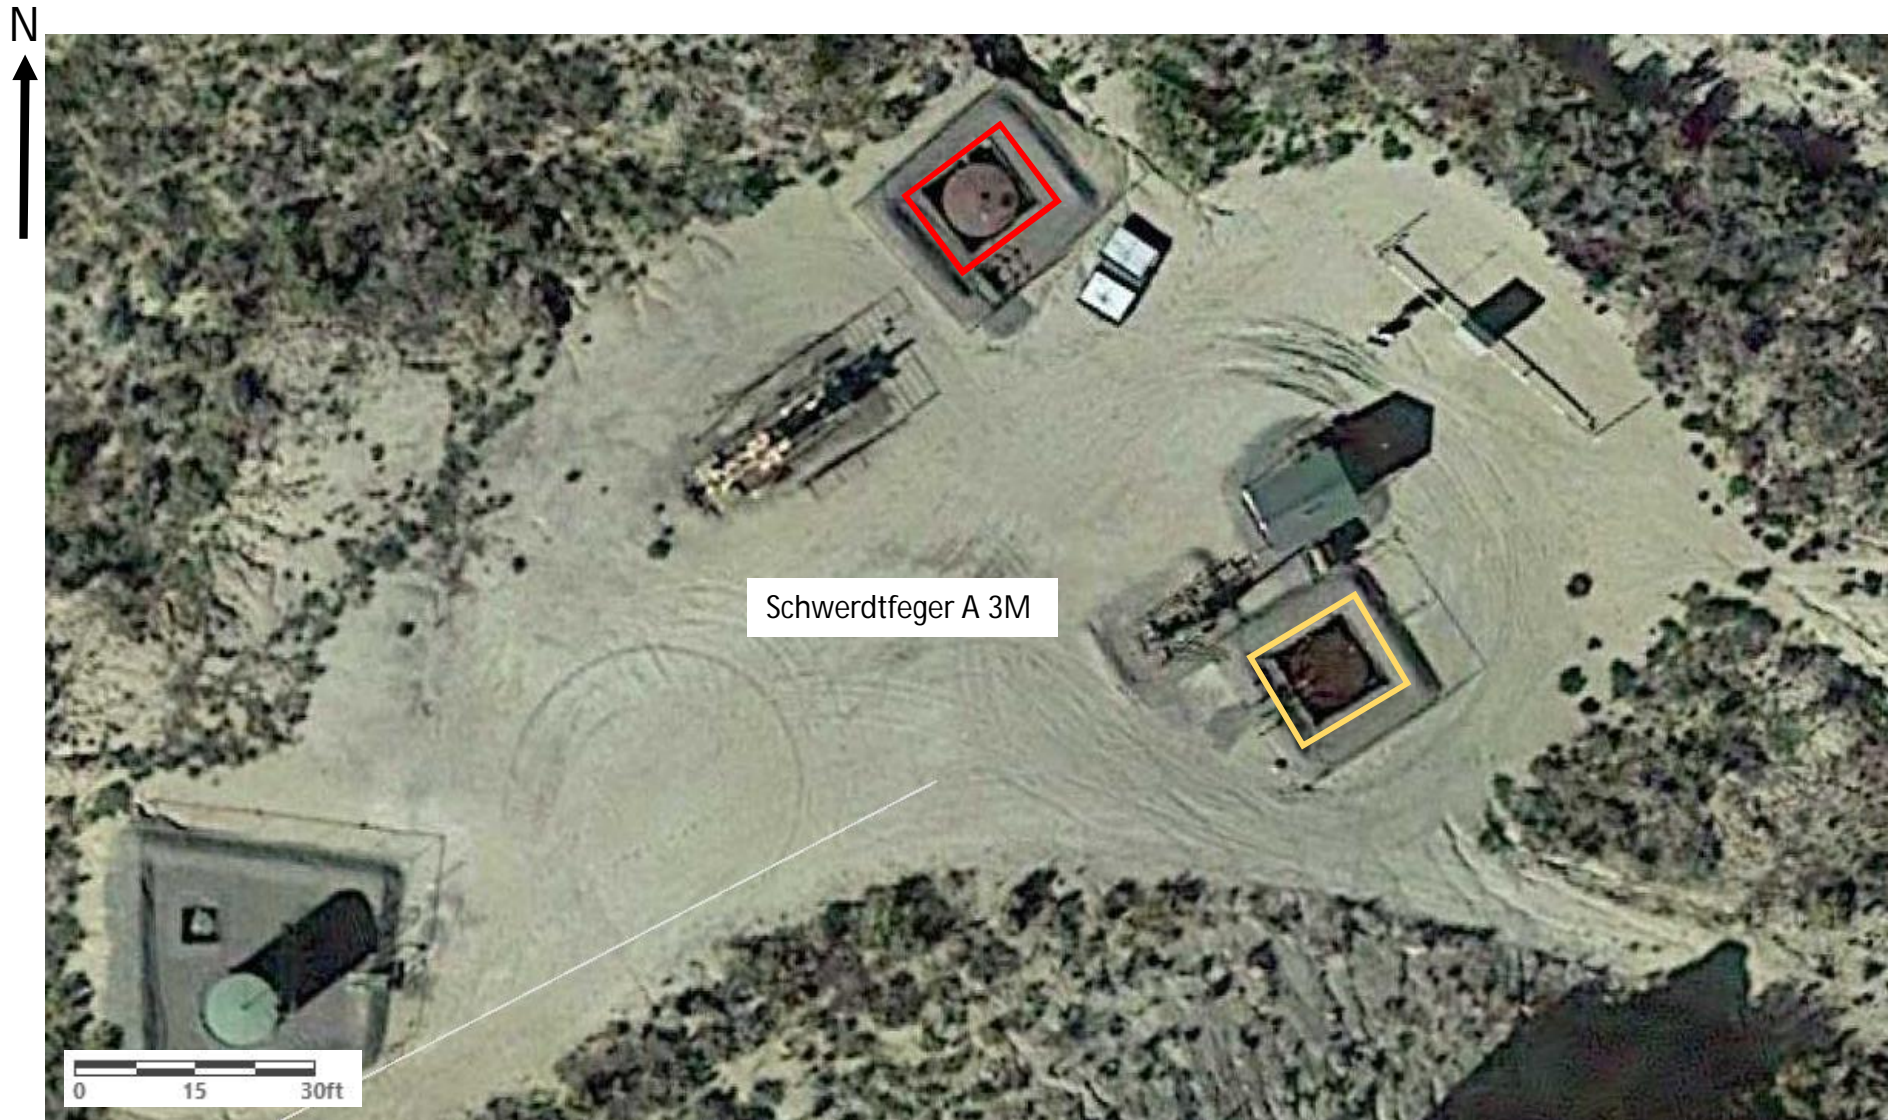
- 95 bbl BGT
- 21 bbl BGT

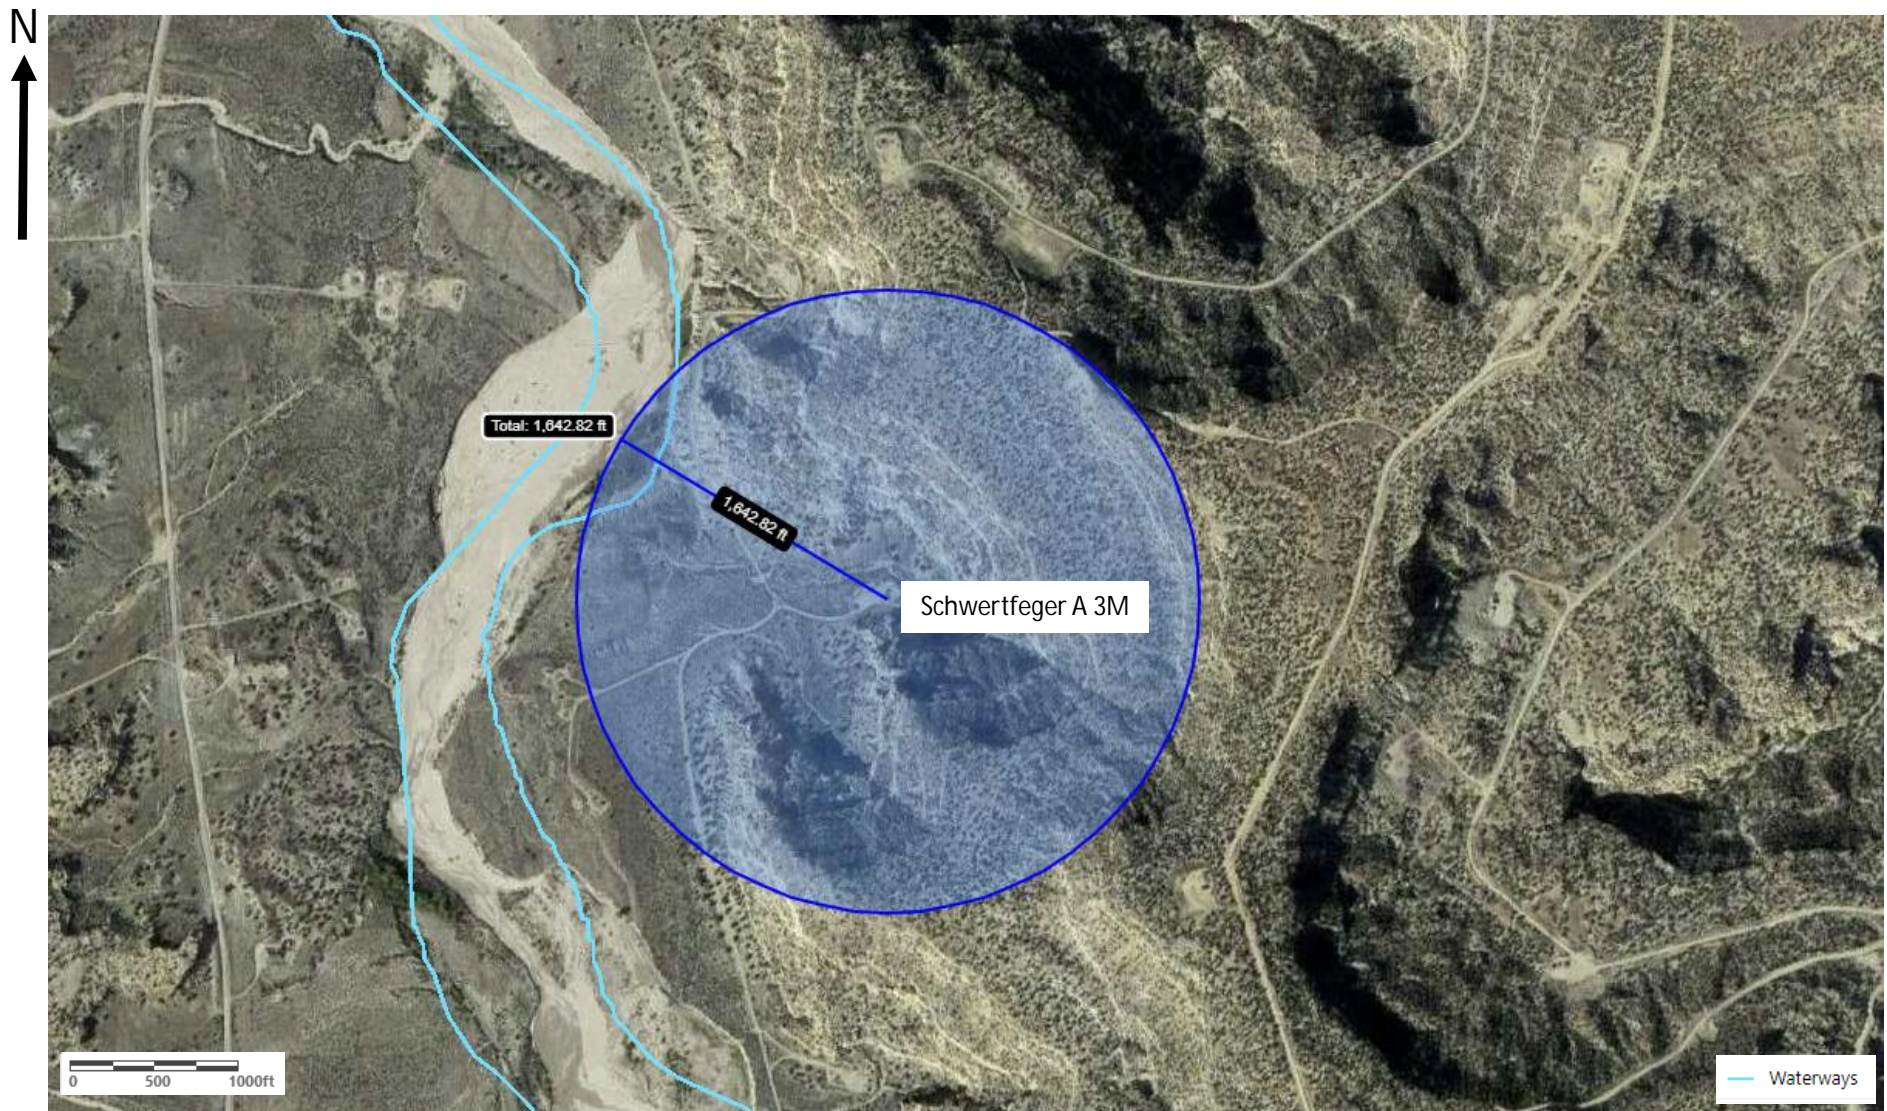
Distance to watercourse approximately 1,643 ft

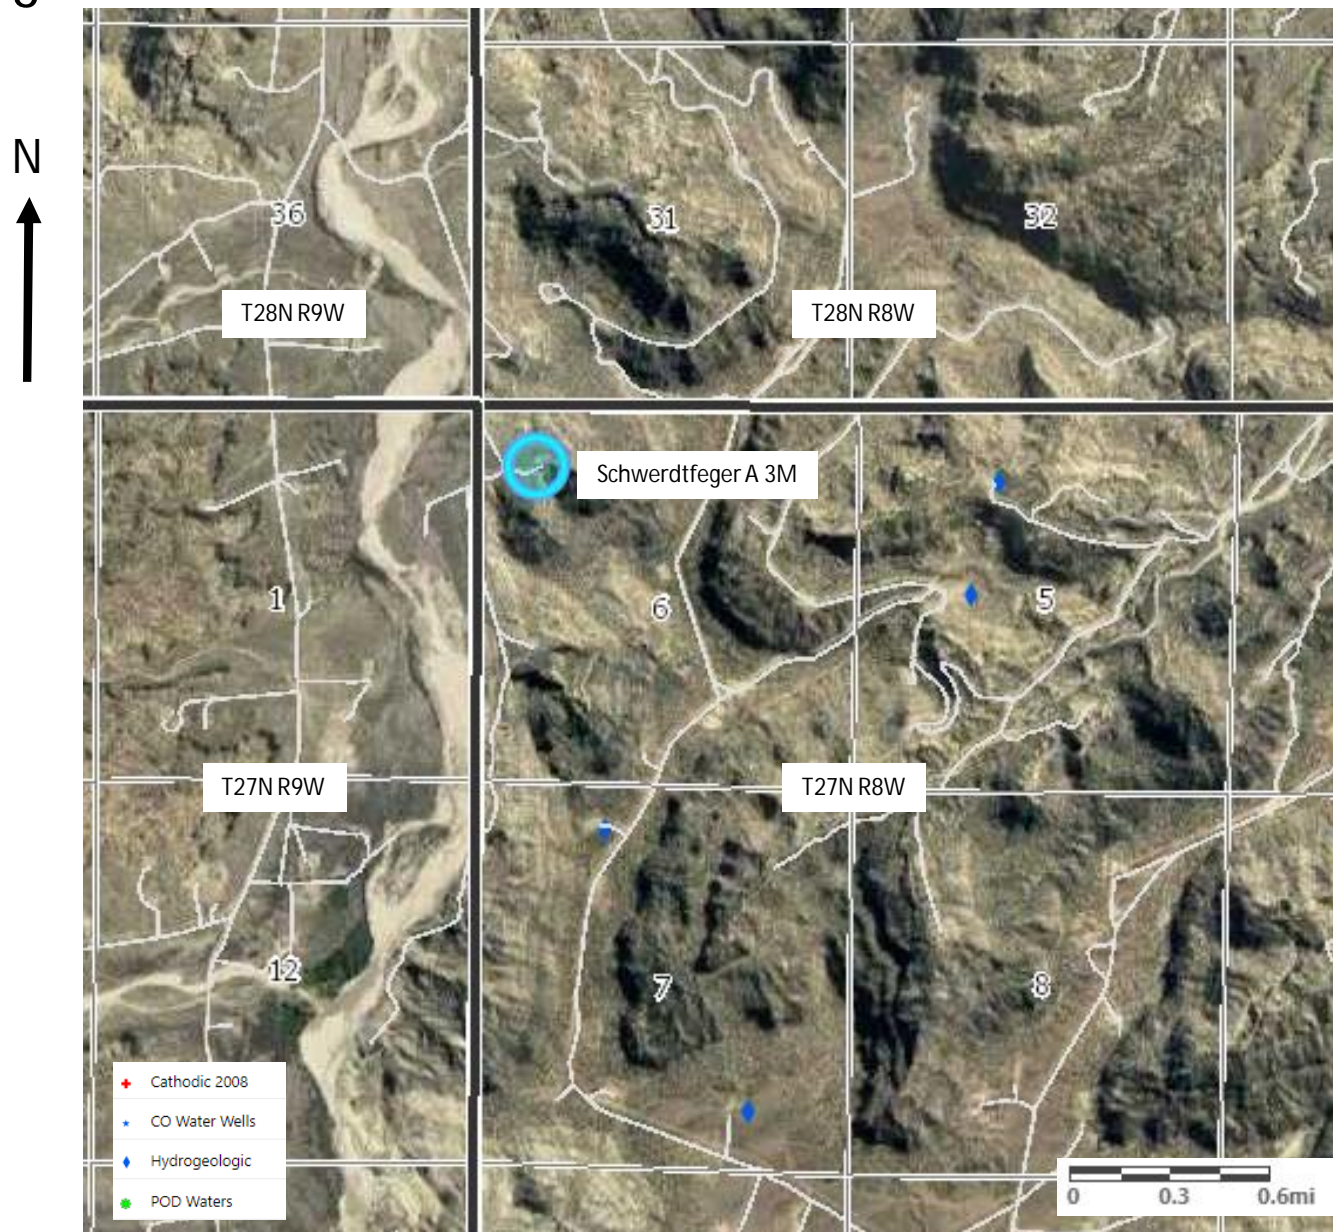
Depth to groundwater

No groundwater depth data available on the NM Office of the State Engineer website or cathodic data from HEC

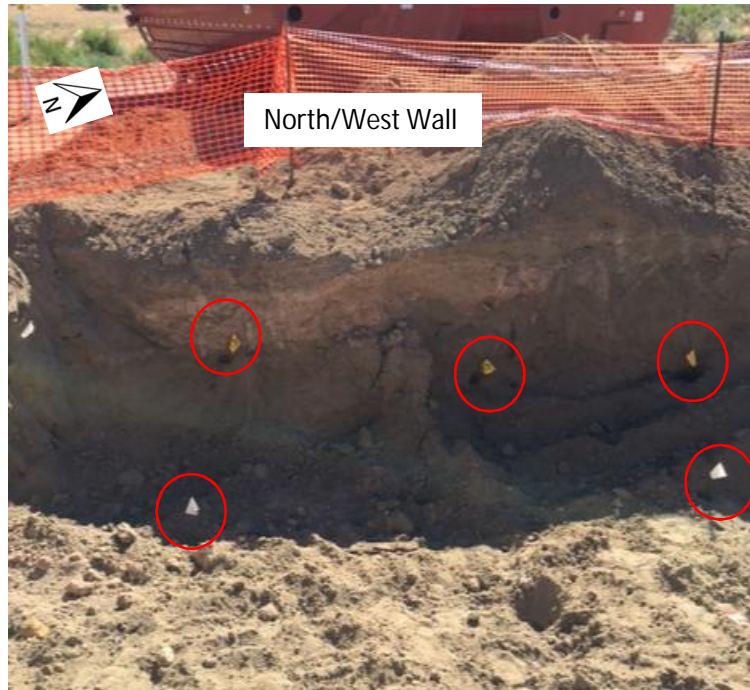
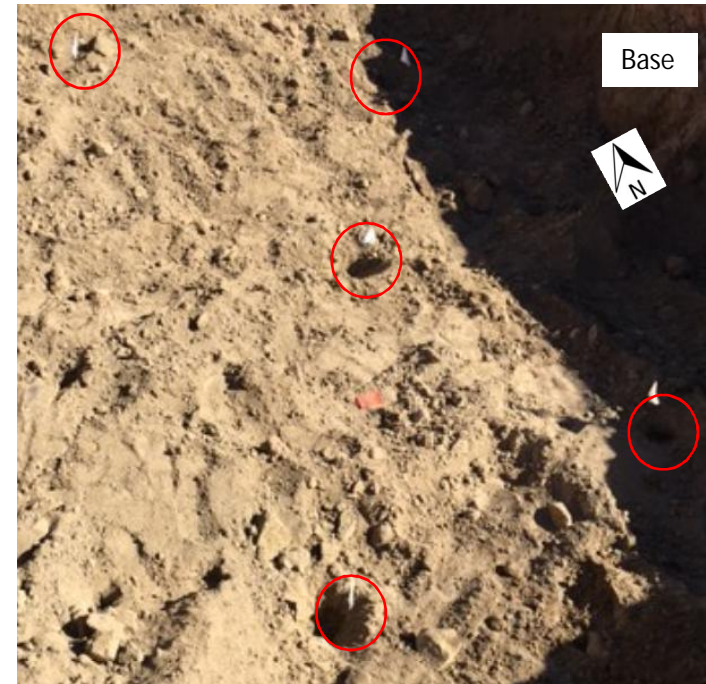
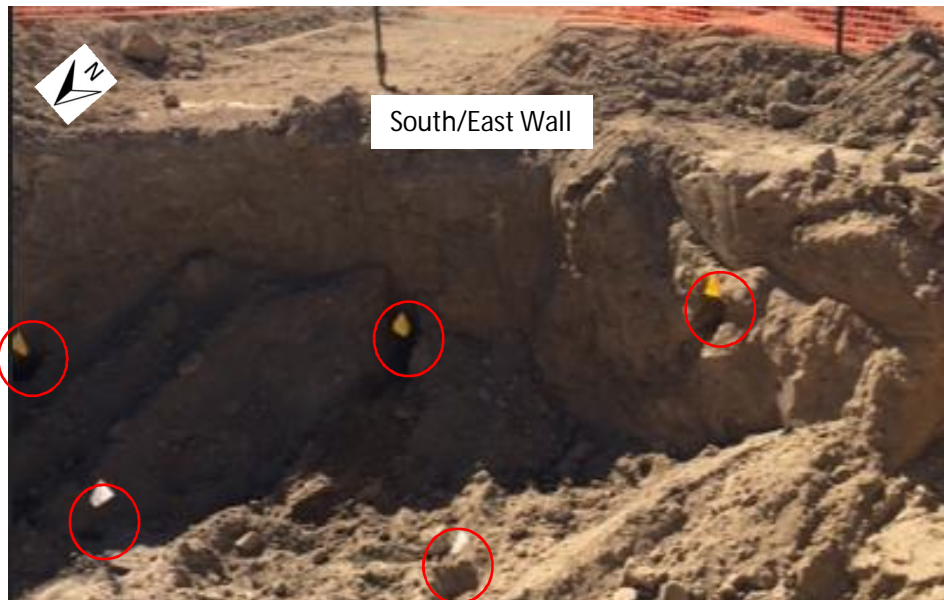
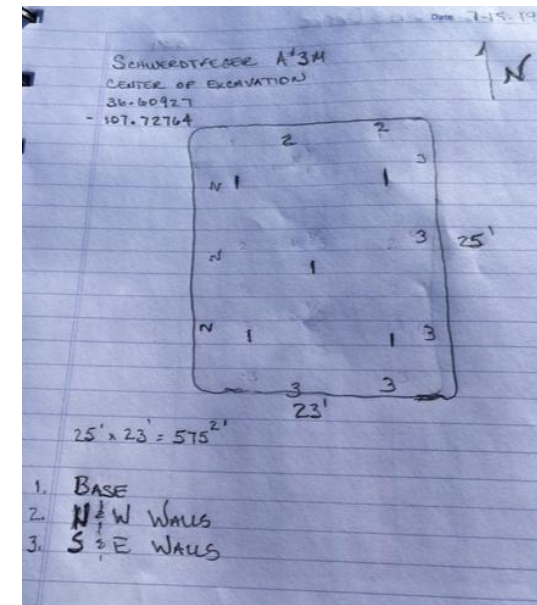
Sample locations from excavation of 95 bbl BGT

Confirmation samples taken on 5/31/2019 in accordance with NMAC 19.15.29.12.D. The 95 bbl BGT failed on Total TPH. The area of the BGT was excavated and samples were taken again on 7/11/2019 in accordance with NMAC 19.15.29.12.D. NMOCD was present during the sampling event. Because there was no groundwater data for this site the closure standards from the BGT permit was utilized. For any future reporting and/or closures this will be revisited as necessary.
