Pit, Below-Grade Tank, or  
Proposed Alternative Method Permit or Closure Plan Application

**Hilcorp Energy Company**  
**San Juan Basin: New Mexico Assets**  
Below Grade Tank Closure Report

**Lease Name:** Huerfano Unit 260

**API No.:** 30-045-21410

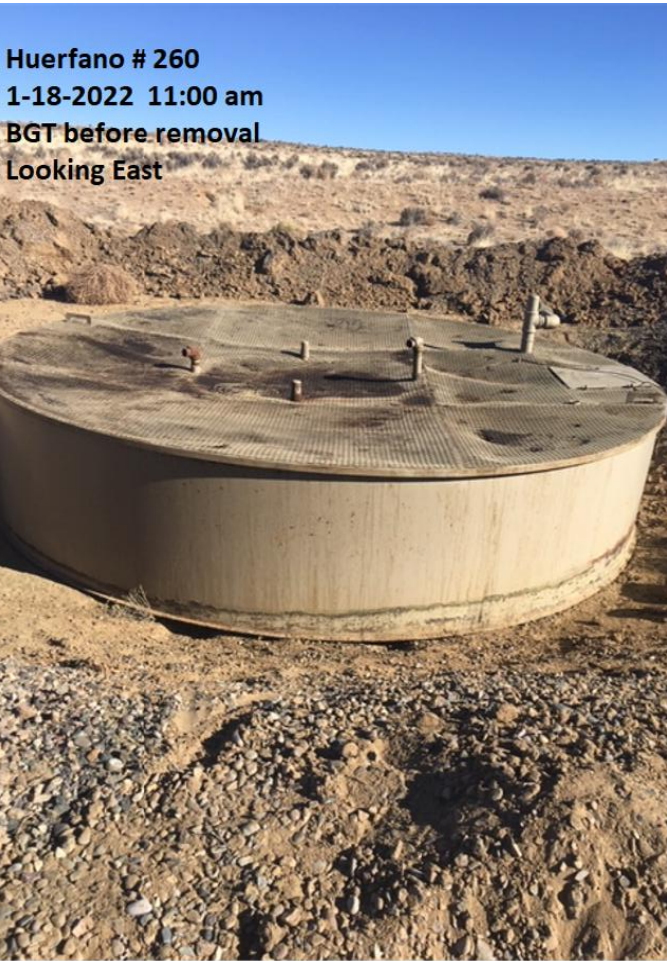
Huerfano # 260  
1-18-2022 11:00 am  
BGT before removal  
Looking East

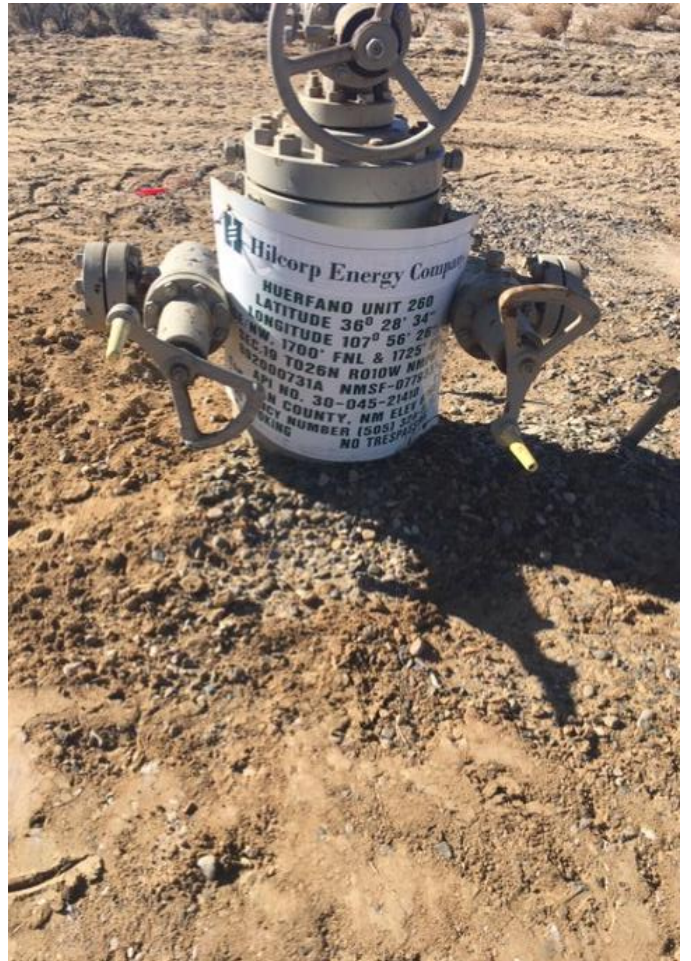
Huerfano # 260  
1-18-2022 11:45 am  
BGT Closure Sample Points  
Looking South
