Pit, Below-Grade Tank, or
Proposed Alternative Method Permit or Closure Plan Application

1.
Operator: LOGOS Operating, LLC OGRID #: 289408
Address: 2010 Afton Place, Farmington, NM 87401
Facility or well name: ROSA UNIT 010B
API Number: 30-039-26556 OCD Permit Number: _____
U/L or Qtr/Qtr N Section 13 Township 31N Range 06W County: Rio Arriba
Center of Proposed Design: Latitude 36.8931885 Longitude -107.4141998 NAD83
Surface Owner: ☐ Federal ☒ State ☐ Private ☐ Tribal Trust or Indian Allotment

3.
☒ **Below-grade tank:** Subsection I of 19.15.17.11 NMAC
Volume: 120 bbl Type of fluid: Produced Water
Tank Construction material: Fiberglass with banded 20 mil HDPE liner
☐ Secondary containment with leak detection ☐ Visible sidewalls, liner, 6-inch lift and automatic overflow shut-off
☒ Visible sidewalls and liner ☐ Visible sidewalls only ☐ Other _____
Liner type: Thickness 20 mil ☒ HDPE ☐ PVC ☐ Other _____

Closure Report (required within 60 days of closure completion): 19.15.17.13 NMAC

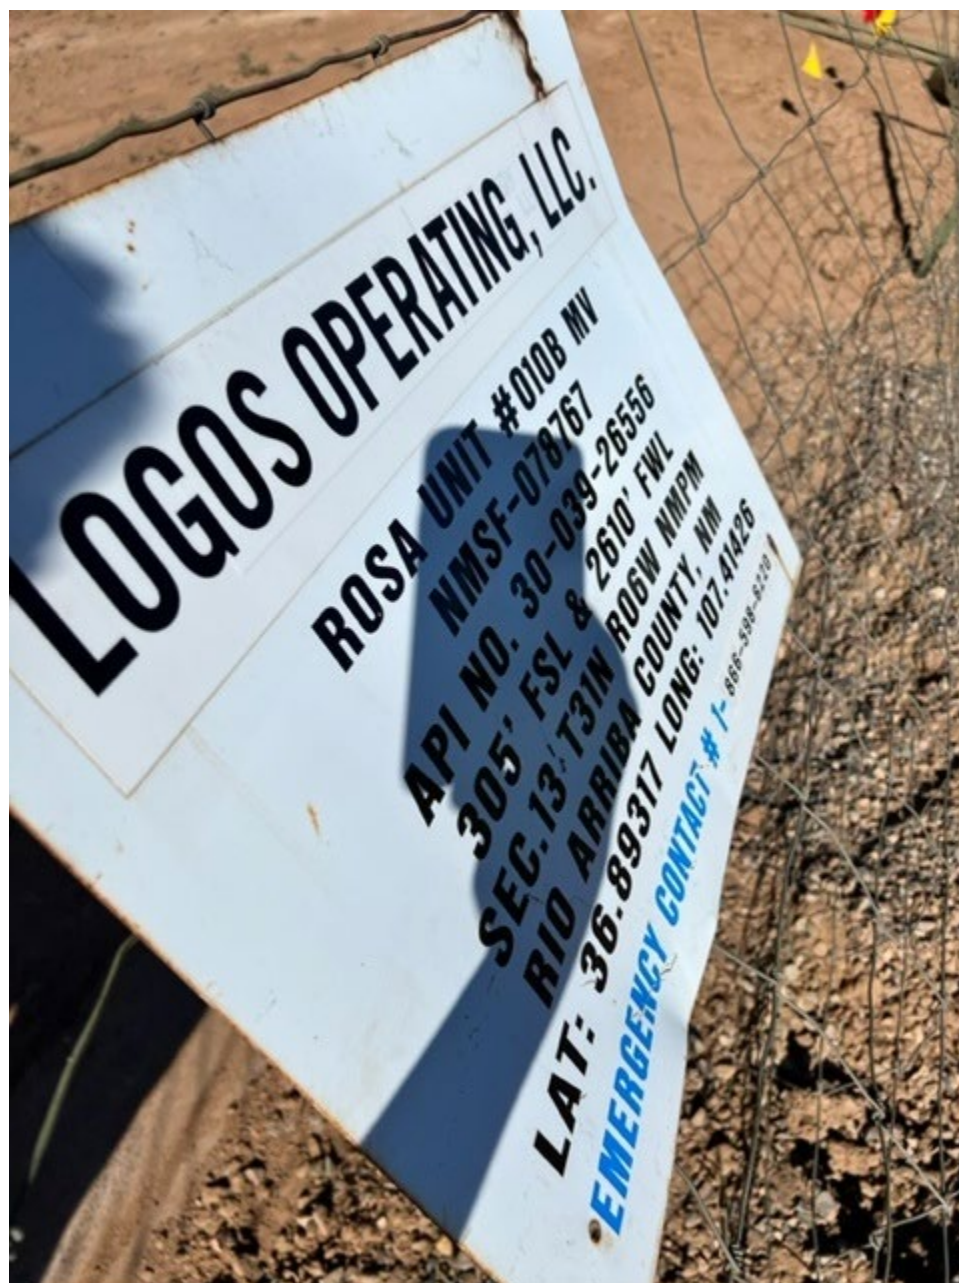
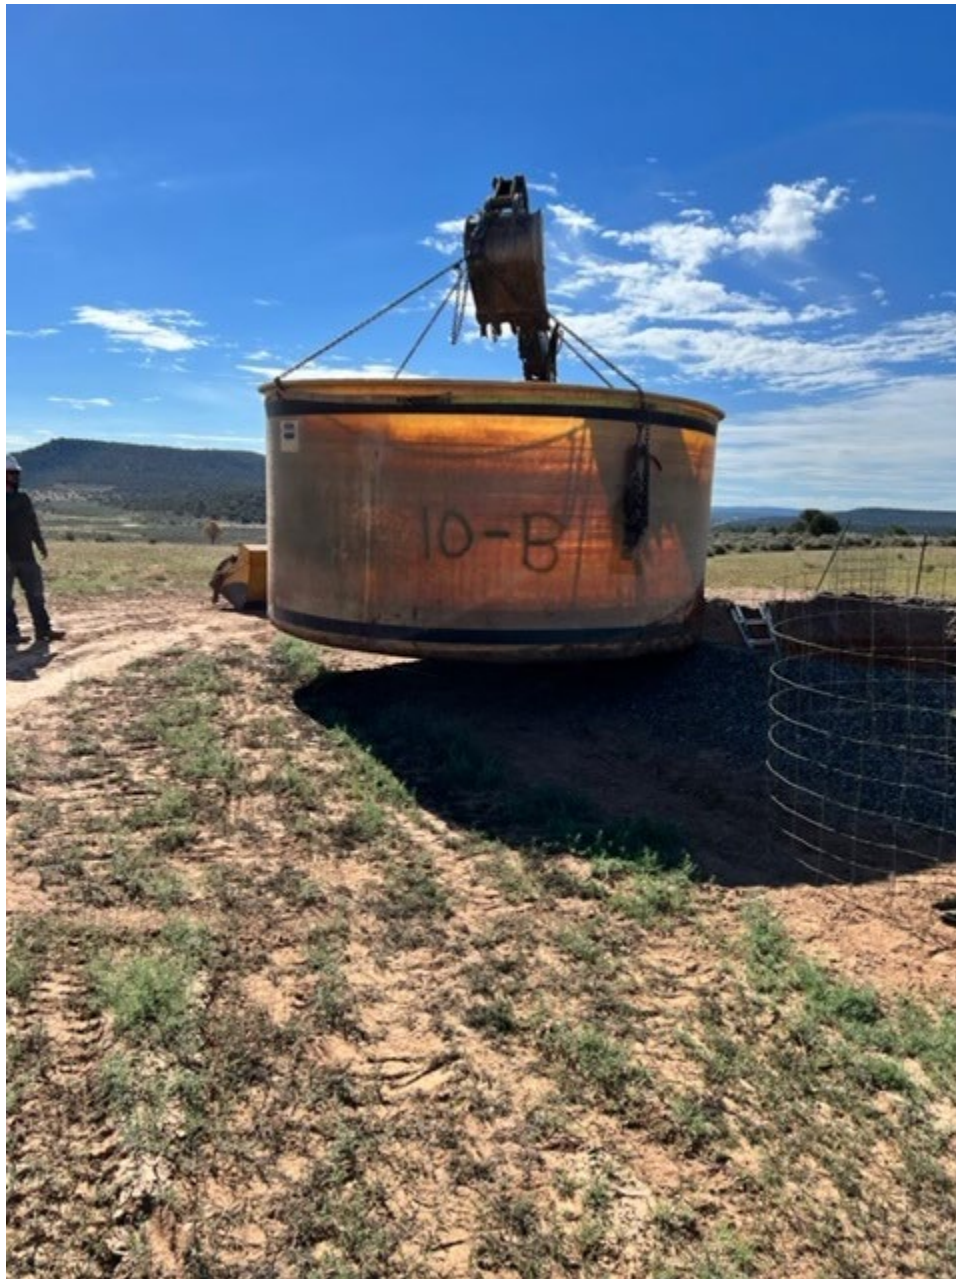
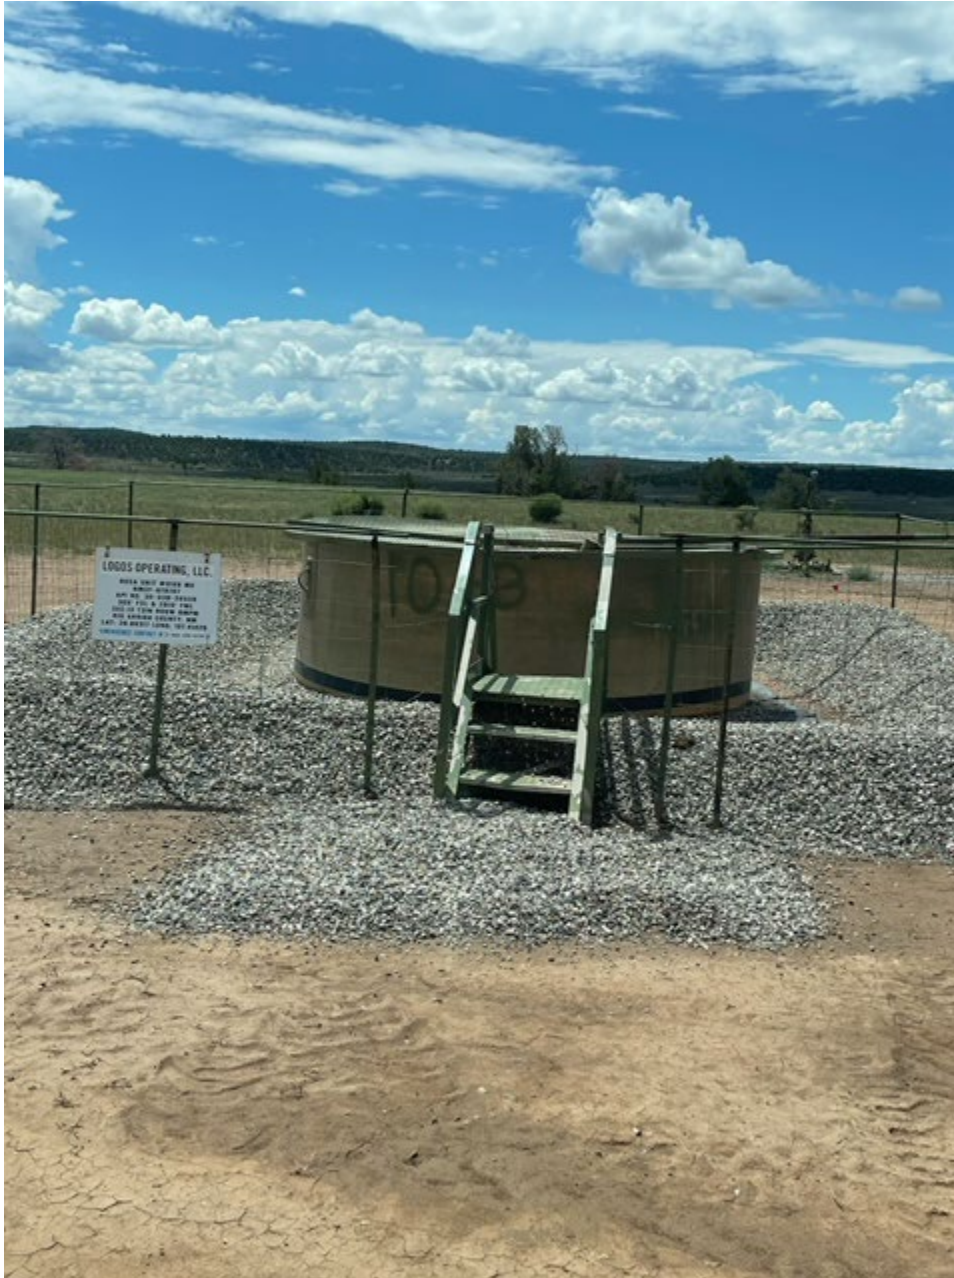
Rosa Unit 10B

On July 1, 2022, LOGOS Operating LLC. removed the fiberglass below grade tank on the Rosa Unit #10B. When the BGT was removed no visible signs of staining or wet soil was observed. LOGOS collected (1) 5-point composite sample from where the BGT was removed. The closure samples were analyzed by Envirotech Labs, and all constituents analyzed were non-detect. Emmanuel Adeloje with the BLM was onsite and witnessed all confirmation sampling.

7. Upon closing of the BGT, Logos will reclaim the unused BGT location to a safe and stable condition that blends with the surrounding undisturbed area as provided in Paragraph 2 of subsection H of 19.15.17.13 as well as recontouring the area in accordance with paragraph 5 in subsection H of 19.15.17.13 NMAC. The soil cover will be constructed to prevent ponding of water and erosion of the cover material.

8. The reclamation of the BGT area will contain a uniform vegetative cover that reflects a life-form ratio of plus or minus fifty (50%) of pre-disturbance levels and a total percent plant cover of at least seventy (70%) of pre-disturbance levels, excluding noxious weeds. The re-vegetation and reclamation obligations imposed by other applicable federal or tribal agencies that manage the lands will supersede these provisions and govern the obligations. Logos will notify the division when reclamation and re-vegetation is complete.
9. Logos will submit a closure report on form C-144 within 60 days of closure completion. The closure report will contain the following:
