Pit, Below-Grade Tank, or
Proposed Alternative Method Permit or Closure Plan Application

Hilcorp Energy Company
San Juan Basin
Below Grade Tank Closure Report

Lease Name: Havasu Com 1
API No.: 30-045-29458

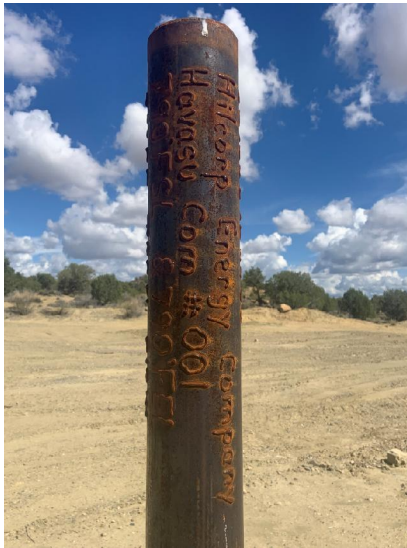
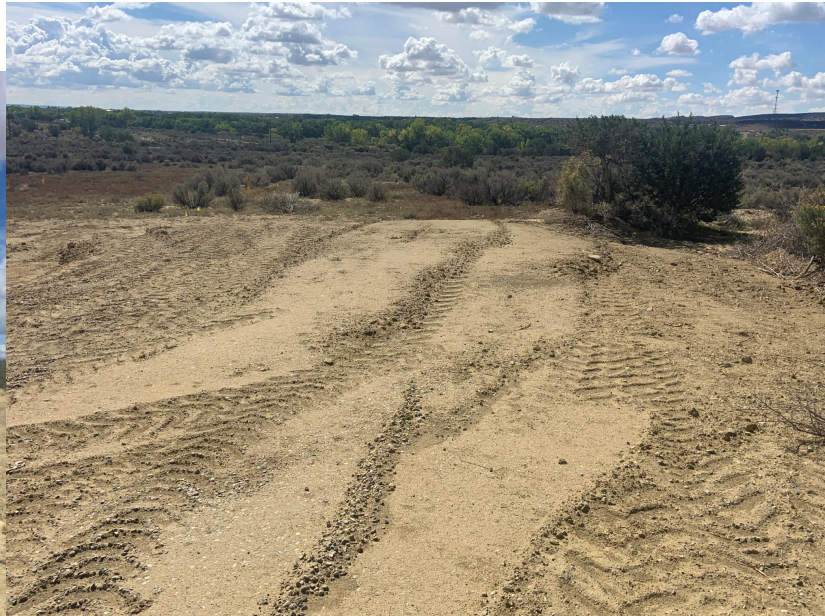
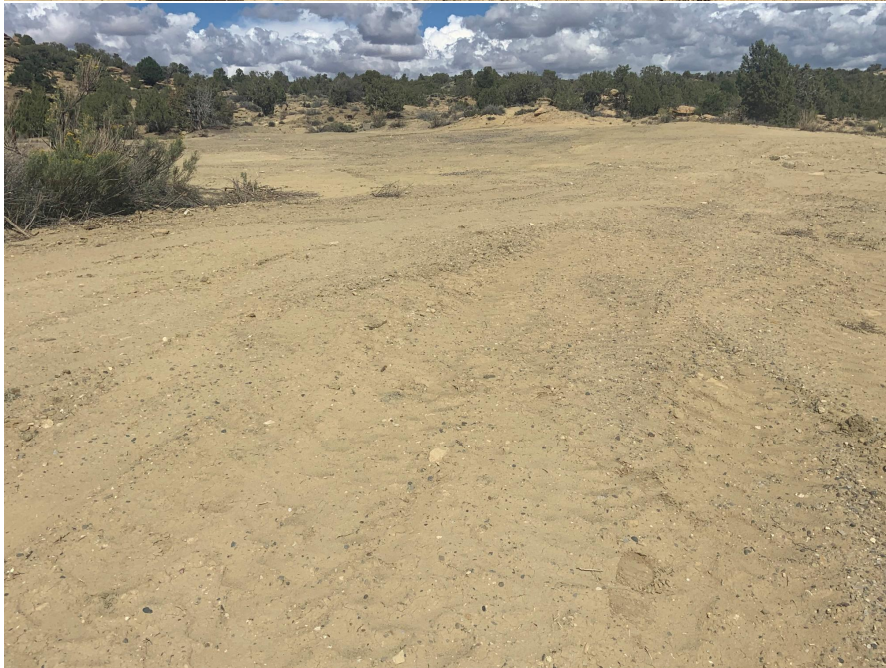
Post Closure Photos

The below-grade tank area passed all requirements of Paragraph (4) of Subsection E of 19.15.17.13 NMAC and was backfilled with compacted, non-waste containing, earthen material.
