Hilcorp Energy Company San Juan Basin Below Grade Tank Closure Report

Lease Name: Frost 5 API No.: 30-045-06293

Frost 5 - Pre Closure Photos

Frost 5 - Post Closure Photos

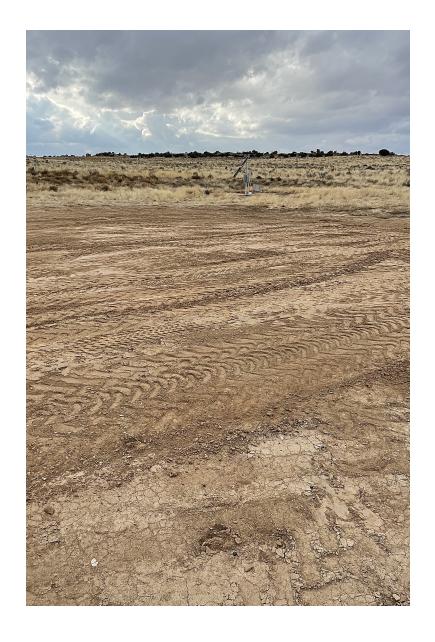
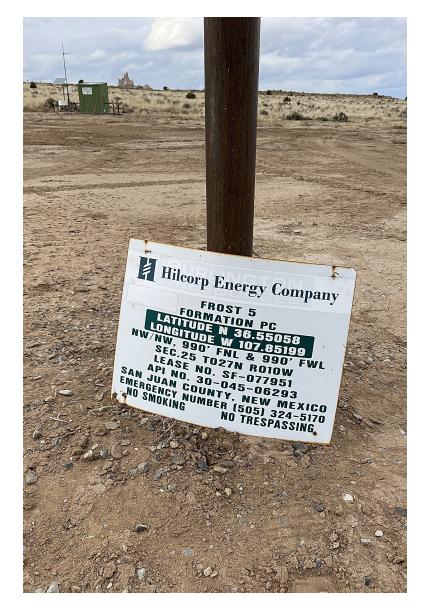
The below-grade tank area was re-contoured to match fit, shape, line, form and texture of the surrounding area. Re-shaping including drainage control, to prevent ponding and erosion. Natural drainages were unimpeded and water bars and/or silt traps were placed in areas where needed to prevent erosion on a large scale. Final recontour has a uniform appearance with smooth surface, fitting the natural landscape.

The below-grade tank area was backfilled and more than four feet of cover was achieved and the cover included one foot of suitable material to establish vegetation at the site.
