Proposed Alternative Method Permit or Closure Plan Application

Hilcorp Energy Company San Juan Basin Below Grade Tank Closure Report

Lease Name: Schwerdtfeger 14

API No.: 30-045-06827

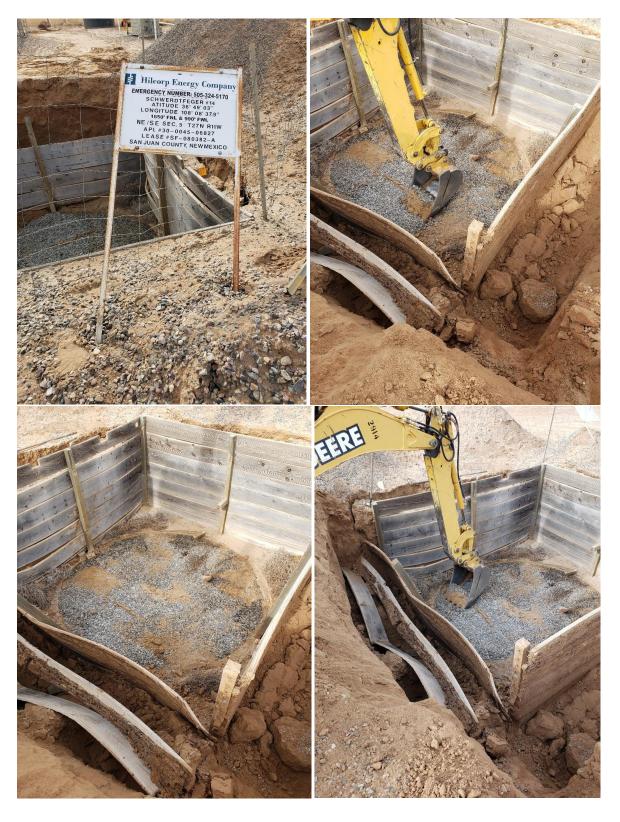
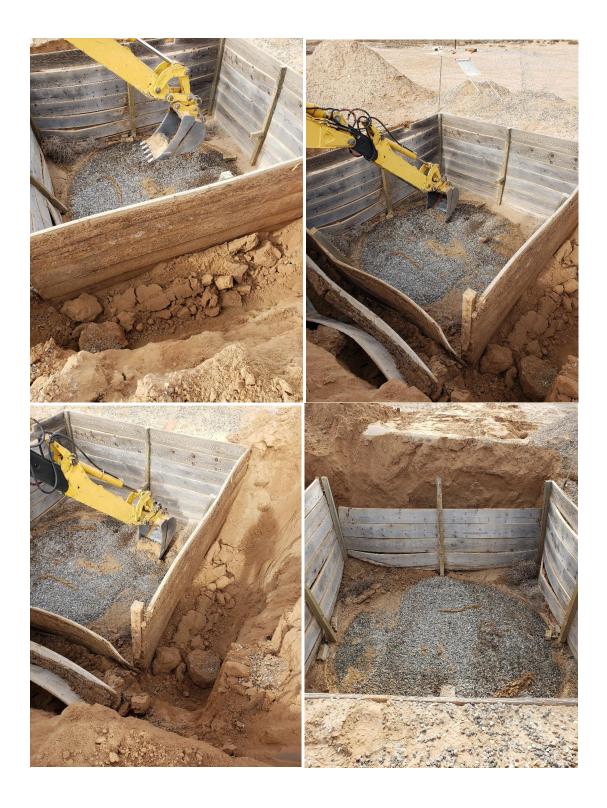
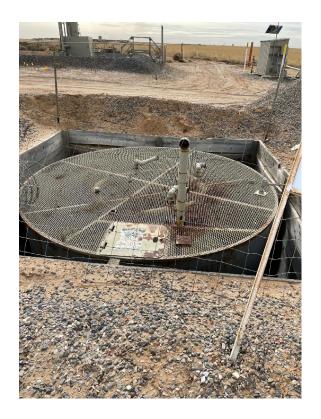
Pre Closure Photos

Photos of the BGT prior to closure

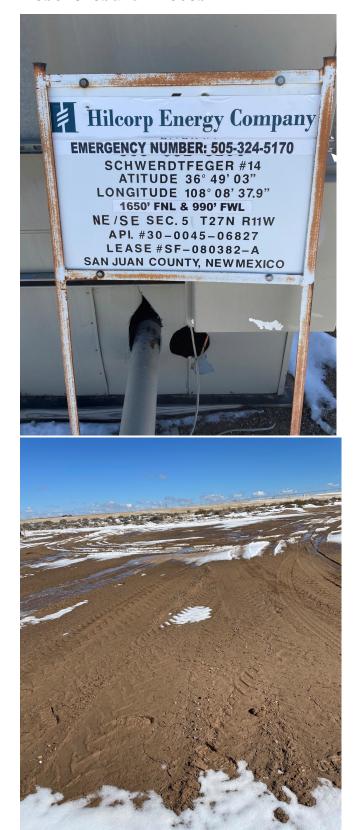
Post Closure Photos

Final state of the area after closure.

The below-grade tank area was re-contoured to match fit, shape, line, form and texture of the surrounding area. Re-shaping including drainage control, to prevent ponding and erosion. Natural drainages were unimpeded and water bars and/or silt traps were placed in areas where needed to prevent erosion on a large scale. Final recontour has a uniform appearance with smooth surface, fitting the natural landscape.

The below-grade tank area was backfilled and more than four feet of cover was achieved and the cover included one foot of suitable material to establish vegetation at the site.
