Pit, Below-Grade Tank, or
Proposed Alternative Method Permit or Closure Plan Application

**Hilcorp Energy Company
San Juan Basin
Below Grade Tank Closure Report**

Lease Name: Nassau 1
API No.: 30-045-20683

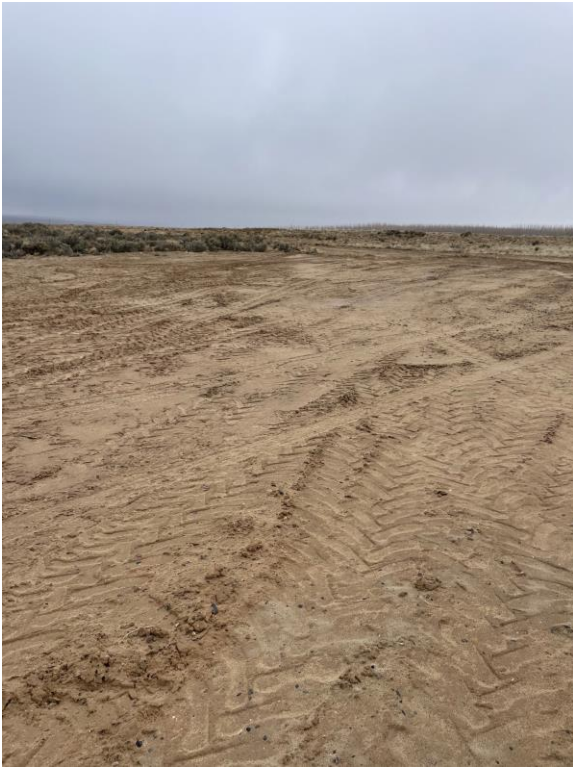
CLOSURE PHOTO

The below-grade tank area passed all requirements of Paragraph (4) of Subsection E of 19.15.17.13 NMAC and was backfilled with compacted, non-waste containing, earthen material.
