<u>Pit, Below-Grade Tank, or</u> <u>Proposed Alternative Method Permit or Closure Plan Application</u>

Hilcorp Energy Company San Juan Basin Below Grade Tank Closure Report

Lease Name: OH Randel 6E API No.: 30-045-24751

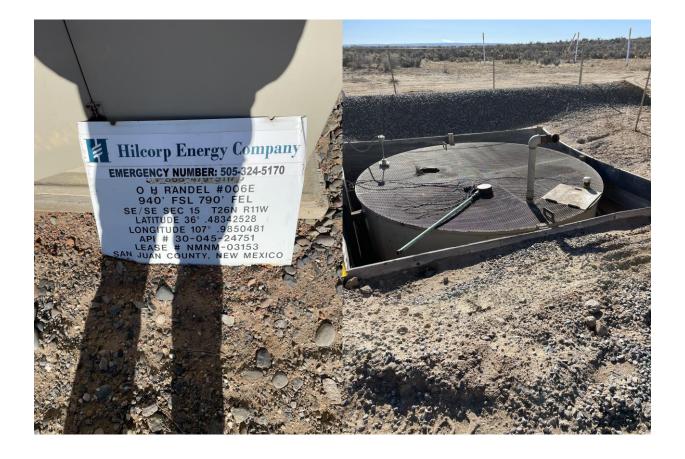
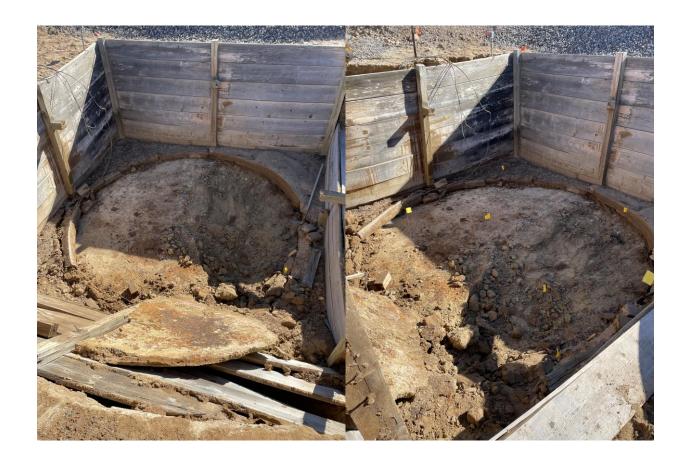
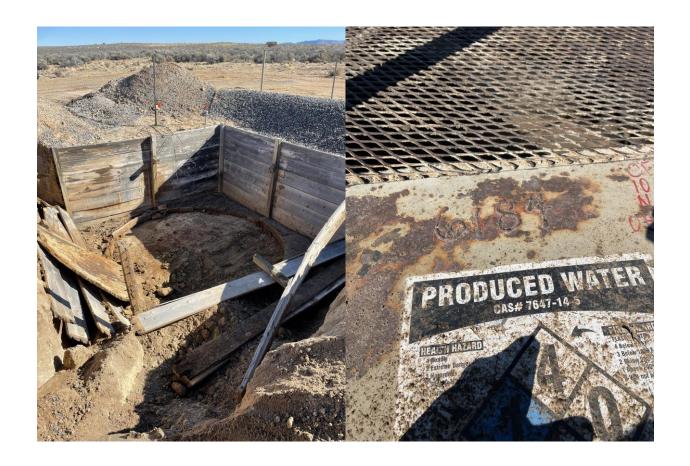
PRE CLOSURE PHOTOS

Photos of the BGT prior to closure

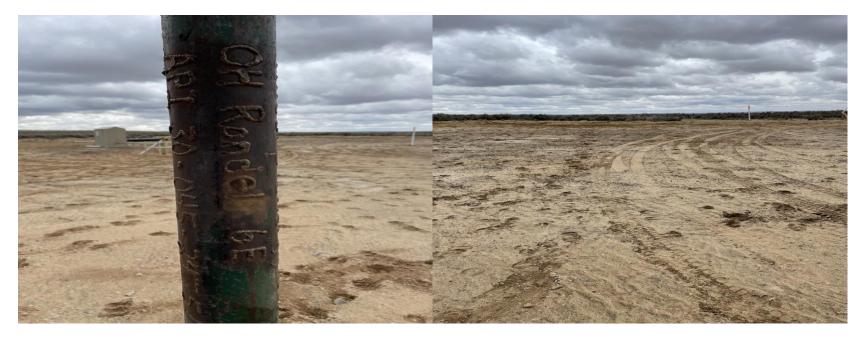
CLOSURE PHOTO

The below-grade tank area was re-contoured to match fit, shape, line, form and texture of the surrounding area. Re-shaping including drainage control, to prevent ponding and erosion. Natural drainages were unimpeded and water bars and/or silt traps were placed in areas where needed to prevent erosion on a large scale. Final recontour has a uniform appearance with smooth surface, fitting the natural landscape.

The below-grade tank area was backfilled and more than four feet of cover was achieved and the cover included one foot of suitable material to establish vegetation at the site.

Final state of the area after closure.
