Pit, Below-Grade Tank, or			
Proposed Alternative Method Permit or Closure Plan Application			
Type of action:       Below grade tank registration         Permit of a pit or proposed alternative method         BGT1       Closure of a pit, below-grade tank, or proposed alternative method         Modification to an existing permit/or registration			
Closure plan only submitted for an existing permitted or non-permitted pit, below-grade tank, or proposed alternative method			
Instructions: Please submit one application (Form C-144) per individual pit, below-grade tank or alternative request			
Please be advised that approval of this request does not relieve the operator of liability should operations result in pollution of surface water, ground water or the environment. Nor does approval relieve the operator of its responsibility to comply with any other applicable governmental authority's rules, regulations or ordinances.

1.     Operator:			
Address:         382 Road 3100         Aztec, NM 87410         OGRID #.         572171			
Facility or well name: <u>Campbell 25-2</u>			
API Number: <u>30-045-30530</u> OCD Permit Number:			
U/L or Qtr/Qtr <u>G</u> Section 25 Township 27N Range

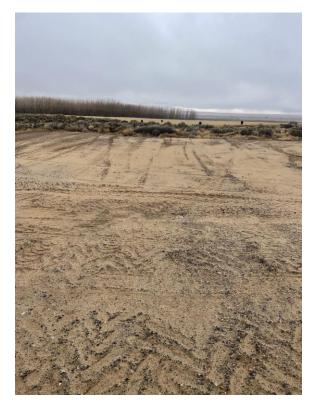
## CLOSURE PHOTO

The below-grade tank area was re-contoured to match fit, shape, line, form and texture of the surrounding area. Re-shaping including drainage control, to prevent ponding and erosion. Natural drainages were unimpeded and water bars and/or silt traps were placed in areas where needed to prevent erosion on a large scale. Final recontour has a uniform appearance with smooth surface, fitting the natural landscape.

# The below-grade tank area was backfilled and more than four feet of cover was achieved and the cover included one foot of suitable material to establish vegetation at the site.
