Pit, Below-Grade Tank, or  
Proposed Alternative Method Permit or Closure Plan Application

1.  
Operator: Hilcorp Energy Company OGRID #: 372171  
Address: 382 Road 3100 Aztec, NM 87410  
Facility or well name: Berger 7S  
API Number: 30-045-32946 OCD Permit Number: \_\_\_\_\_  
U/L or Qtr/Qtr I Section 22 Township 26N Range 11W County: San Juan  
Center of Proposed Design: Latitude 36.47133 Longitude -107.98548 NAD83  
Surface Owner: ☒ Federal ☐ State ☐ Private ☐ Tribal Trust or Indian Allotment

**Hilcorp Energy Company  
San Juan Basin  
Below Grade Tank Closure Report**

**Lease Name: Berger 7S**  
**API No.: 30-045-329463**

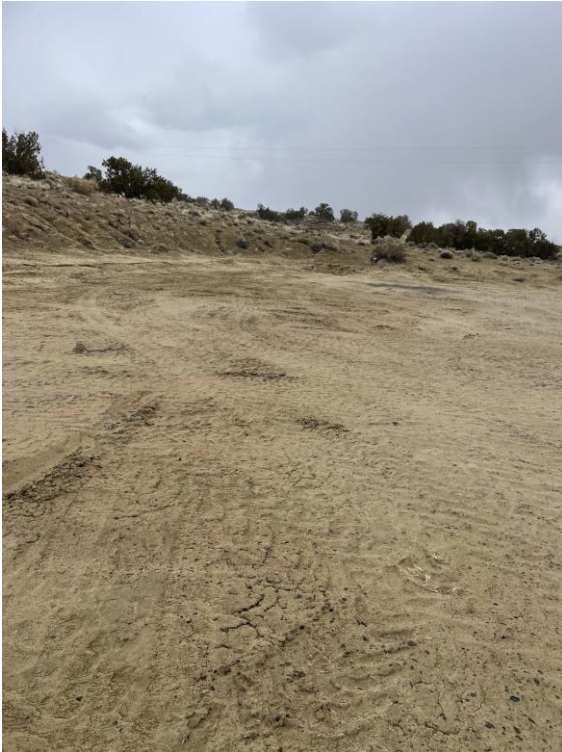
CLOSURE PHOTO

**The below-grade tank area passed all requirements of Paragraph (4) of Subsection E of 19.15.17.13 NMAC and was backfilled with compacted, non-waste containing, earthen material.**
