<u>Pit, Below-Grade Tank, or</u> <u>Proposed Alternative Method Permit or Closure Plan Application</u>

Hilcorp Energy Company San Juan Basin Below Grade Tank Closure Report

Lease Name: Federal 30-11 API No.: 30-045-24997

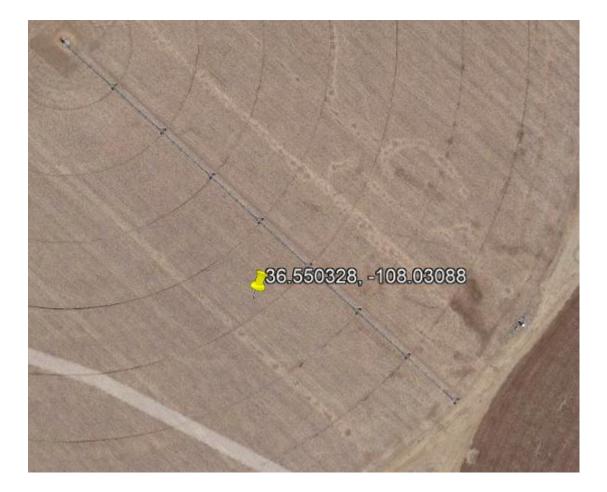
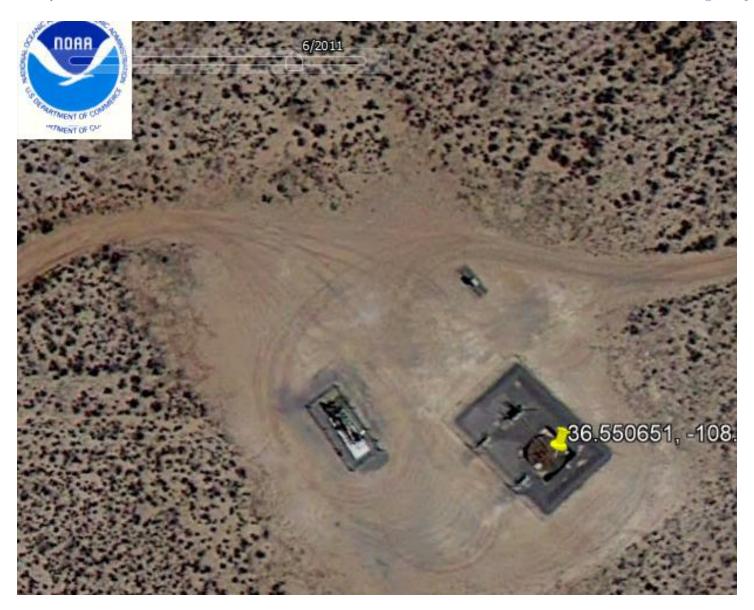
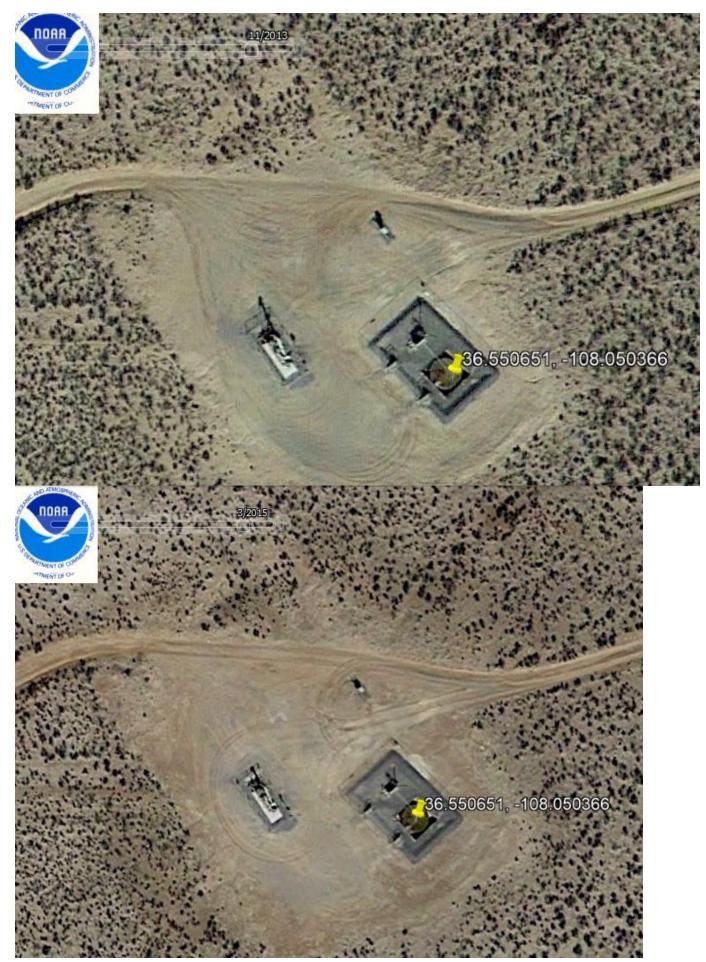
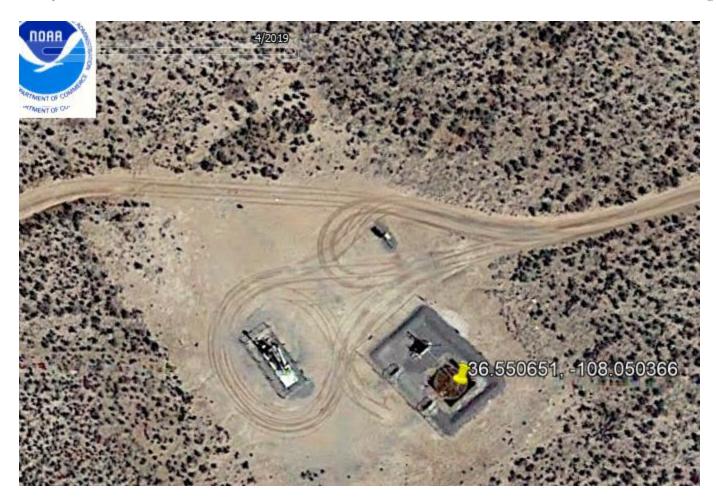
For the well listed above, it looks like XTO filed two separate BGT permits, however there is only 1 BGT that exists on location. I am not sure why two permits were filed. Can we cancel one of the permits, and then close out the remaining permit once the P&A is complete? The permit for the 2008 permit is sitting in the middle of a field.

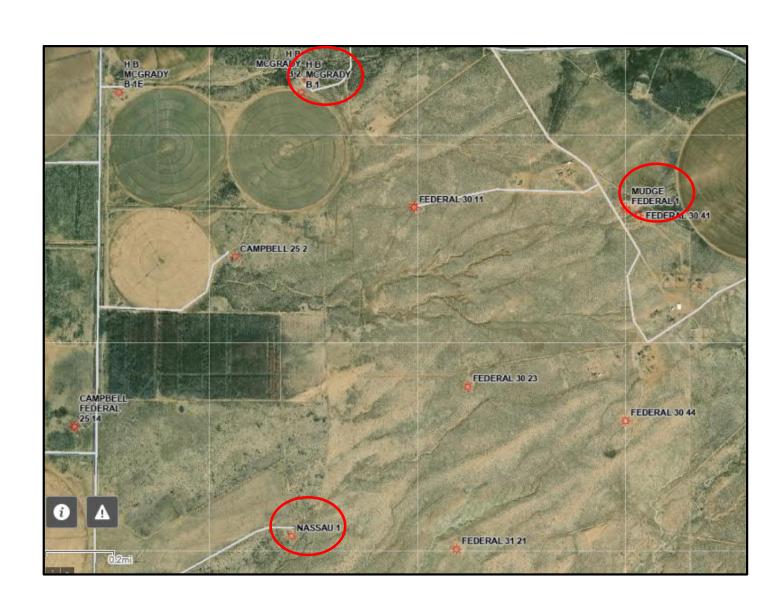
HB McGrady B1: Elevation 6051' 0.46 miles north >100' depth to GW

Nassau 1: Elevation 6030' 1 mile south >100' depth to GW

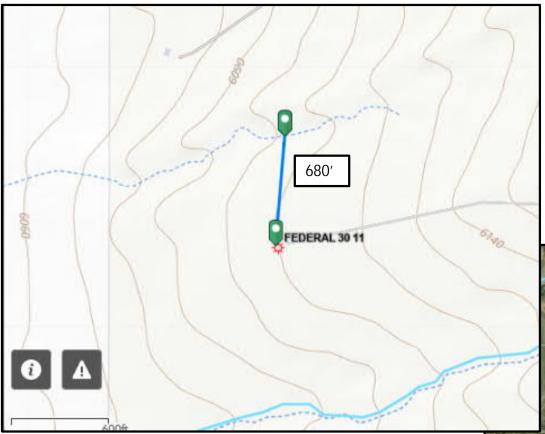
NMAC 19.15.29 Siting Criteria for Closure Standards

BGT is not shown to be within:

300 ft of any continuously flowing watercourse or any other significant water course.

- 200 feet of any lakebed, sinkhole or playa lake
- 300 feet of any occupied permanent residence
- 500 feet of a spring or private, domestic fresh water well.
- 1000 feet of any fresh water well
- 300 feet of a wetland
- Incorporated municipal boundaries
- Overlying a subsurface mine
- An unstable area
- A 100-year floodplain
