Pit, Below-Grade Tank, or
Proposed Alternative Method Permit or Closure Plan Application

**Hilcorp Energy Company
San Juan Basin
Below Grade Tank Closure Report**

Lease Name: Ohio C Govt 3F

API No.: 3004534072

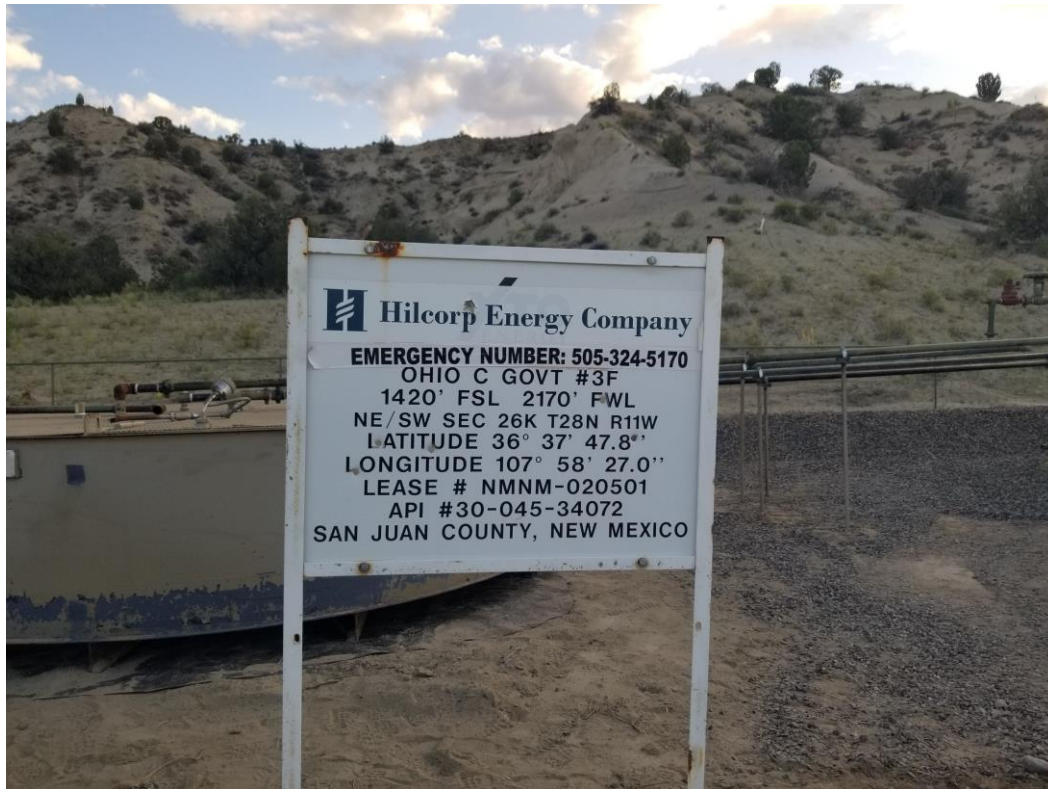
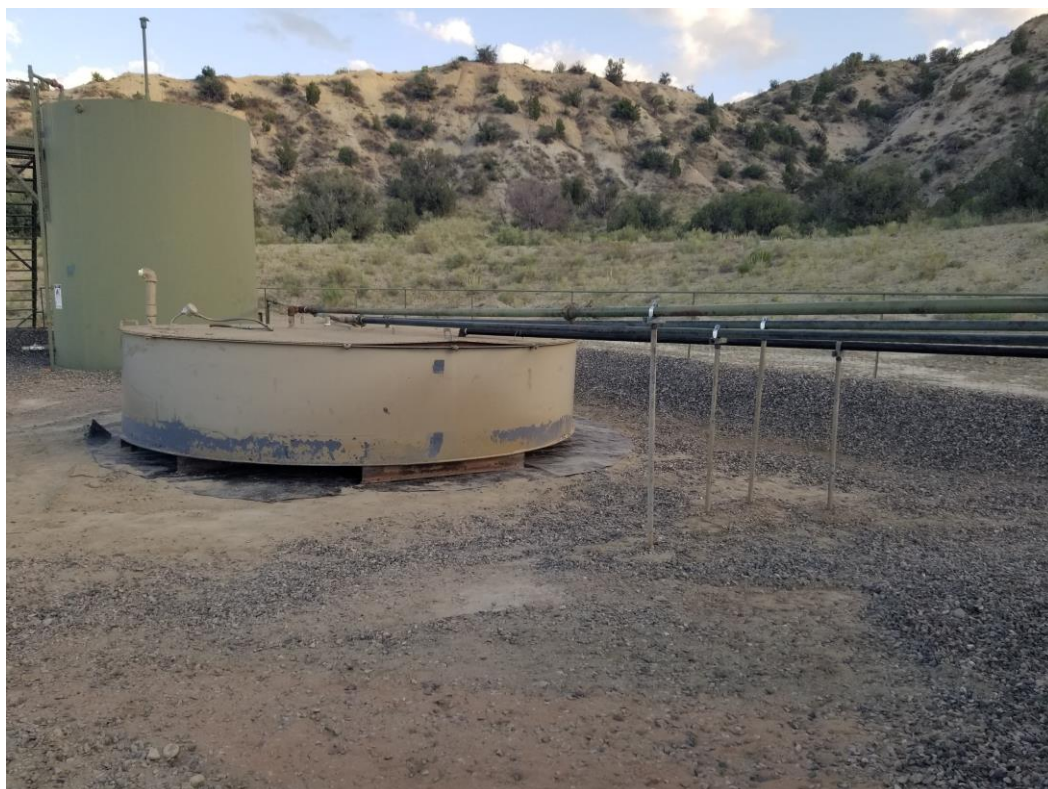
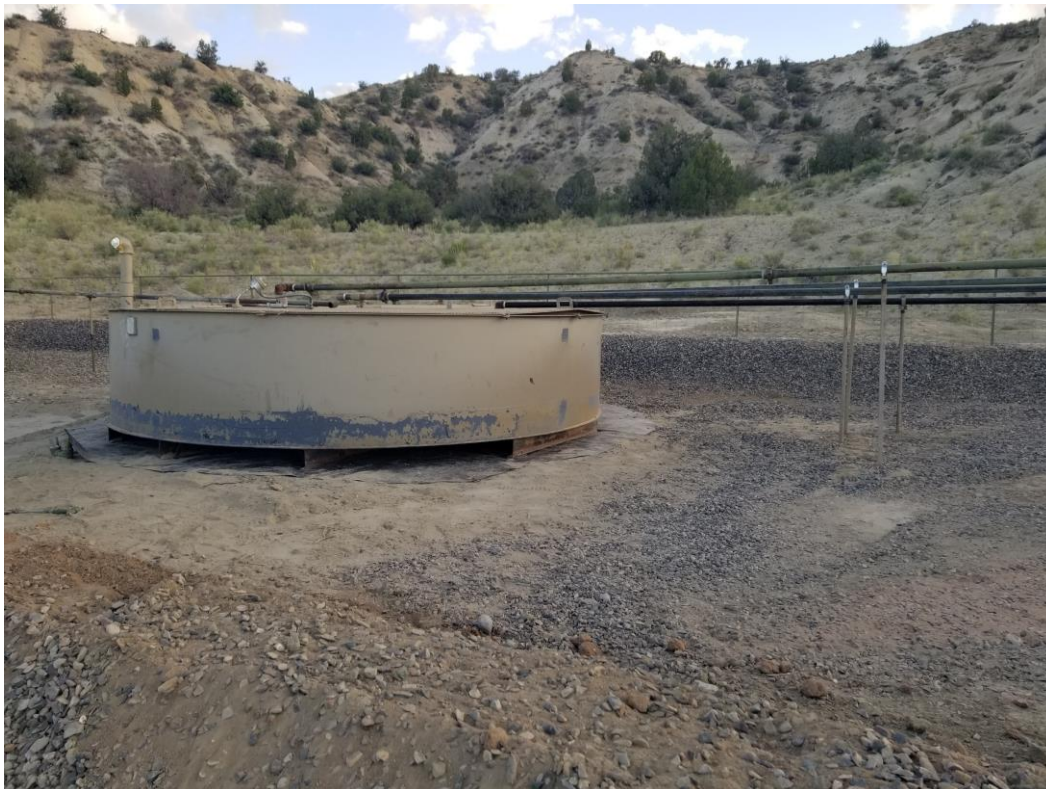
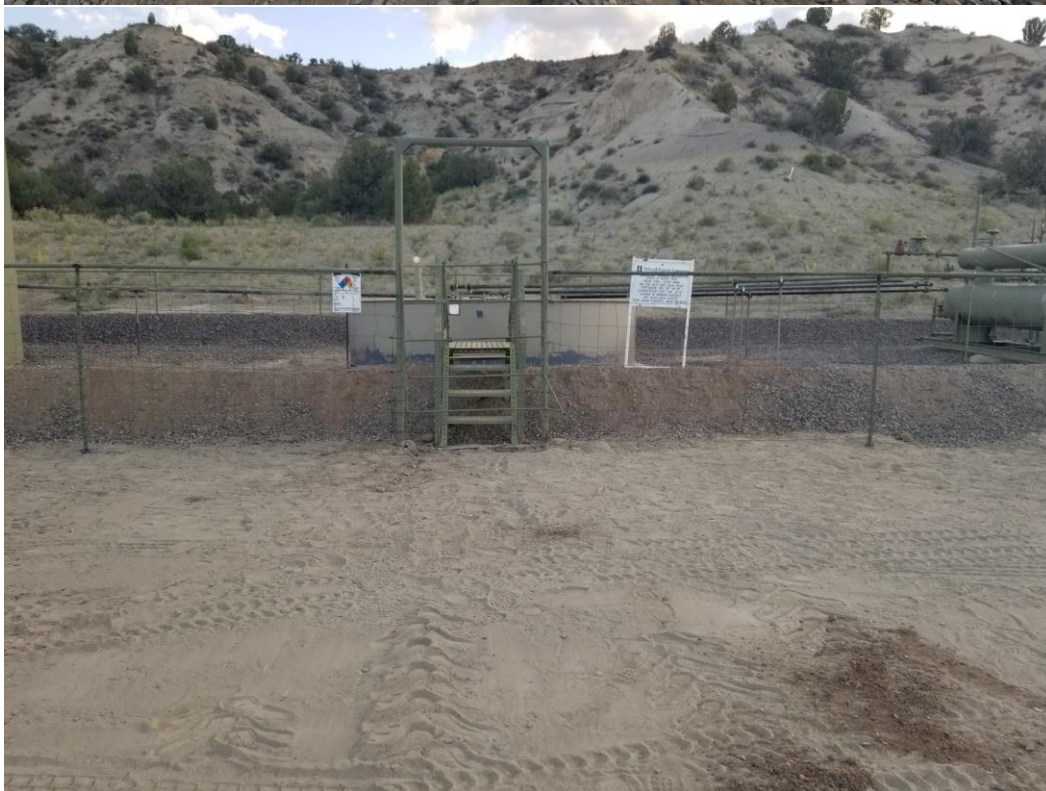
Ohio C Govt 3F Post Closure Photos

The below-grade tank area passed all requirements of Paragraph (4) of Subsection E of 19.15.17.13 NMAC and was backfilled with compacted, non-waste containing, earthen material.
