Proposed Alternative Method Permit or Closure Plan Application

Hilcorp Energy Company San Juan Basin Below Grade Tank Closure Report

Lease Name: Ka Souse 1 API No.: 30-45-05662

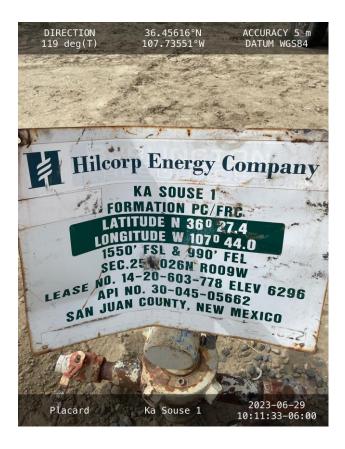
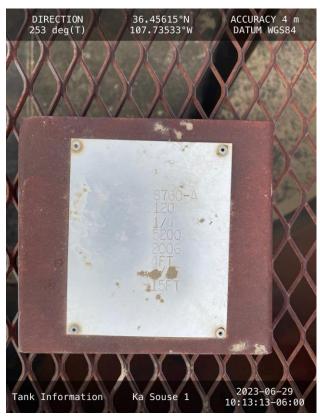
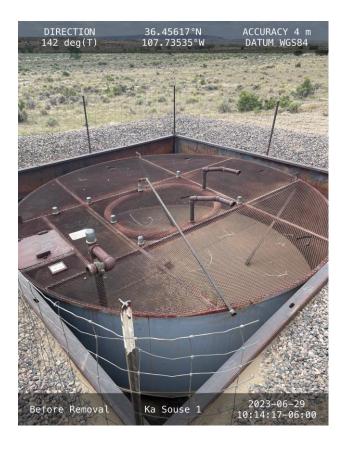
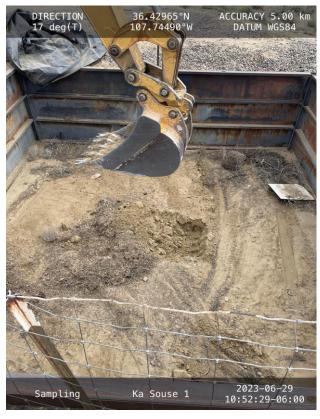
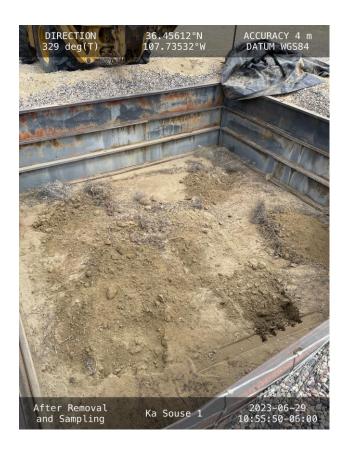
Well site placard

Photos of the BGT prior to closure

The sample location or, more preferred, photos of actual sample collection

Final state of the area after closure.
