Hilcorp Energy Company San Juan Basin Below Grade Tank Closure Report

Lease Name: Ballard 9 API No.: 30-045-05824

BGT Closure

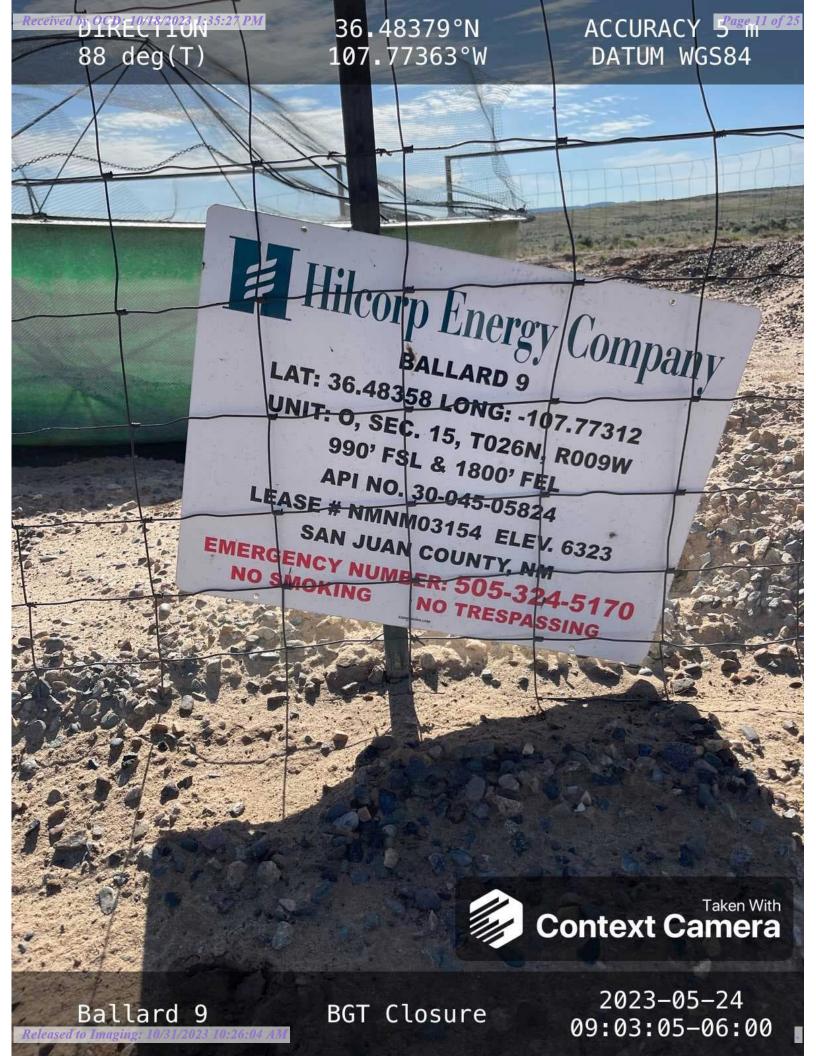
202 deg(T)

36.48383°N 107.77358°W

2023-05-24 09:10:51-06:00

Ballard 9
