Hilcorp Energy Company San Juan Basin Below Grade Tank Closure Report

Lease Name: JC Gordon B 1 API No.: 30-045-06426

In accordance with Rule 19.15.17.13 NMAC the following information describes the closure of the below-grade tank referenced above. All proper documentation regarding closure activities is being included with the C-144.

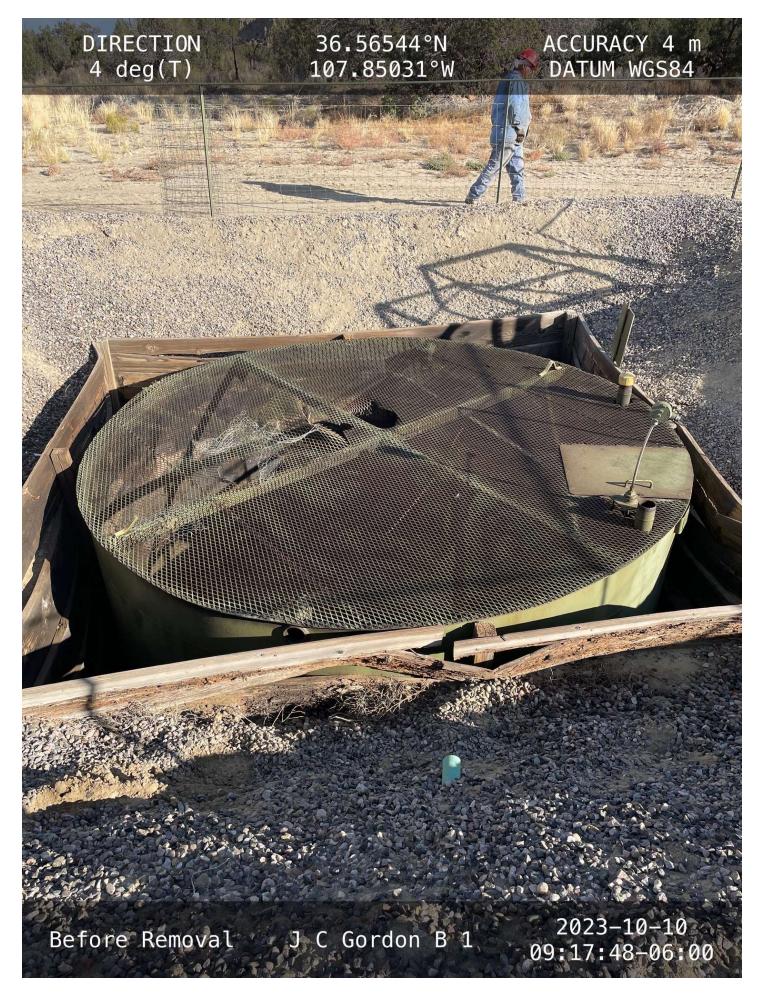
DIRECTION 16 deg(T)	36.56544°N 107.85039°W	ACCURACY 5 m DATUM WGS84
-		
	J.C. M. C. M.	
	ХТ709 120	6 – 9 9
	3/16	NA
	EXP	3/16
		2023-10-10
Tank Information	J C Gordon B 1	09:40:14-06:00
