Site Assessment and Reclamation Work Plan

**Sierra Blanca Operating Company
Northeast Caprock Queen Unit #19**

Lea County, New Mexico

API #: 30-025-00155

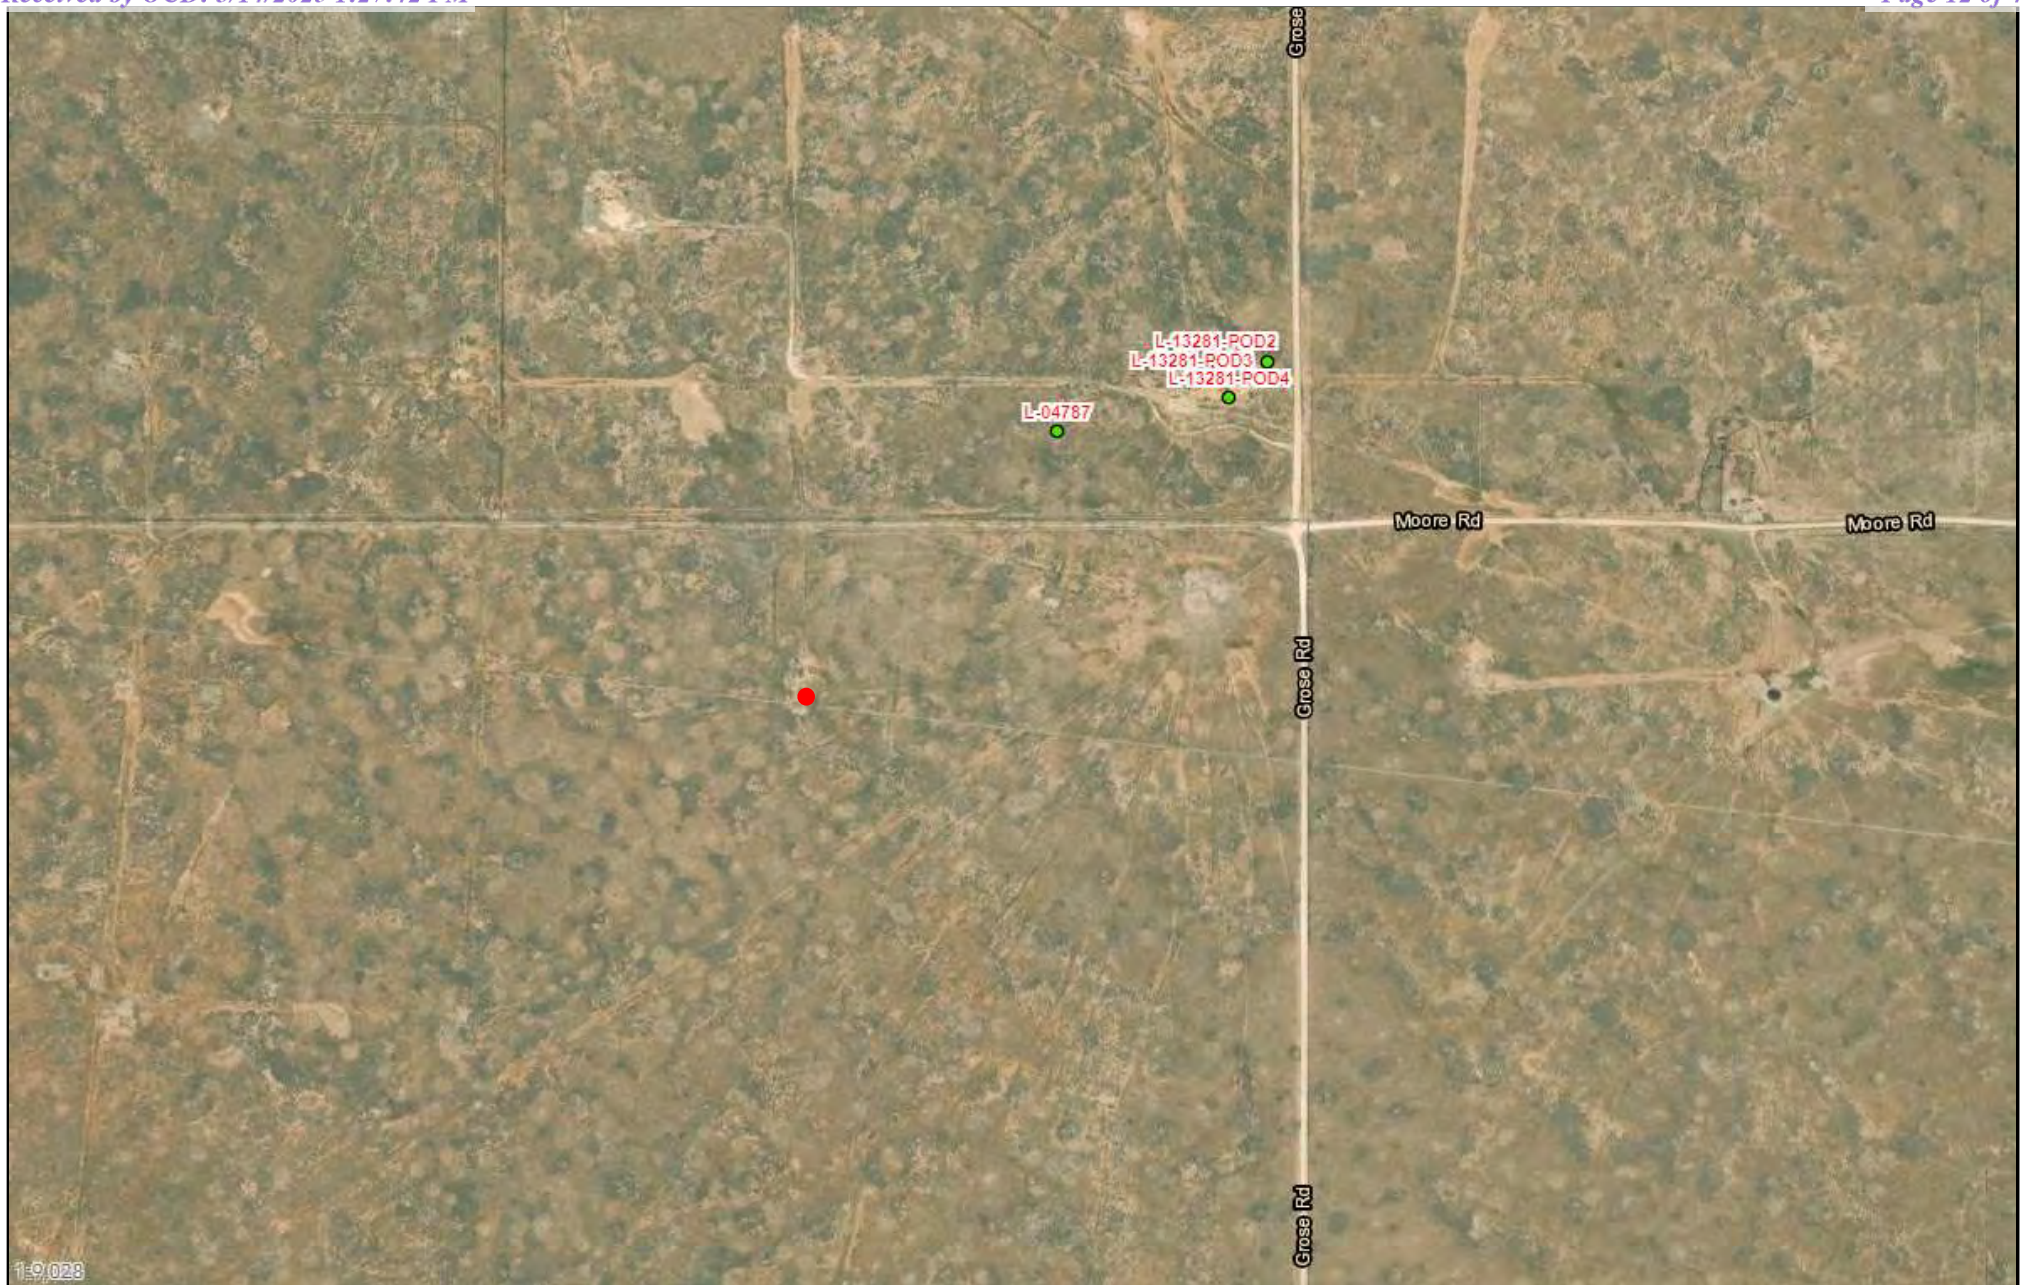
**Figure 2**

A search of the New Mexico Office of the State Engineer (NMOSE) and United States Geological Survey (USGS) groundwater databases was completed in an effort to determine the horizontal distance to known water sources within a half mile radius of the Release Site. Approximate depth to groundwater was determined using maintained and published water well data. Karst mapping indicates the site is located in an Erosional Karst designated area. Groundwater depth information is provided as Attachment II and the results are depicted on Figures 2 and 3.

OSE POD Locations Map
Sierra Blanca Operating Company
NE Caprock Queen 19
GPS: 33.26973, -103.72081
Lea County

No water wells were located within a half mile of the release area. Therefore, as the site is also located in an Erosional Karst designated area, the site will be reclaimed according to the strictest NMOCD Closure Criteria. Utilizing this information, the NMOCD Closure Criteria for the Site were determined as follows:

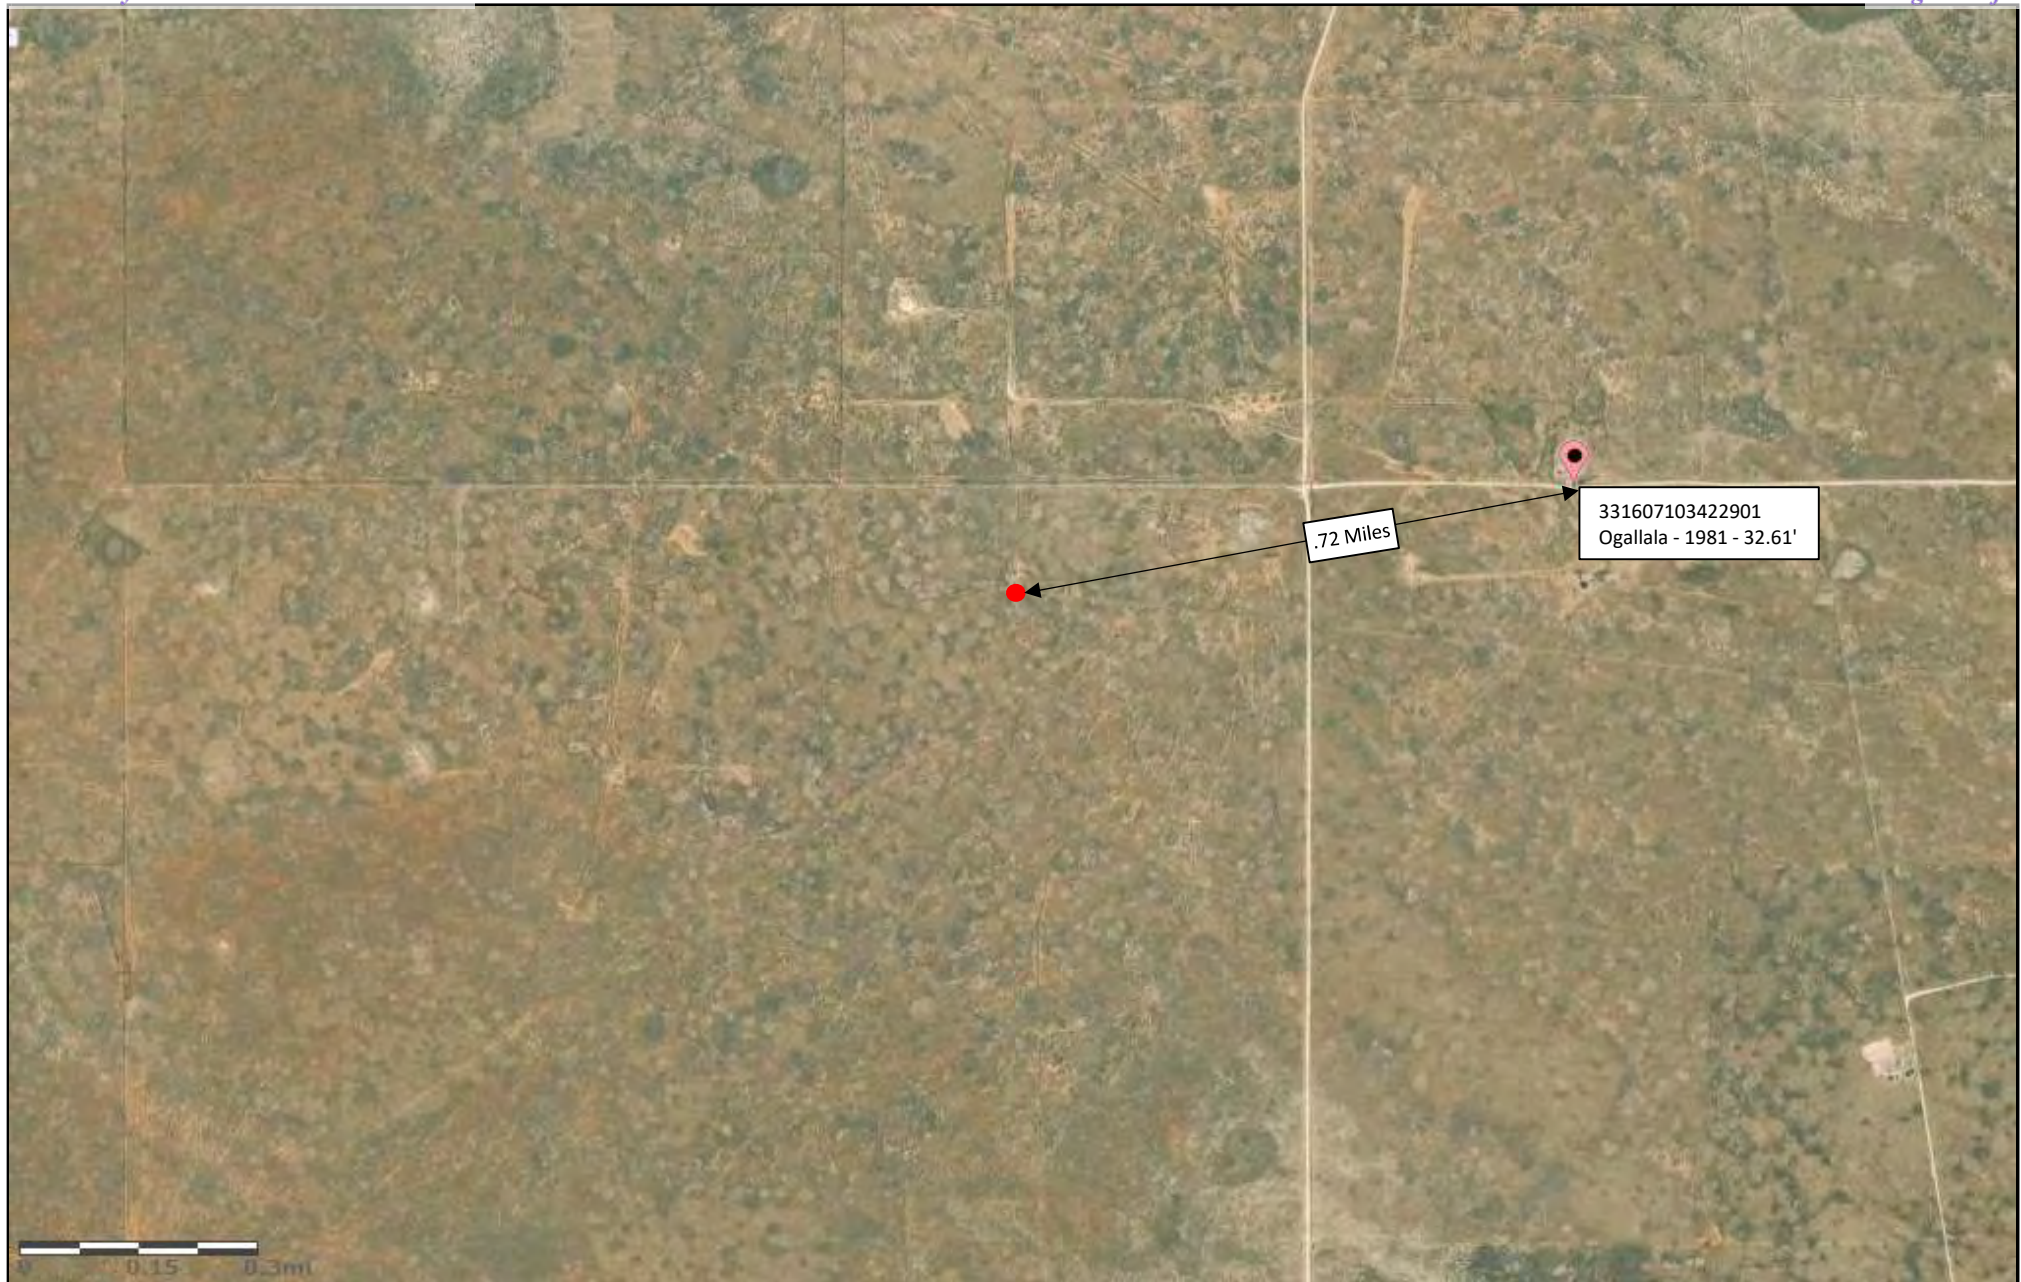
**Figure 3**

USGS Well Locations Map
Sierra Blanca Operating Company
NE Caprock Queen 19
GPS: 33.26973, -103.72081
Lea County

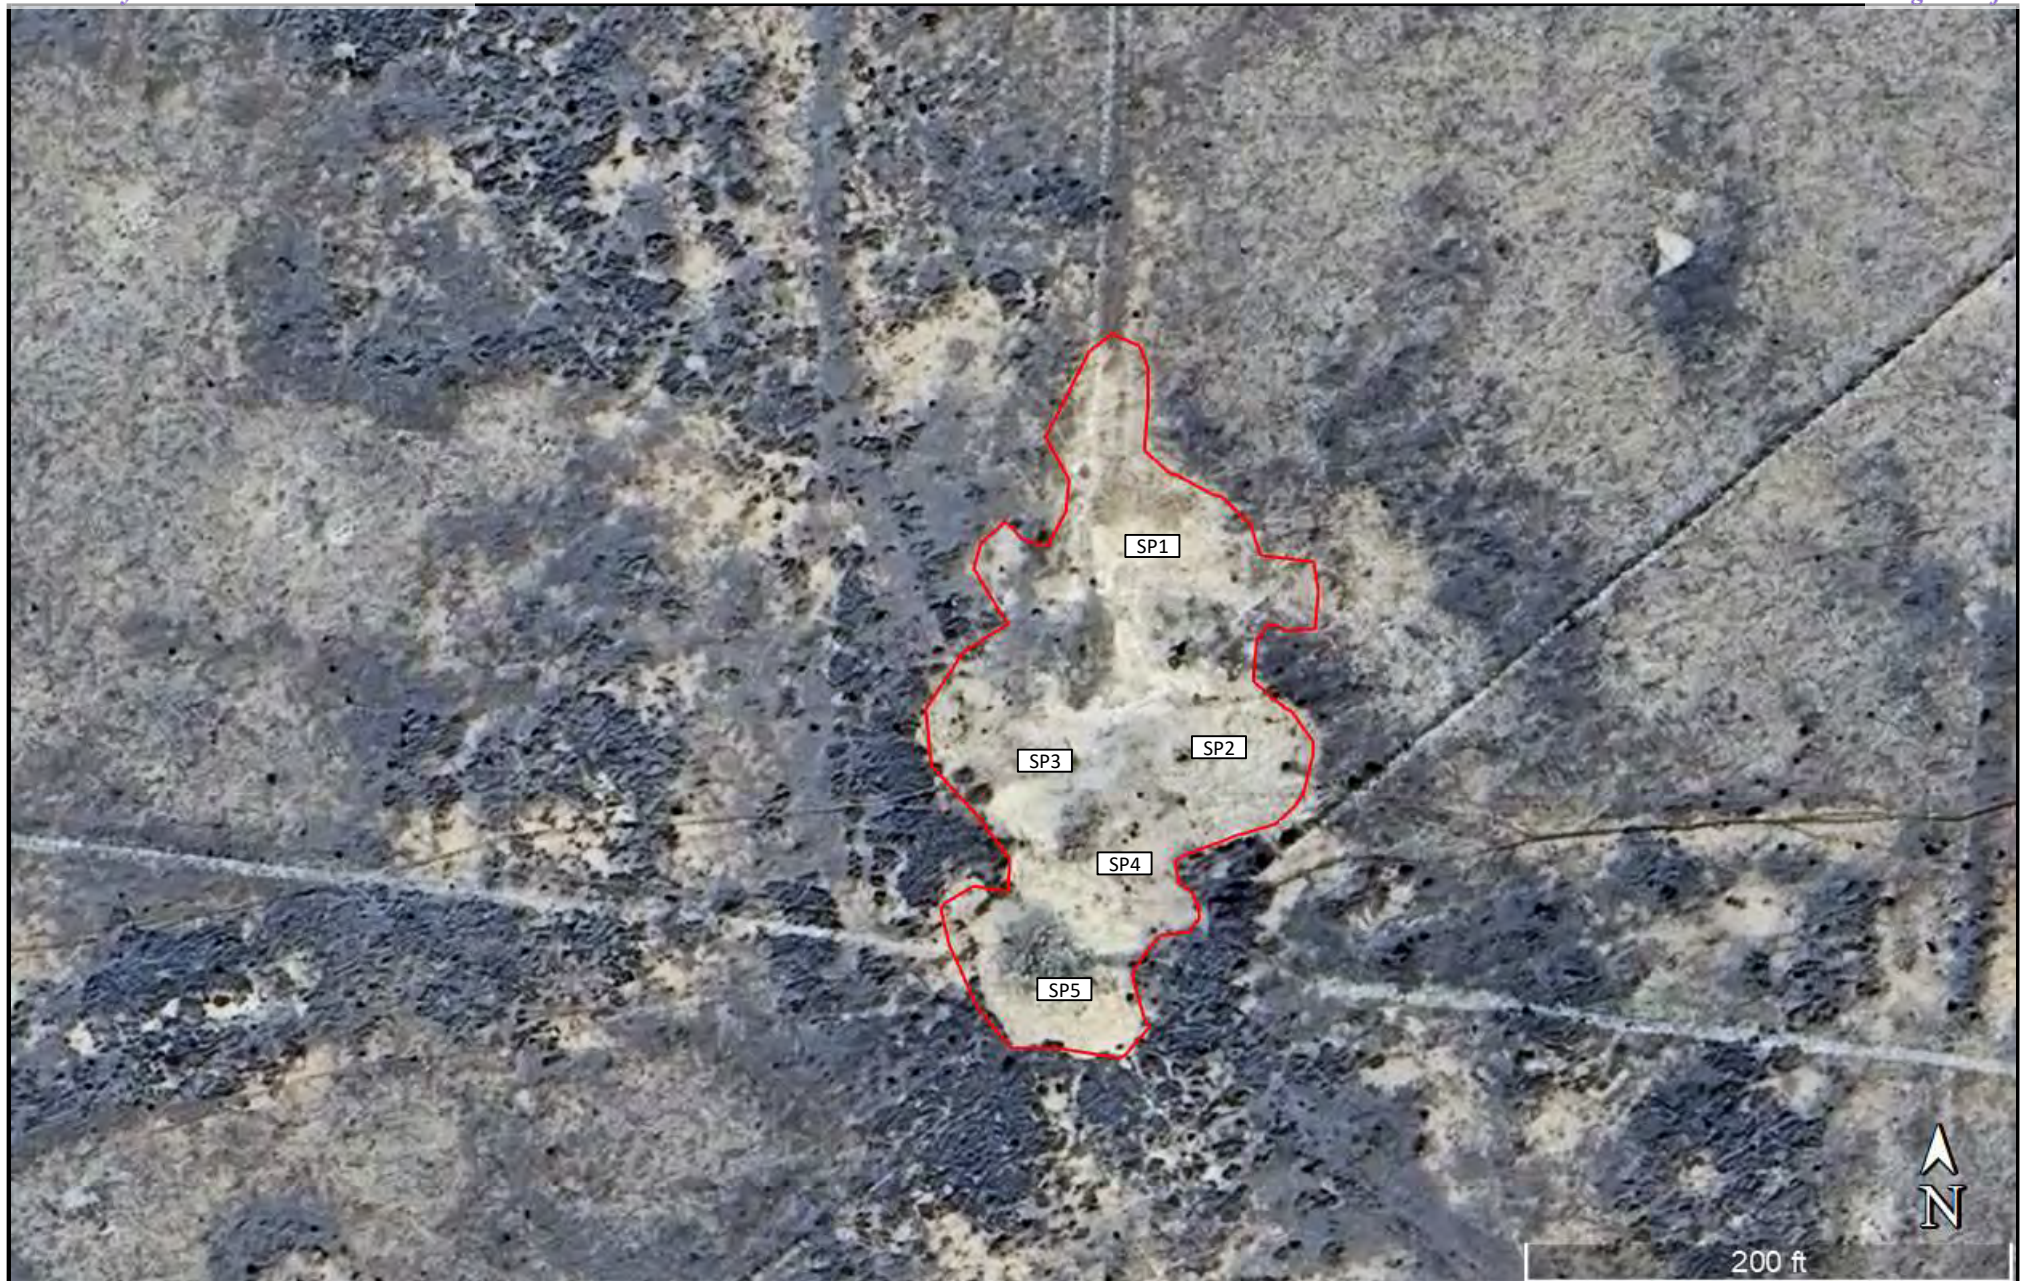
**Figure 4**

Proposed Sampling and Reclamation Map
Sierra Blanca Operating Company
NE Caprock Queen 19
GPS: 33.26973, -103.72081
Lea County

- Reclamation Area
 SP1 Delineation Sample Location

- Delineation sampling began on January 31, 2025; however, complete delineation was not achieved at each sample location. Sample locations SP1, SP2, SP3, and SP5, will require additional delineation.

- Sample locations SP1, SP2, SP3, and SP5, will be fully delineated, according to the strictest NMOCD Closure Criteria.
- Soil samples will be submitted to the laboratory for analysis of BTEX, TPH, and chloride.

- Based upon laboratory analytical results, the area characterized by sample locations SP1 through SP5, will be excavated to depth of clean submitted sample, or until closure criteria is achieved.

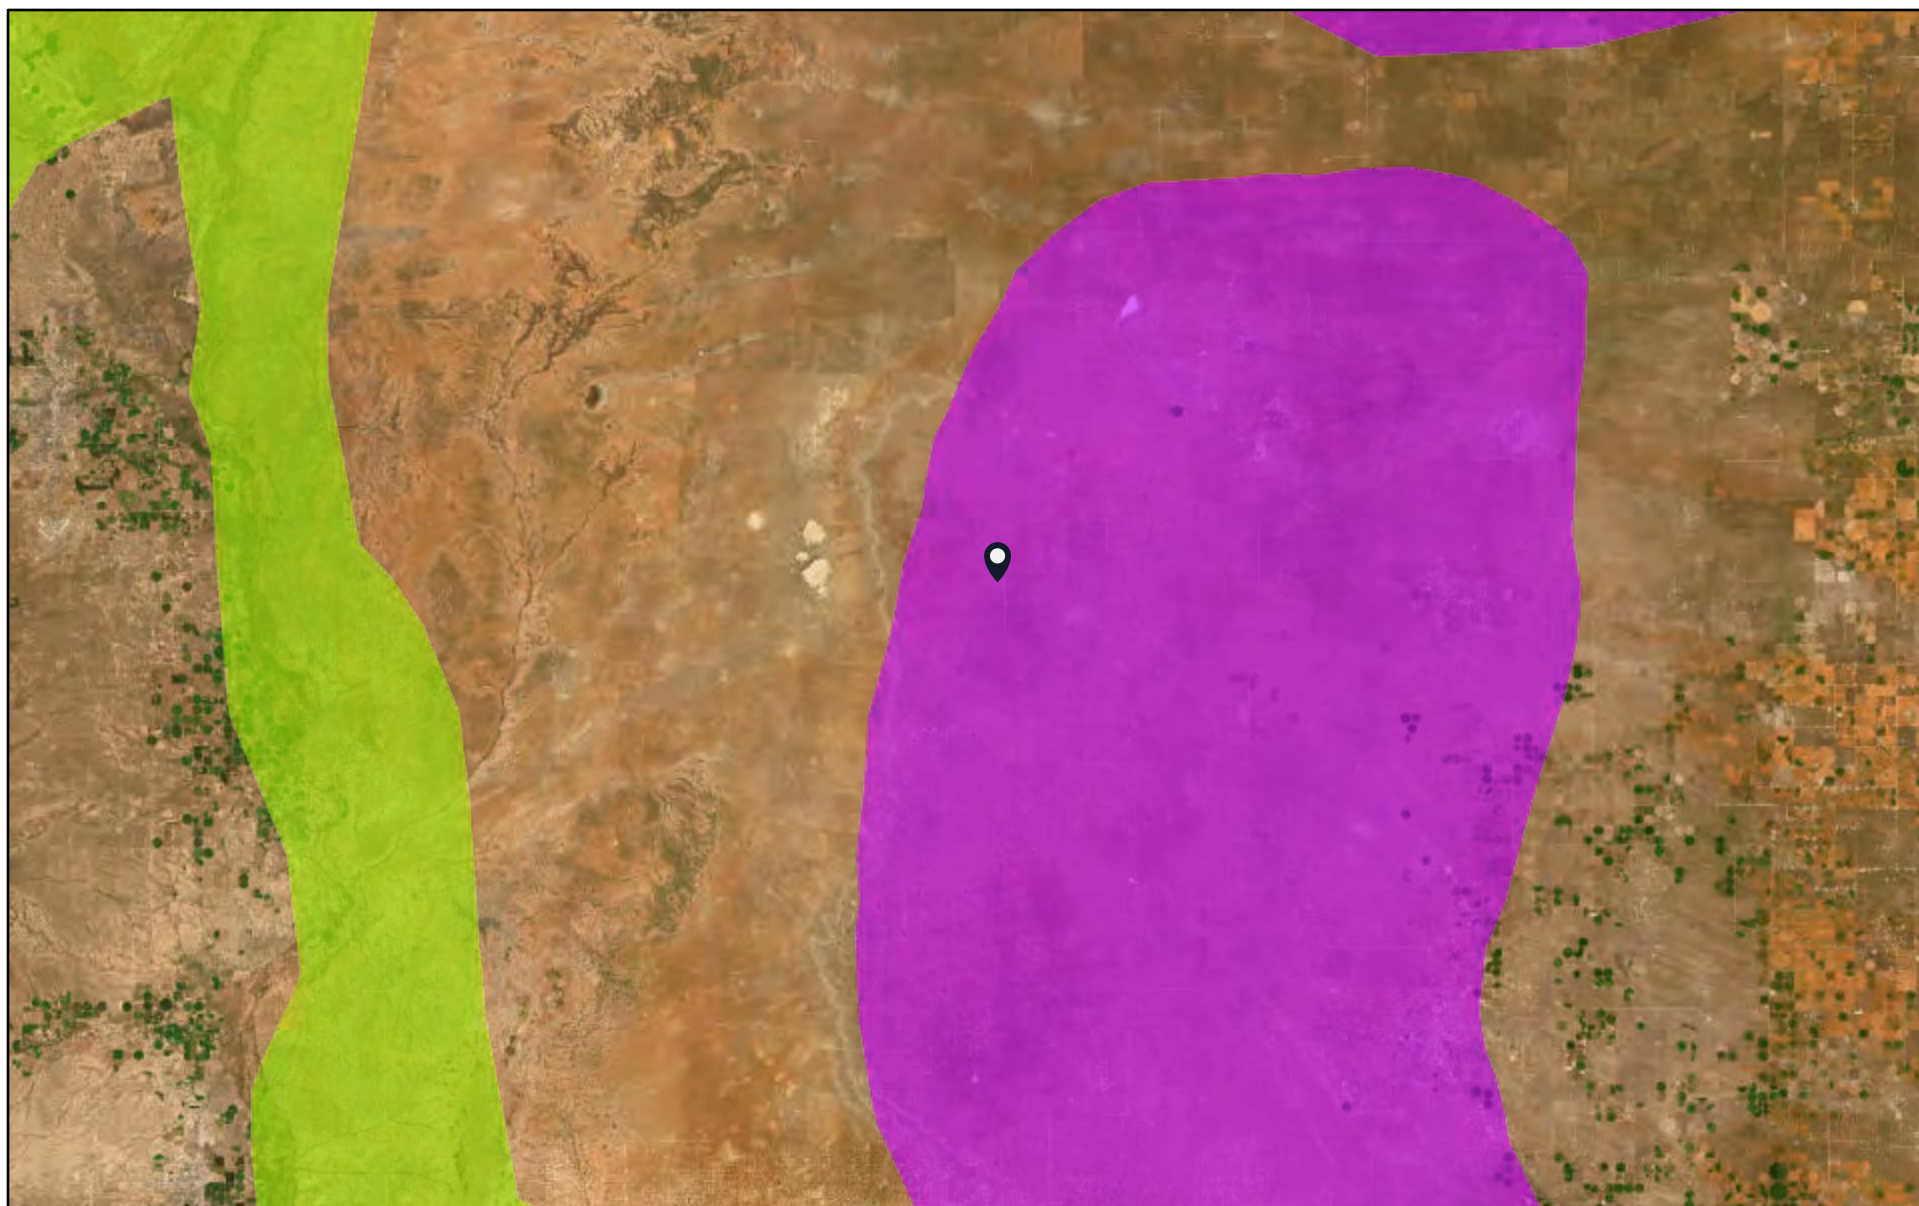
Karst Type

- Carbonate
- Erosional
- Gypsum

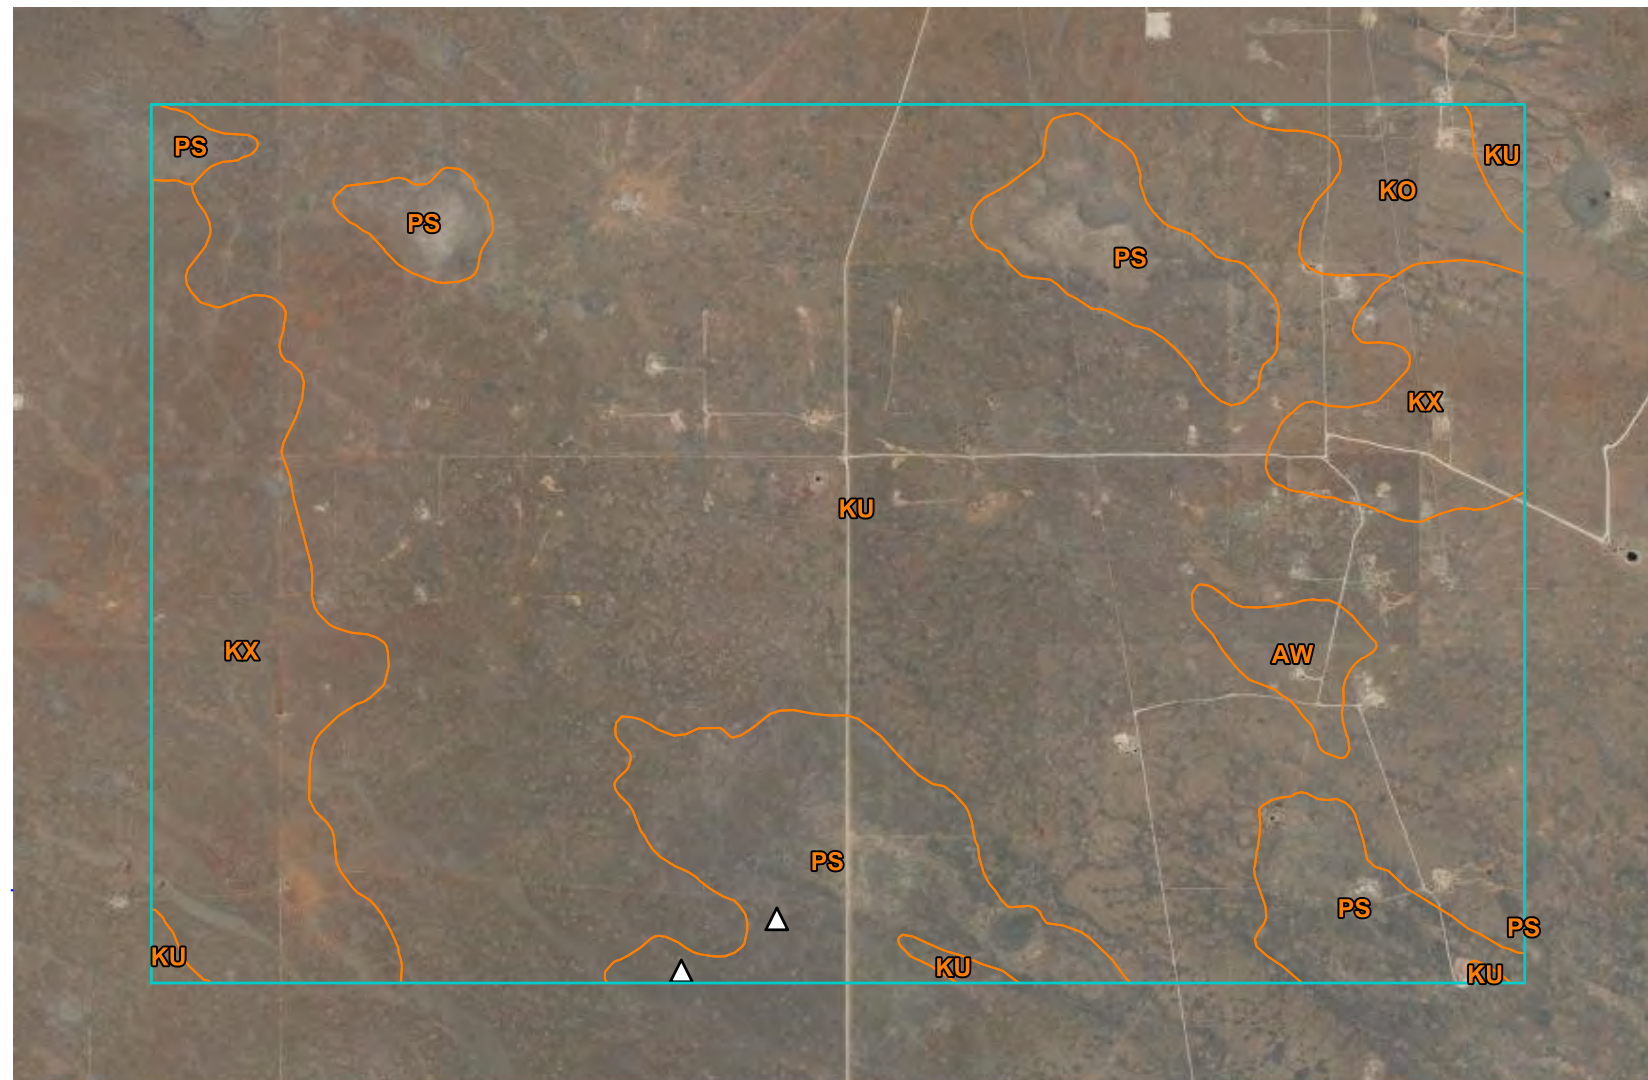
Soil Map—Lea County, New Mexico
(Northeast Caprock Queen Unit #19)

Map Scale: 1:32,000 if printed on A landscape (11" x 8.5") sheet.

Map Unit Symbol	Map Unit Name	Acres in AOI	Percent of AOI
AW	Arvana-Lea association	65.5	1.2%
KO	Kimbrough gravelly loam, dry, 0 to 3 percent slopes	136.6	2.5%
KU	Kimbrough-Lea complex, dry, 0 to 3 percent slopes	3,658.0	68.2%
KX	Kimbrough-Spraberry complex, dry, 0 to 3 percent slopes	747.3	13.9%
PS	Portales-Stegall loams	753.5	14.1%
Totals for Area of Interest		5,361.1	100.0%

A United States Department of Agriculture (USDA) Web Soil Survey was completed to determine soil types in the area of reclamation. Web Soil Survey indicates the area is located in the Kimbrough-Lea complex comprised of gravelly loam soils with 0 to 3 percent slopes. Landowner approved seed Mixture will be utilized for seeding the area after reclamation activities are complete. Karst, Wetland, and Soil Maps are provided as Attachment I.
