# R. T. HICKS CONSULTANTS, LTD.

RE: Termination Request and Monitoring Well Plugging Report  
NMOCD Case #: 1R425-36  
Vacuum C-33, T17S, R35E, Section 33

## **Corrective Action Plan Addendum**

Vacuum C-33 boot (1R425-36)  
Unit Letter C, Section 33, T17S, R35E

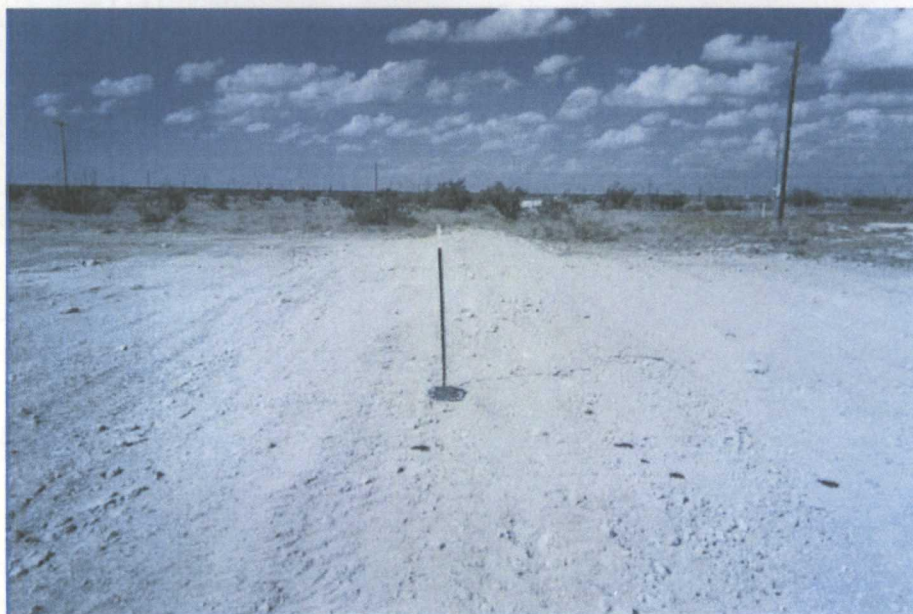
**Figure 1.**  
Vacuum C-33,  
Backfilled  
Excavation with  
Identification Plate,  
October 2007

The site was a junction box with boot in the Vacuum System which was abandoned in 2001. In 2007, Rice Operating Company (ROC) excavated and removed the C-33 box and a 30-foot by 30-foot area of surrounding soil to a depth of twelve-feet. Junction box characterization activities at the site followed ROC standard practices associated with junction box characterization and closure and the results of this program are presented in Appendix A. The surface was contoured to the surrounding area and an identification plate was placed at the site to mark the location of the former junction box.

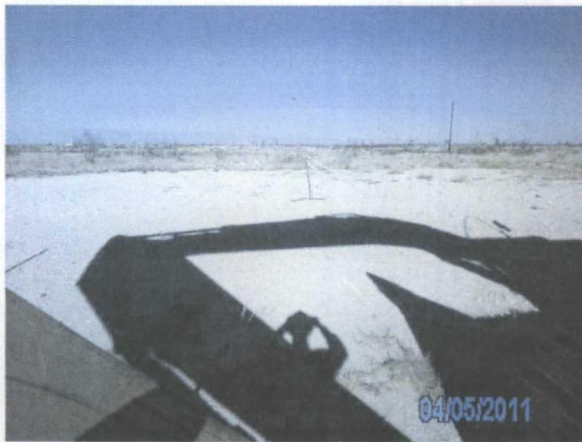
site prior to excavation, facing west

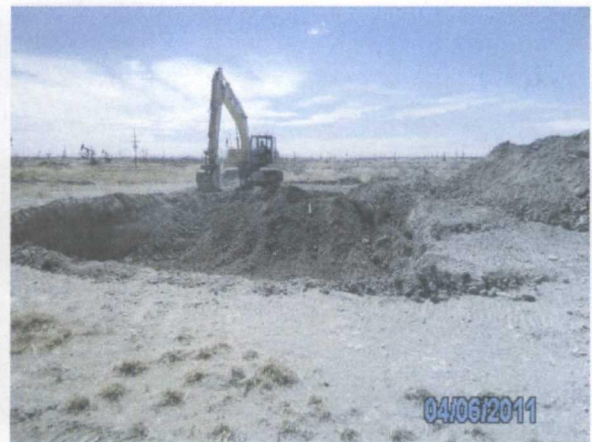
excavating the site, facing west

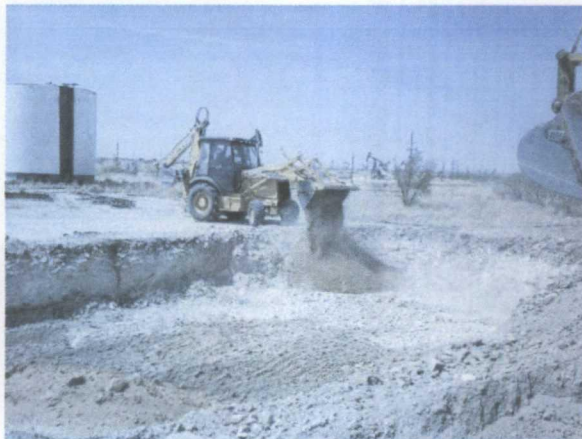
padding the base of the excavation with 6" of blow sand, facing west

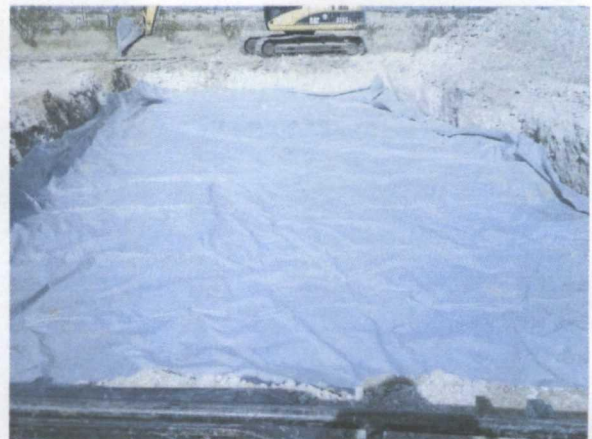
70x30 ft, 20-mil reinforced liner installed at 4 ft bgs, facing west

- The liner was installed at 4-feet below existing grade on April 13, 2011
- The site was excavated and backfilled to grade from April 6 through April 26, 2011. A total of 888 yards of earth were transported to Sundance Disposal and 936 yards of soil was imported.
- Seeding of the area occurred on April 26, 2011
- Imported soil met the concentration requirements of the CAP
  - Backfill Pad: Cl<sup>-</sup> 80 mg/kg and PID 0.0 ppm
  - Imported Soil: Cl<sup>-</sup> 32 mg/kg and PID 0.0 ppm
  - Imported Soil for Top Cap: Cl<sup>-</sup> <16 mg/kg and PID 19.6 ppm

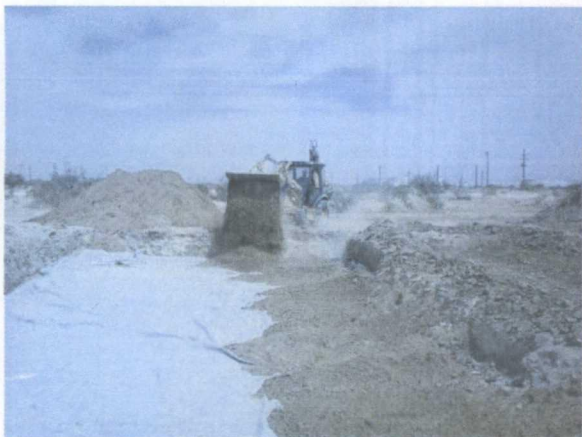
padding above the liner with 6" of blow sand, facing east

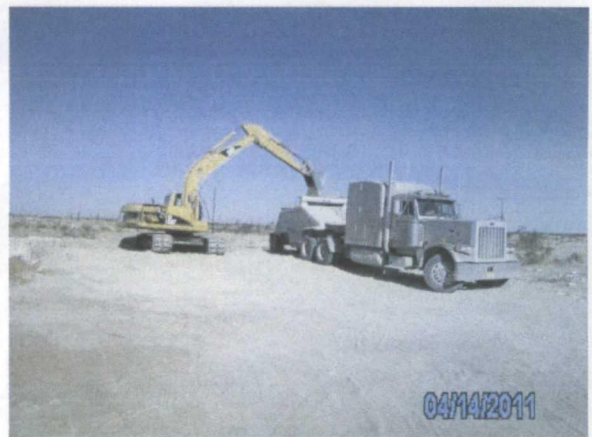
hauling off soil to Sundance, facing west

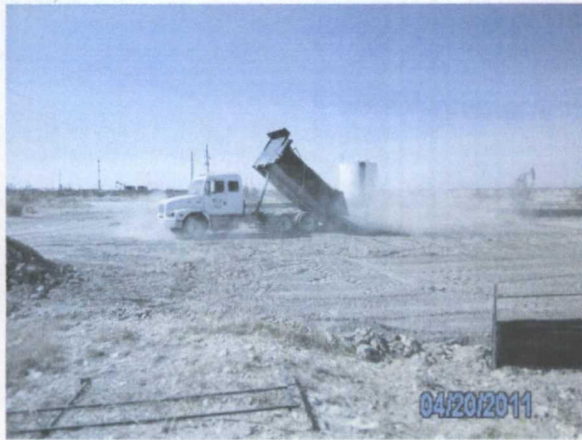
importing clean soil, facing south

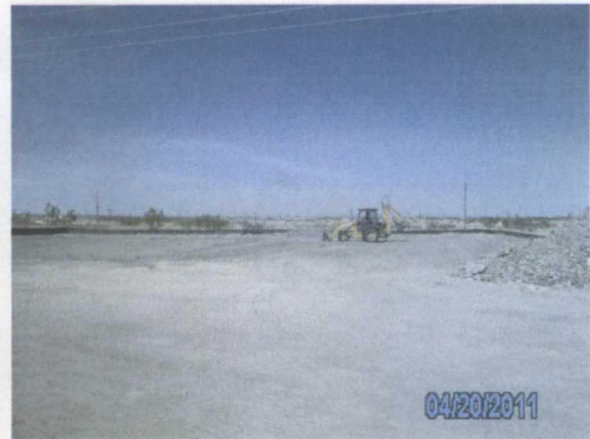
contouring the site with imported soil,  
facing west

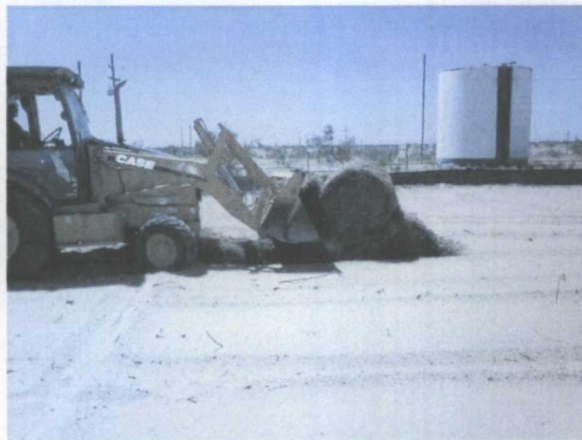
spreading peanut hay on the backfilled site,  
facing north

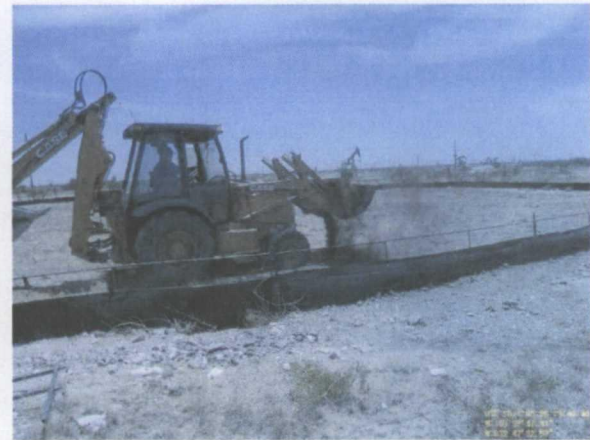
spreading bioNhance on the backfilled site,  
facing southwest

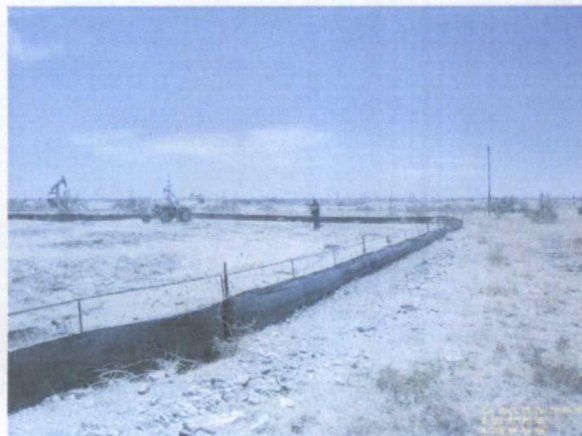
seeding the backfilled site, facing southwest

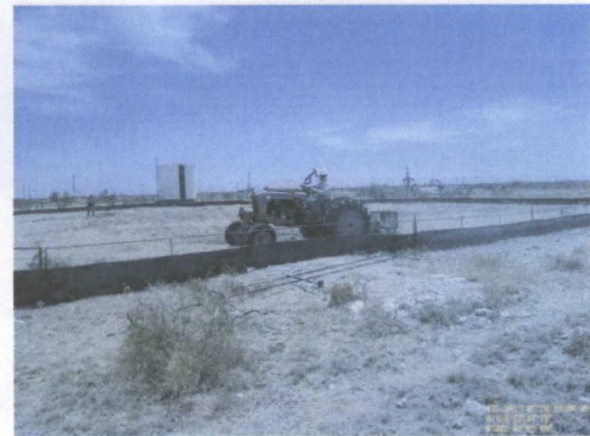
tilling in seed and bioNhance, facing southwest

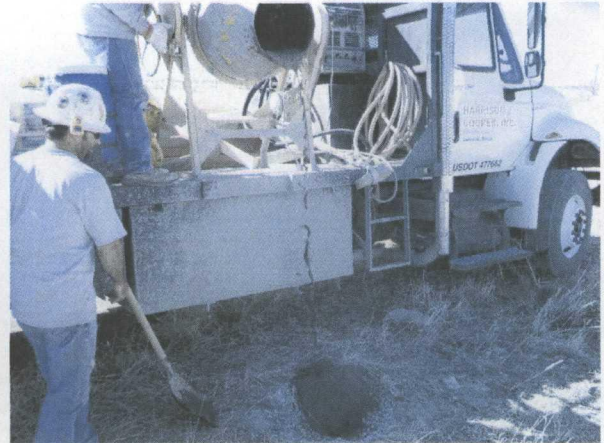
Plugging the bore with 1-3% bentonite/concrete  
slurry

Attachment B also includes driller's plugging report and photos documenting the March 23, 2011 plugging and abandonment of MW-1 according to NMOCD specifications. MW-1 was plugged using a cement grout containing 1% to 3% bentonite and a 3 foot cap of cement.

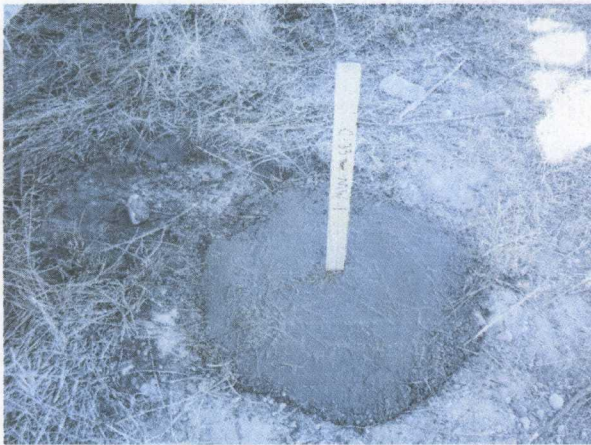
Completed plug and abandon
