From: Hansen, Edward J., EMNRD
Sent: Wednesday, August 14, 2013 6:05 PM
To: Hack Conder (hconder@riceswd.com)
Cc: Leking, Geoffrey R, EMNRD; Laura Pena (lpna@riceswd.com); Katie Jones <kjones@riceswd.com> (kjones@riceswd.com); Scott Curtis (scurtis@riceswd.com)
Subject: Remediation Plan (1R427-115) Termination - ROC EME U6 Site

**RE: Termination Request
for the Rice Operating Company's
EME U6 Site
Unit Letter U, Section 6, T21S, R36E, NMPM, Lea County, New Mexico
Remediation Plan (1R427-115) Termination**

EME U6 (1R427-115): UL/U, Sec. 6, T21S, R36E

RICE OPERATING COMPANY JUNCTION BOX FINAL REPORT

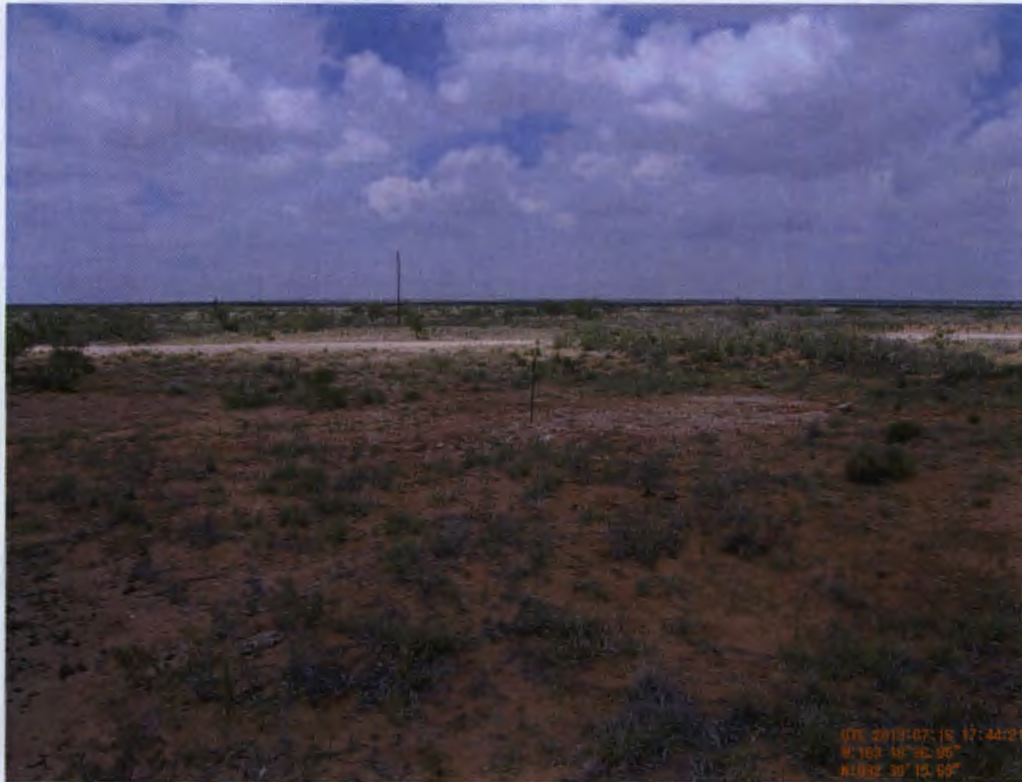
Facing west

7/16/2013

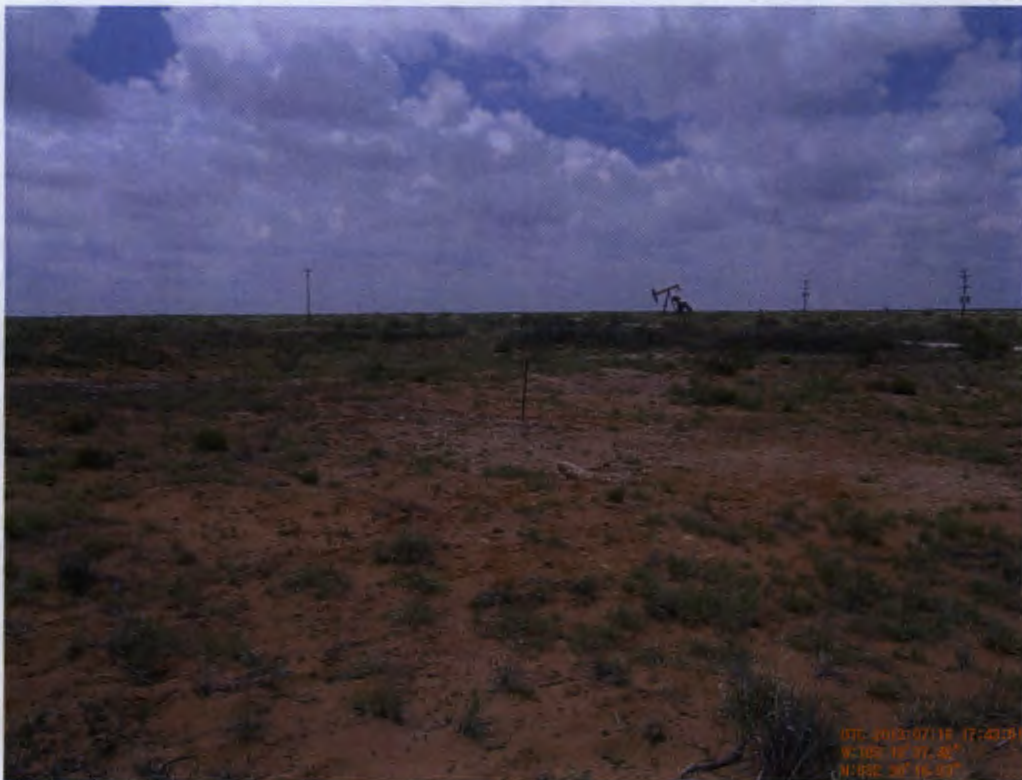
Facing south

7/16/2013
