1R - 425-37

WORKPLANS

**RE: Corrective Action Plan (CAP)
Rice Operating Company – Vacuum SWD System
Vacuum F-33 boot (1R425-37): UL/F sec. 33 T17S R35E**

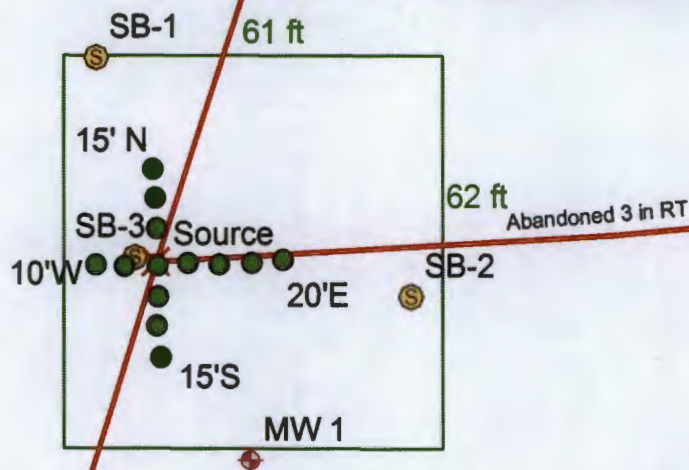
Figure 2

Soil Data

Vertical Lab Data						
	Benzene	Toluene	Ethly Benzene	Xylenes	GRO	DRO
4 wall comp	<0.025	0.128	0.624	1.85	67.3	1180
Bottom Comp	0.012	0.103	0.096	0.527	127	1710
Backfill					<10	1700
						3600

In 2007, ROC initiated work on the former Vacuum F-33 boot junction box. The site was delineated using a backhoe to form a 30 ft x 30 ft x 12 ft deep excavation and soil samples were screened at regular intervals for both hydrocarbons and chlorides (Figure 2). From the excavation, the four-wall composite, bottom composite and the backfill were taken to a commercial laboratory for analysis. Laboratory tests of the four-wall composite showed a chloride reading of 2,260 mg/kg, a gasoline range organics (GRO) readings of 67.3 mg/kg and a diesel range organics (DRO) reading of 1,180 mg/kg. The sample was also submitted for BTEX analysis which returned results of non-detect for benzene, 0.128 mg/kg for toluene, 0.624 mg/kg for ethyl-benzene and 1.85 mg/kg for total xylenes. The bottom composite showed a chloride laboratory reading of 6,800 mg/kg, a GRO reading of 127 mg/kg and a DRO reading of 1,710 mg/kg. BTEX readings returned results of 0.012 mg/kg for benzene, 0.103 mg/kg for toluene, 0.096 mg/kg for ethyl benzene and 0.527 mg/kg for total xylenes. The excavated soil was

An Investigation and Characterization Plan (ICP) was submitted to NMOCD on March 17th, 2008 and was approved on May 21st, 2008. As part of the ICP, three soil bores and a monitor well were installed at the site on February 3rd and 4th, 2009 (Figure 2). As the soil bores and monitor well were installed, sample were taken at regular intervals and field tested for chlorides and hydrocarbons. Representative samples were taken to a commercial laboratory for confirmatory chloride analysis (Appendix A). SB-1 and SB-2 were installed to 20 ft bgs. Laboratory analysis of SB-1 returned with a chloride value of 384 mg/kg at 5 ft bgs; however, field chloride levels dropped to a concentration of 222 mg/kg at 20 ft bgs. Laboratory analysis of SB-2 returned a chloride value of 1,860 mg/kg at 10 ft bgs; however, the chloride field values dropped as the bore was being advanced. SB-3, installed near the source, returned laboratory chloride readings of 4,400 mg/kg at 20 ft bgs and 5,760 mg/kg at 65 ft bgs. Field chloride levels remained high throughout the bore.

RECS recommends that ROC install a 20-mil reinforced poly liner measuring 62 ft x 61 ft at a depth of 3 ft bgs, due to the presence of hard rock in the area (Figure 2). The liner will provide a barrier that will inhibit the downward migration of chlorides to groundwater. The soils placed above the liner will have a laboratory chloride reading no greater than 500 mg/kg and a field PID reading below 100 ppm. Excavated soil will be evaluated for use as backfill and any soils requiring disposal will be properly disposed of at a NMOCD approved facility. Upon completion of backfilling, the site will be seeded with a native vegetative mix and soil amendments will be added as necessary. Vegetation above the liner will also provide a natural infiltration barrier for the site since plants capture water through their roots thereby reducing the volume of water moving through the vadose zone to groundwater.

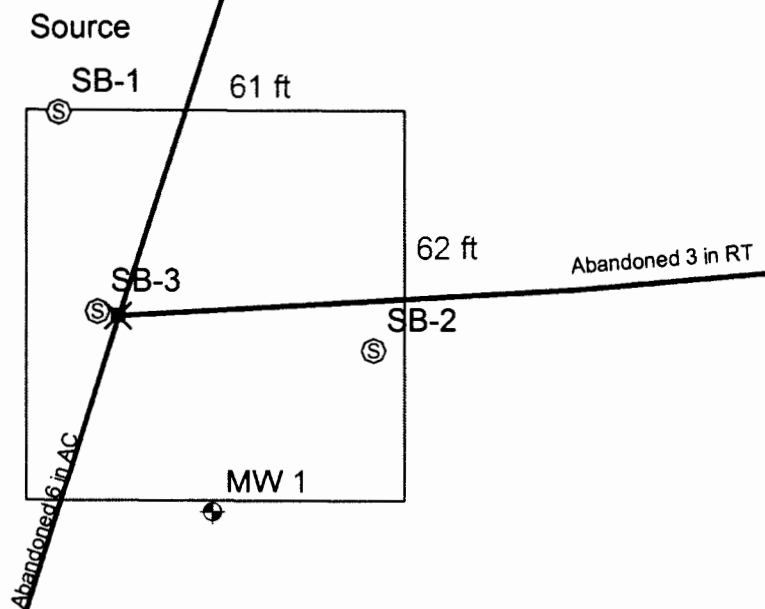
Figure 3

MW Sampling Data

Proposed MW-2

In order to determine if there is an up-gradient groundwater source for contamination at the site, RECS recommends that ROC install a monitor well (MW-2) approximately 100

ft up-gradient of the site (Figure 3). The monitor well will be sampled quarterly in conjunction with MW-1. Once the monitor wells at the site have been analyzed for chloride and TPH readings, ROC will submit a groundwater remedy to NMOCD to address groundwater quality at the site.
