WORKPLANS

**RE: Investigation and Characterization Plan (ICP) Report and Corrective
Action Plan (CAP)
Rice Operating Company – Vacuum SWD System
Vacuum C-36 EOL (1R425-103): UL/C sec. 36 T17S R34E**

Soil Bore Installation and Proposed Liner

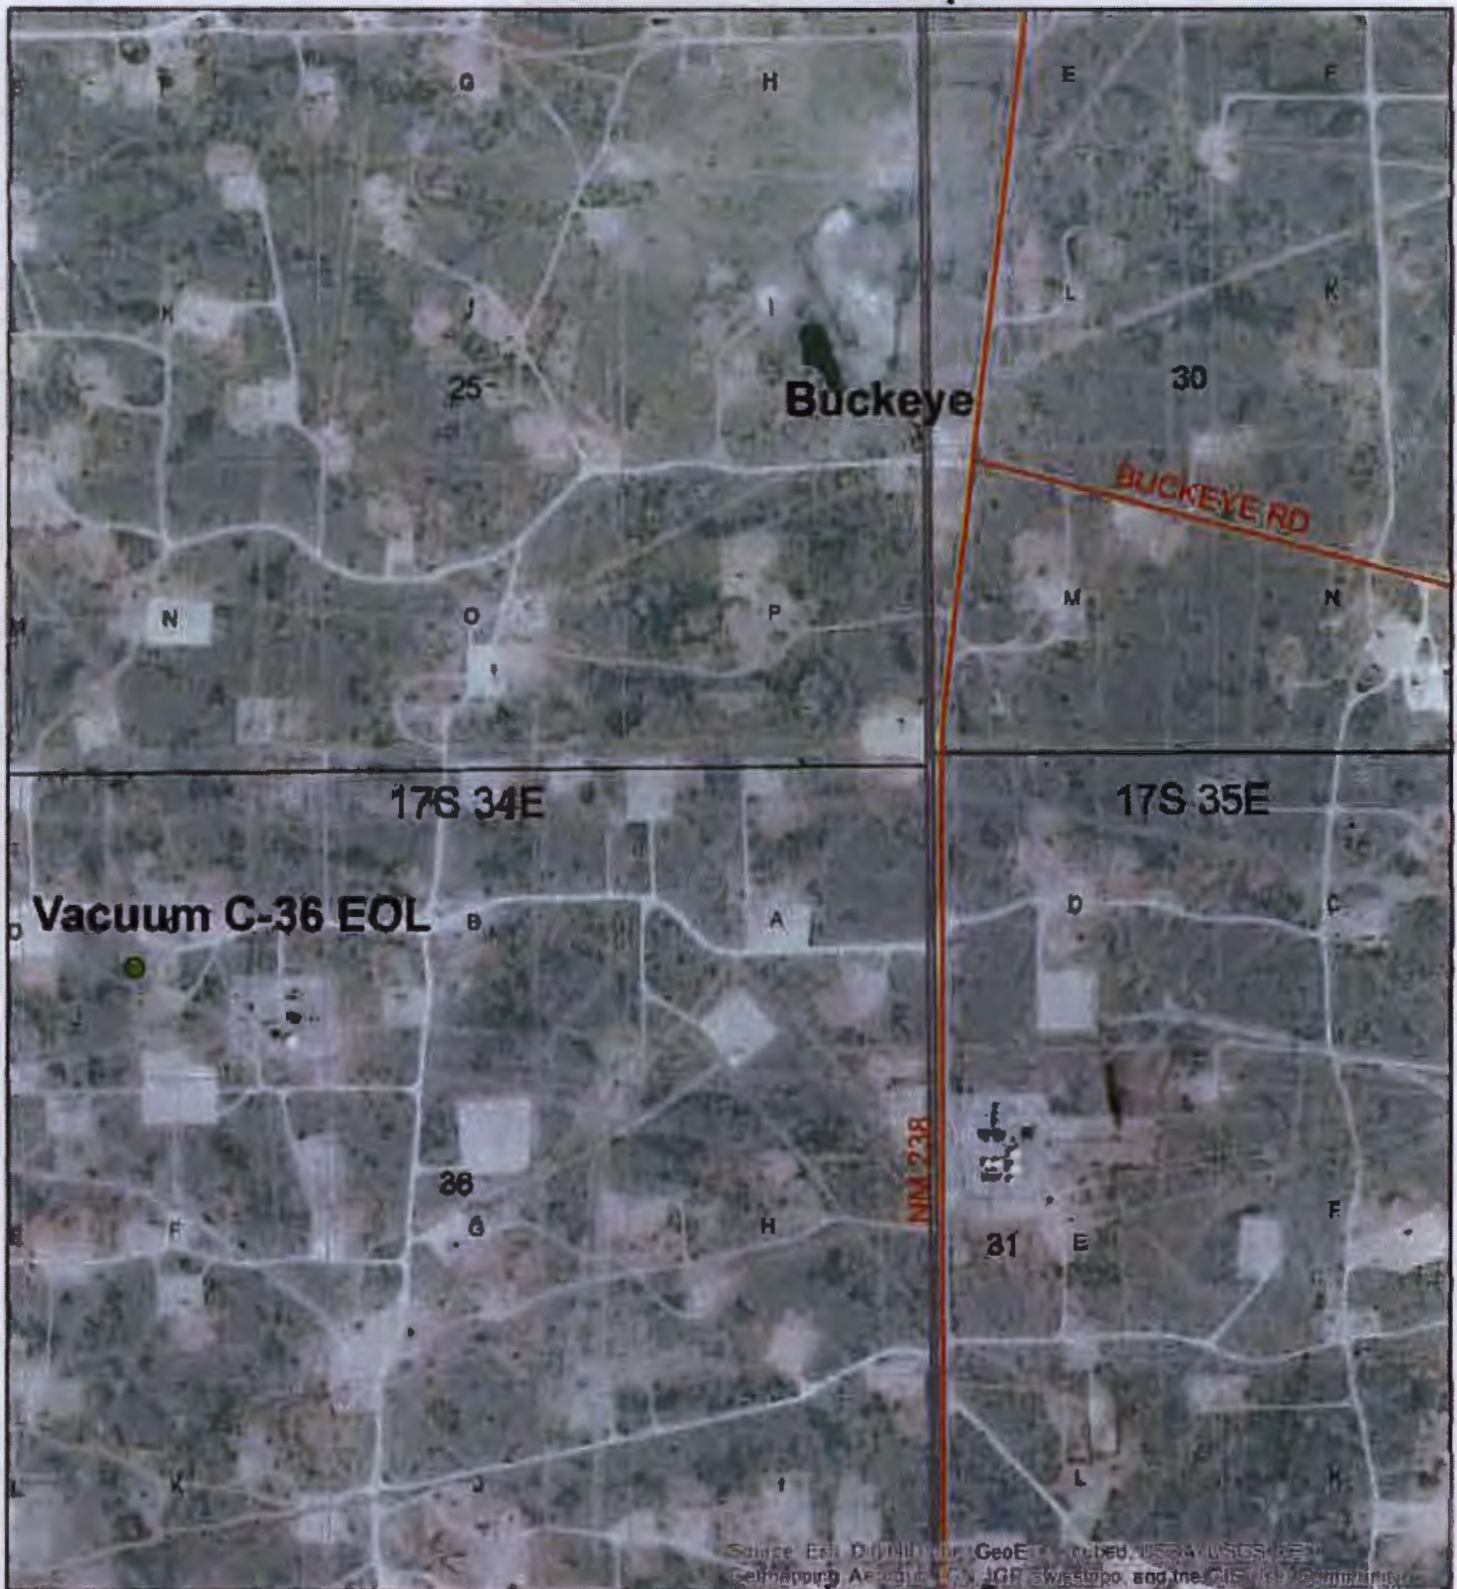
The site is located approximately 0.8 miles southwest of Buckeye, New Mexico in Unit C, Section 36, T17S, R34E as shown on the Site Location Map (Figure 1). NM OSE records indicate that groundwater will likely be encountered at a depth of approximately 107 +/- feet.

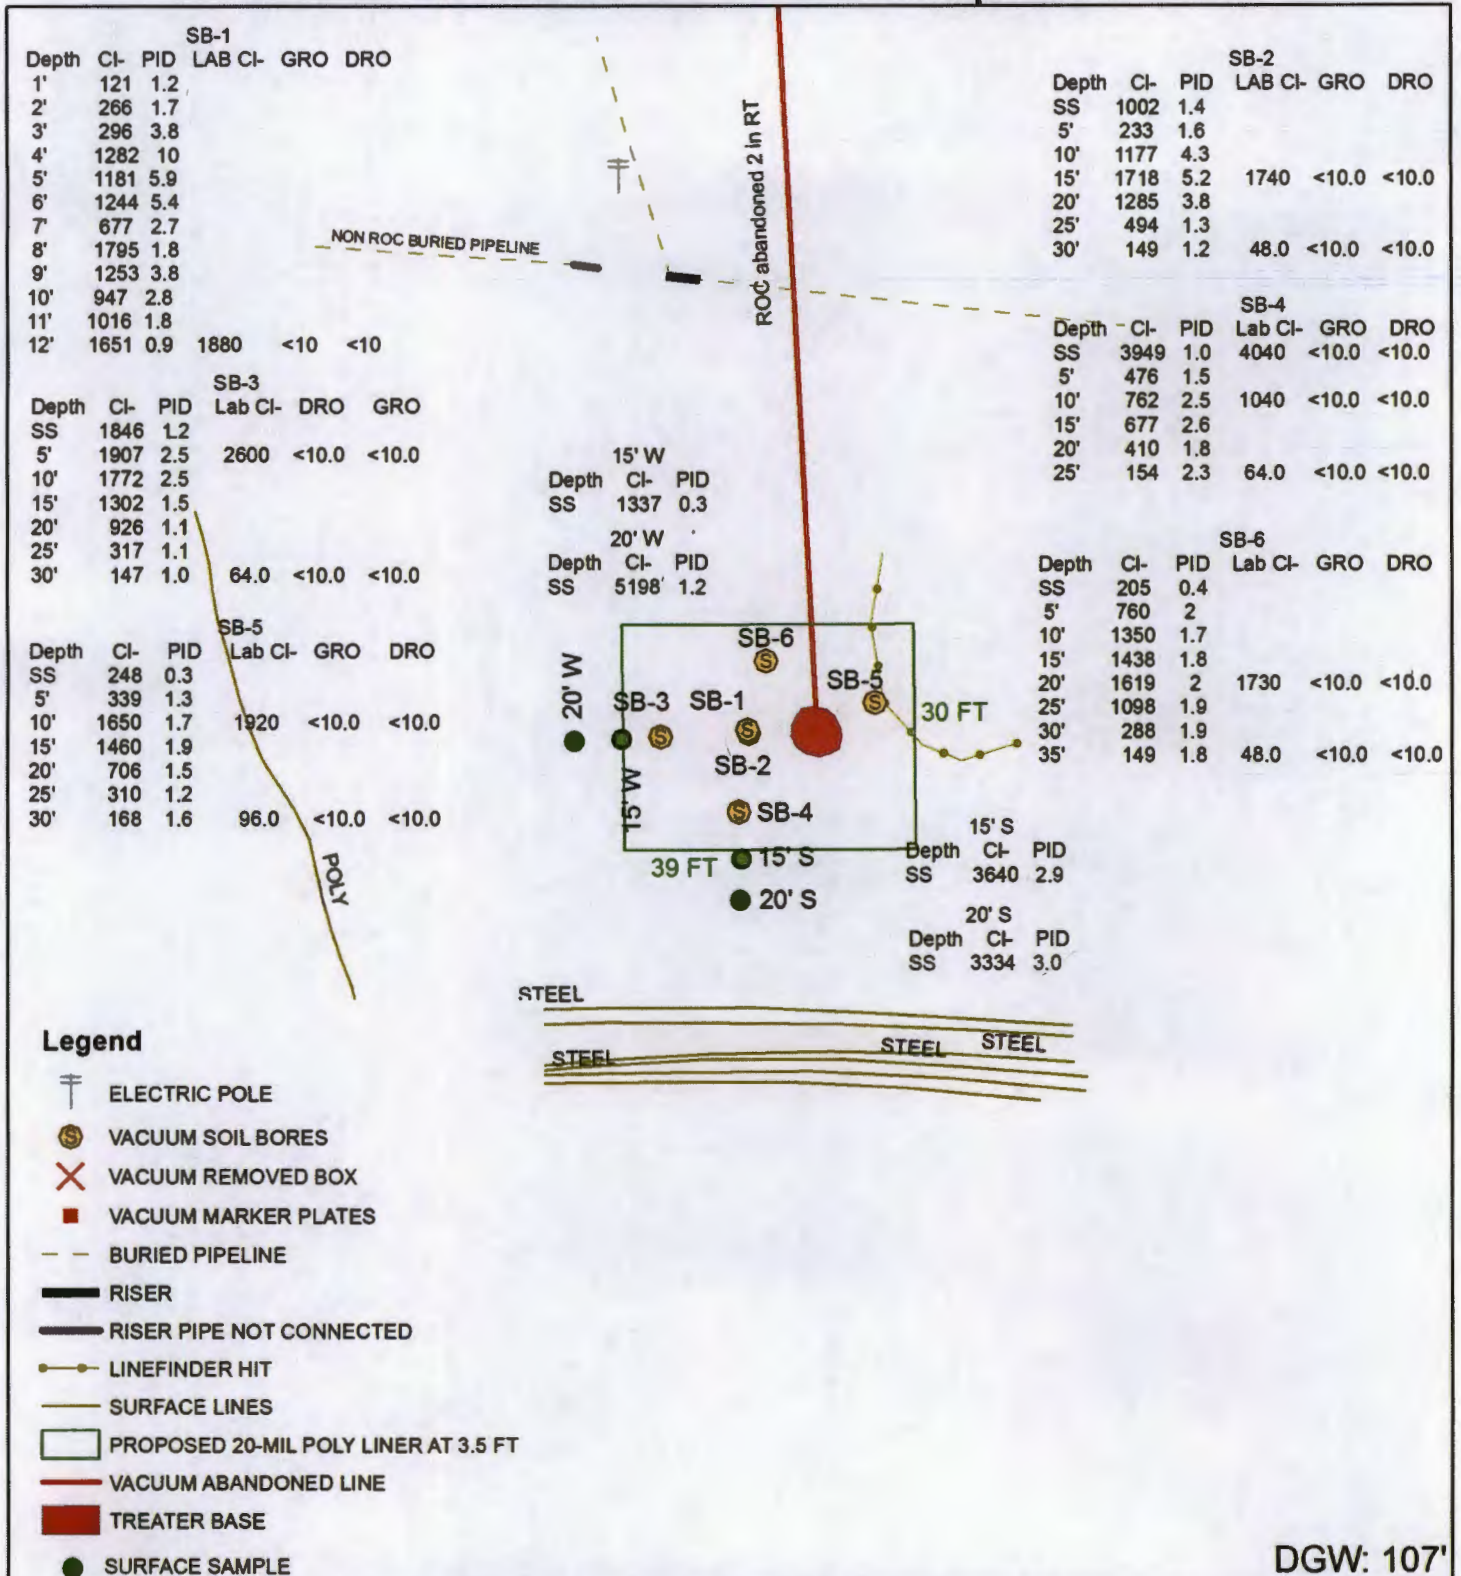
Figure 2

DGW: 107'

From the analysis of the soil bore data, residual chlorides and TPH at the site have not affected groundwater. In order to protect groundwater from residual soil chlorides, RECS recommends that ROC install a 20-mil reinforced poly liner at the site with dimensions of 30 ft x 39 ft at a depth of 3.5 ft bgs (Figure 2). The junction box investigation, conducted in 2010, showed an extremely hard rock layer to be located at approximately 4 ft bgs. Lithology description of the soil samples collected while drilling soil bores also showed a caliche/sandstone layer beginning at a depth of approximately 4 ft bgs. The liner will inhibit the downward migration of residual constituents to

groundwater. The soils placed above the liner will have a laboratory chloride reading no greater than 500 mg/kg and a field PID measurement below 100 ppm. Excavated soil will be evaluated for use as backfill and any soil requiring disposal will be properly disposed of at a NMOCD approved facility. The soils over and surrounding the site will then be prepared with soil amendments as necessary and seeded with a native vegetative mix. Vegetation above the liner will also provide a natural infiltration barrier for the site since plants capture water through their roots thereby reducing the volume of water moving through the vadose zone to groundwater.

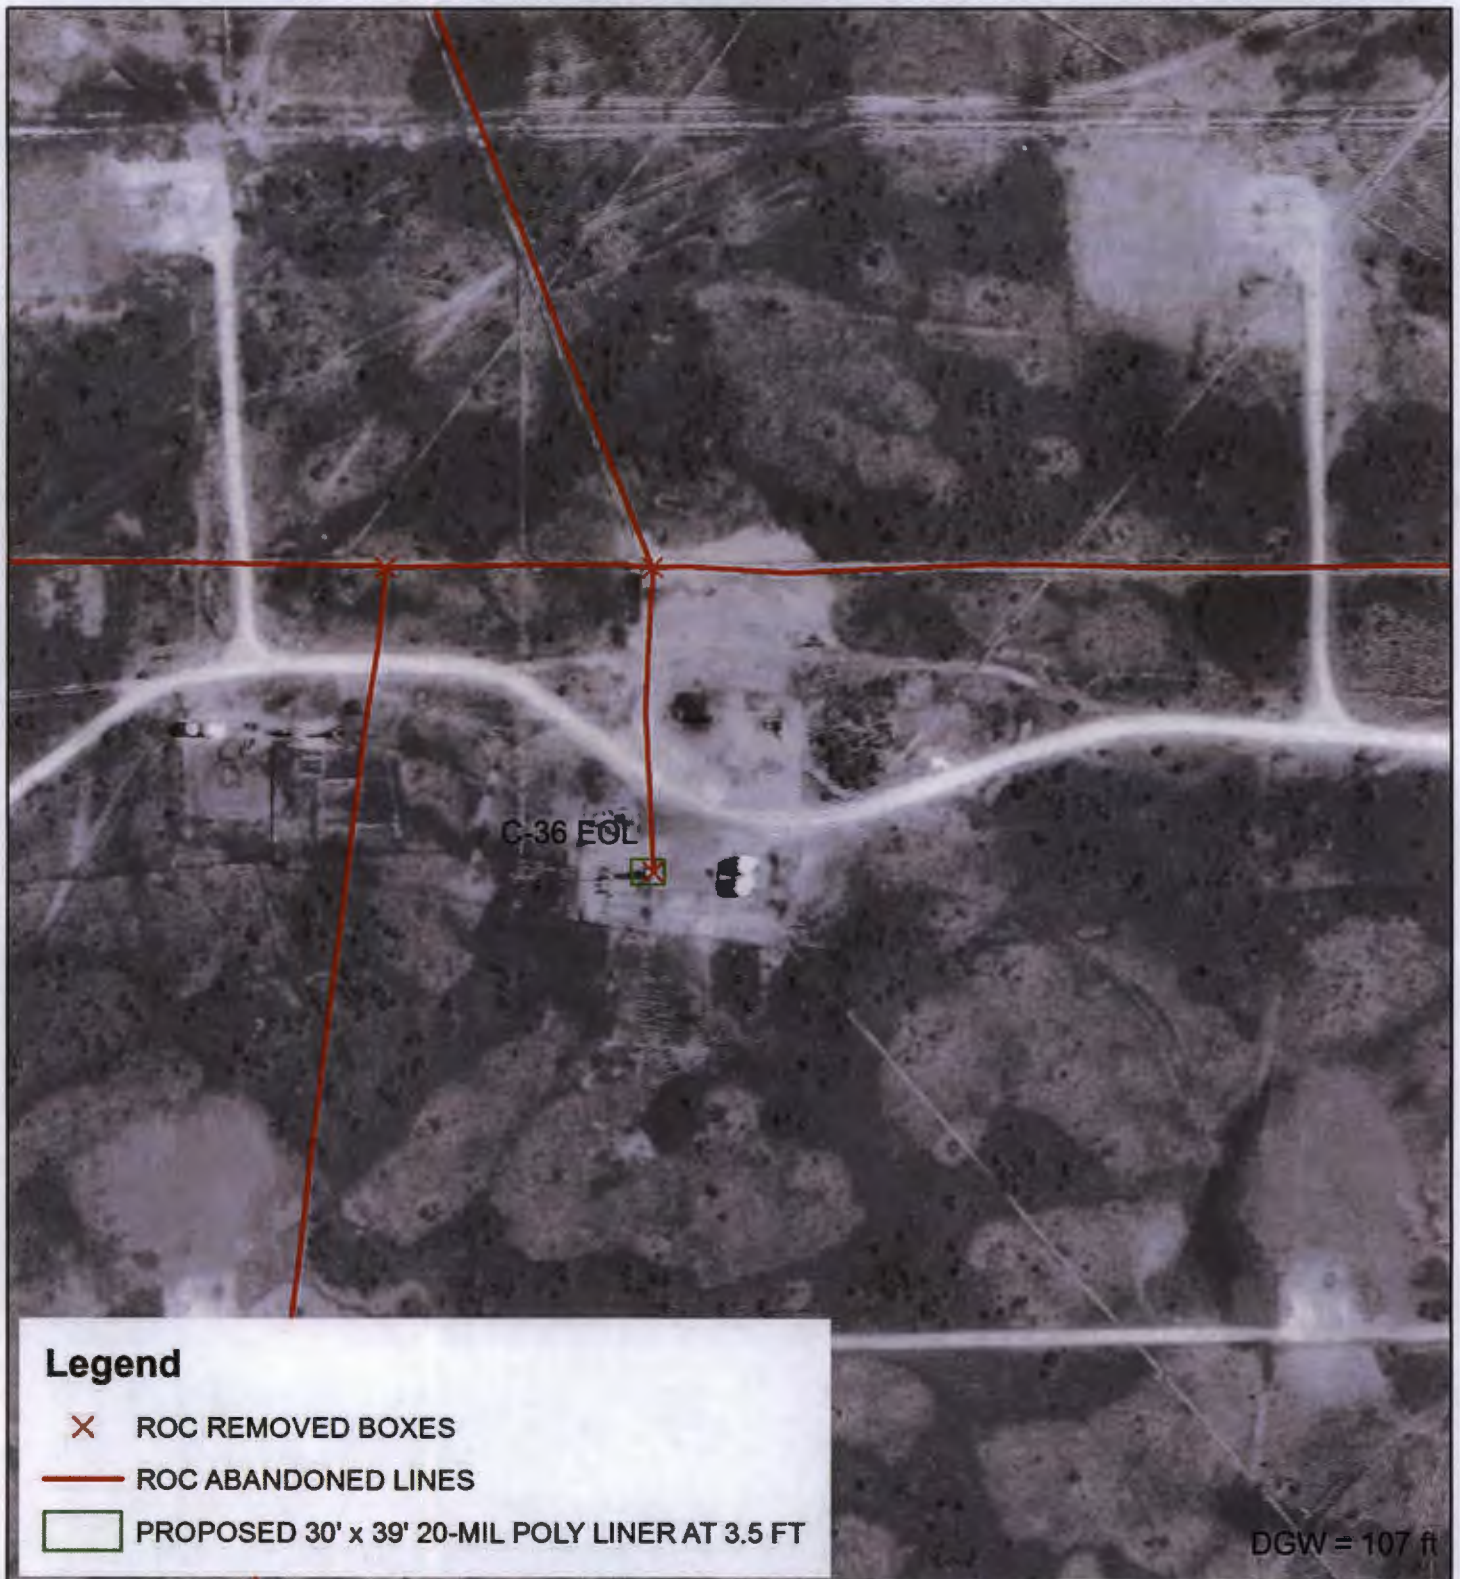
The site surrounds the base of an old heater-treater which indicates the presence of an old tank battery at the site. A series of historical photos were created of the site and from the photos, particularly the 1978 historical photo, it is evident that the C-36 junction box sat inside a tank battery (Appendix B). There are also numerous non-ROC steel lines located south of the site, and a non-ROC poly line located west of the site. This suggests that the elevated chloride concentrations observed in the surface samples were contributed from past operations of the non-ROC facility and not the former junction box.
