RE: **Investigation and Characterization Plan (ICP) Report**  
**Rice Operating Company – Vacuum SWD System**  
**Vacuum Jct. A-36: UL A, Sec. 36, T17S, R34E**  
**NMOCD Case Number: 1R424-83**

**Vacuum Jct. A-36**  
Unit A, Section 36, T17S, R34E  
NMOCD Case #: 1R425-83

# Soil Bore Installation

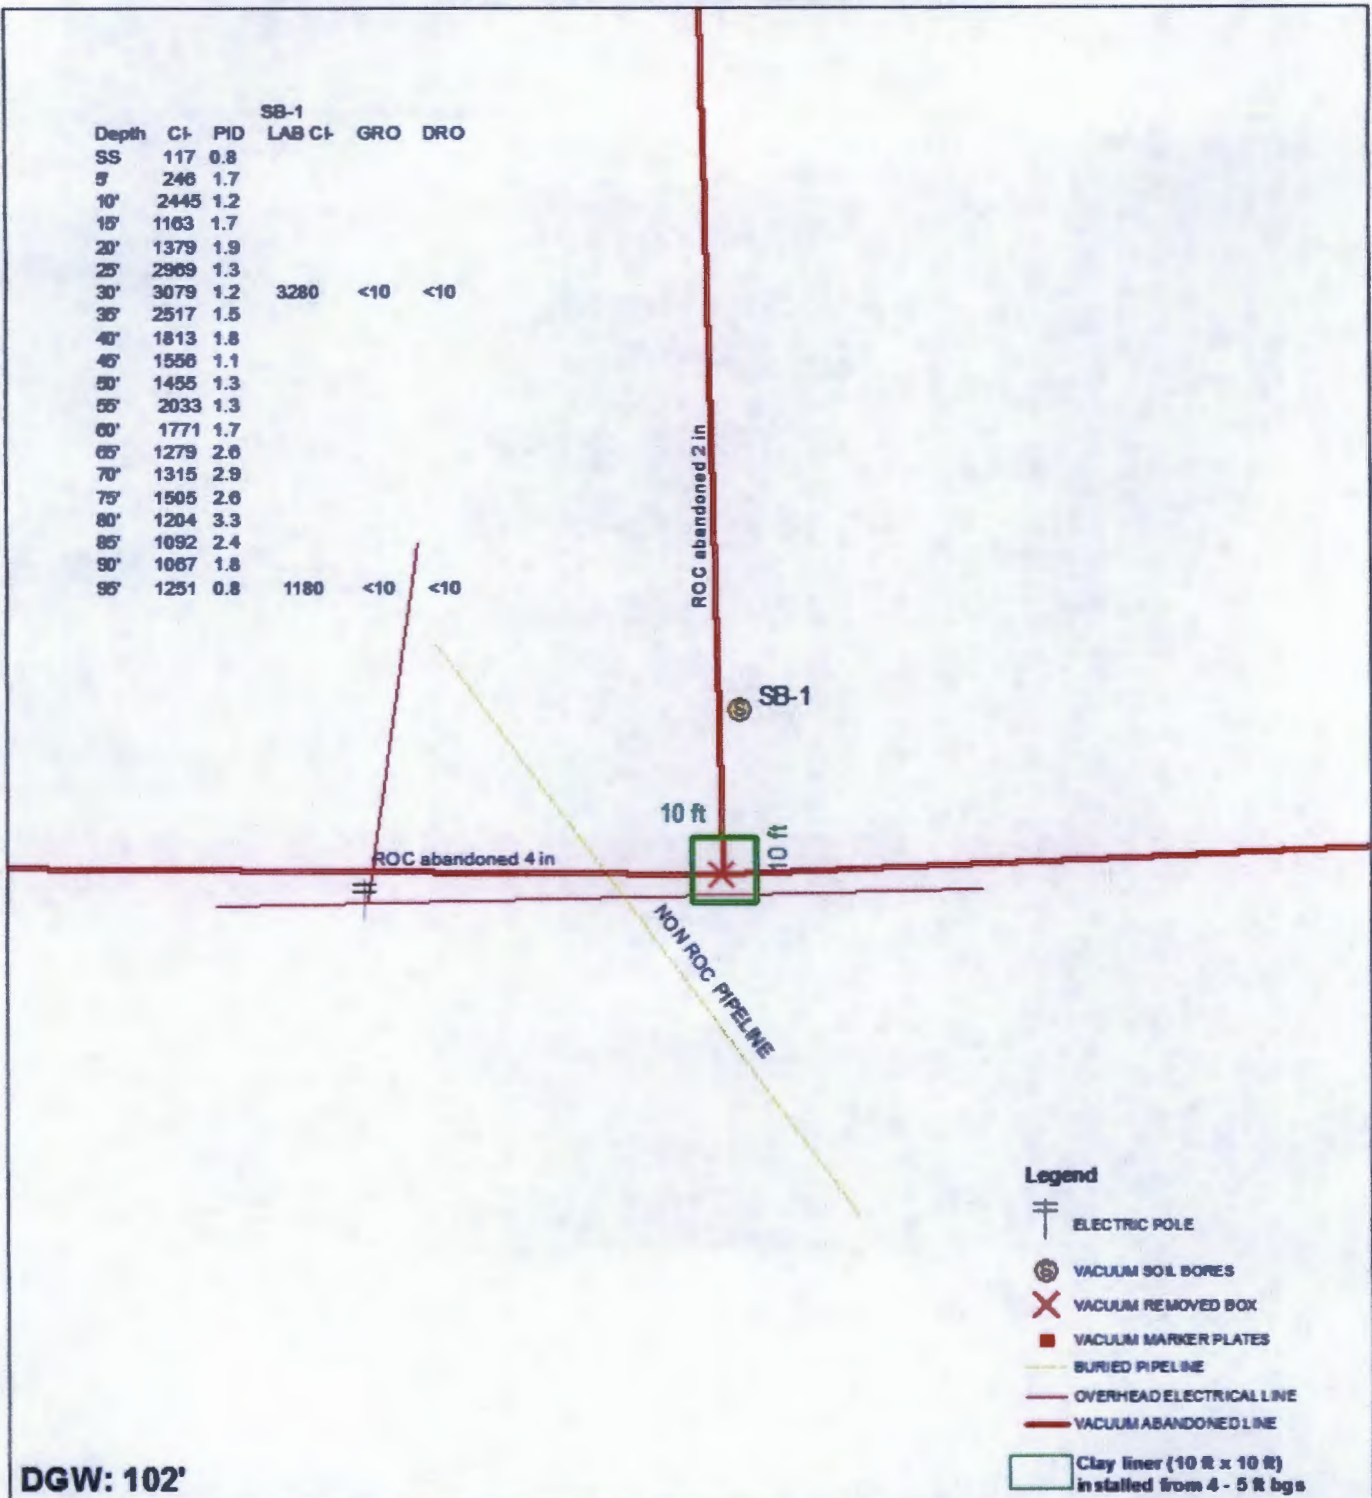
Rice Operating Company (ROC) has initiated soil sampling and analysis indicated in our Investigation and Characterization Plan (ICP) of February 15<sup>th</sup>, 2013. As part of the ICP, personnel were on site May 7<sup>th</sup> to conduct soil bore installations. One soil bore was installed at the closest possible distance, 30 feet north of the source, due to safety concerns. There are numerous safety hazards surrounding this site, including electrical high line wires located over the source that run east to west, and an underground non-ROC pipeline running northwest to southeast of our site. The highline wire prevented a soil bore from being drilled west of the site. The highline wire in combination with the non-ROC pipeline prevented a bore from being drilled south or east of the site. ROC was required to remain at least 30 ft away from the highline wire as well as a safe distance away from the non-ROC line (at least 10 ft). As the bore was advanced, samples were field tested for chlorides and hydrocarbons (Appendix). Representative samples from the bore were taken to a commercial laboratory for analysis of chlorides and hydrocarbons. SB-1 returned laboratory chloride readings of 3,280 mg/kg at 30 ft bgs and decreased to 1,180 mg/kg at 95 ft bgs. GRO and DRO results were non detect throughout the bore.

Depth	Ct	PID	SB-1 LAB Ct	GRO	DRO
SS	117	0.8			
5'	246	1.7			
10'	2445	1.2			
15'	1163	1.7			
20'	1379	1.9			
25'	2969	1.3			
30'	3079	1.2	3280	<10	<10
35'	2517	1.5			
40'	1813	1.8			
45'	1556	1.1			
50'	1455	1.3			
55'	2033	1.3			
60'	1771	1.7			
65'	1279	2.6			
70'	1315	2.9			
75'	1505	2.6			
80'	1204	3.3			
85'	1092	2.4			
90'	1067	1.8			
95'	1251	0.8	1180	<10	<10

Soil bores completed so far resulted in elevated chloride concentration, and the lateral extent of the contamination in the vadose zone has yet to be determined. Due to the safety hazards surrounding the site, Texerra recommends that ROC analyze historical photos to determine if there are any abandoned facilities in the area of the former junction box. If warranted, ROC will continue to investigate the site to determine the lateral extent of the chloride contamination.
