**Corrective Action Plan (CAP) Report and Termination Request
EME Jct. F-29-2
Unit F, SEC. 29, T19S, R37E, Monument, Lea County, New Mexico
NMOCD CASE # 1R427-318**

CAP Activities Photodocumentation

**EME Jct. F-29-2 (1R427-318)
Unit F, Section 29, T19S, R37E**

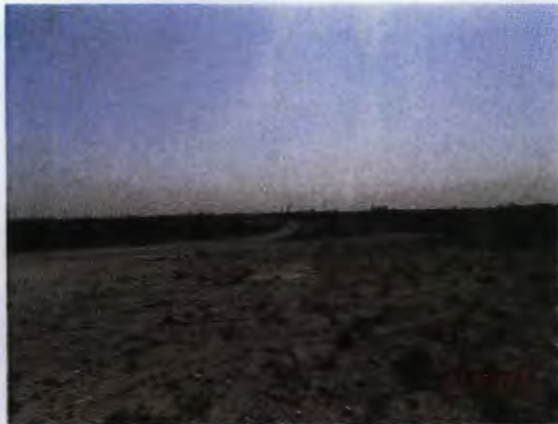
Site prior, facing south 2/7/2013

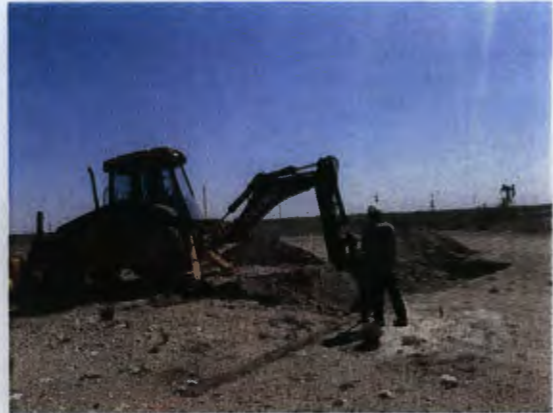
Excavating, facing north 6/3/2013

As proposed in the CAP dated January 31, 2013, which was approved by the NMOCD on March 6, 2013, the site was excavated to dimensions of approximately 52' x 26' x 5 feet deep. The spoil pile (a total of 252 cubic yards) was transported to Sundance Services for disposal. The bottom of the excavation was padded with six inches of blow sand, and a 20 mil, reinforced polyethylene liner was installed at a depth of 4.5 ft bgs. The liner was then padded with an additional 6 inches of blow sand. Upon completion of the liner installation, the excavation was backfilled with 1.5 feet of excavated soil. A composite sample of the excavated soil was analyzed by a commercial laboratory (8 point backfill composite: chloride 144 mg/kg, PID 10.4 ppm). Approximately 228 cubic yards of soil was imported and used to backfill the excavation to ground surface and to contour the site to the surrounding area. A composite sample of the imported soil was analyzed by a commercial laboratory (imported topsoil: chloride <16 mg/kg, PID 5.6 ppm). The site was then seeded with 15 pounds of blue grama, 15 pounds of black grama, 20 pounds of Sudan seed, 20 bags of BioNhance, 2 bags of potting soil, and 1 bag of manure. Vegetation above the backfilled site is recovering, which can be seen in the attached photograph. Photographs of the CAP activities, laboratory data, PID sheet, and revegetation form are attached.

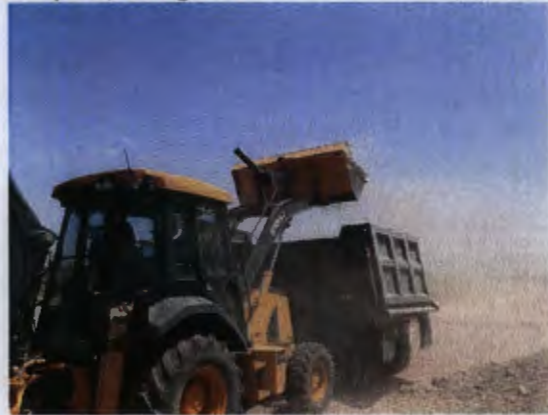
Exporting excavated soil, facing southeast 6/5/2013

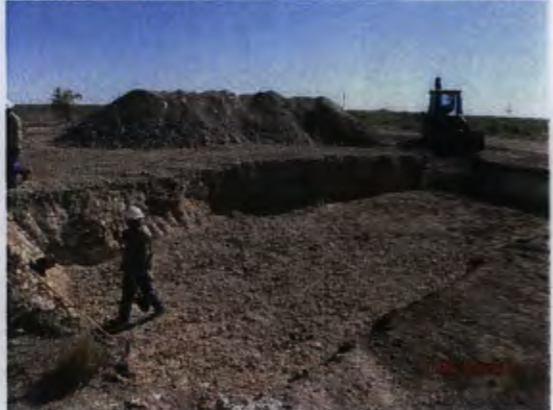
Site excavated to a depth of 5 ft bgs, facing northeast 6/10/2013

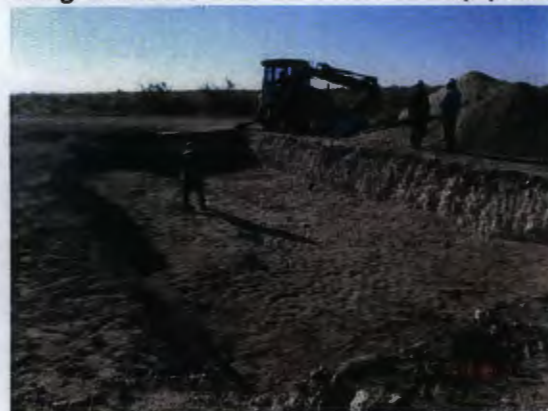
The bottom of the excavation padded with 6 inches of blow sand, facing southeast 6/10/2013

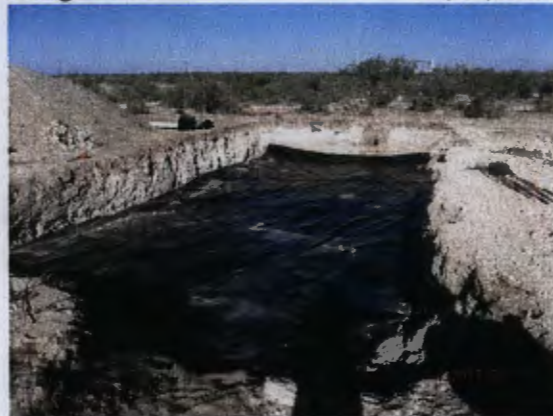
20-mil reinforced liner installed, facing southwest 6/11/2013

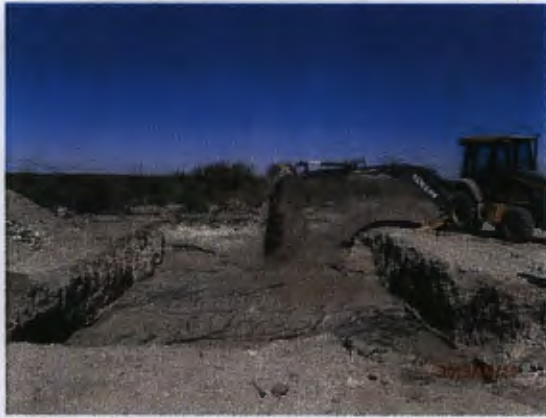
Padding liner with blowsand,
facing east 6/11/2013

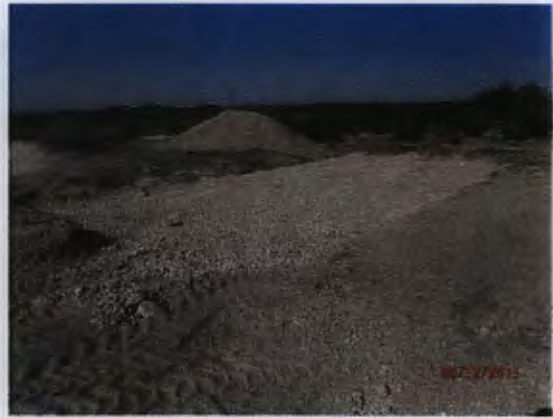
Backfilling,
Facing south 6/12/2013

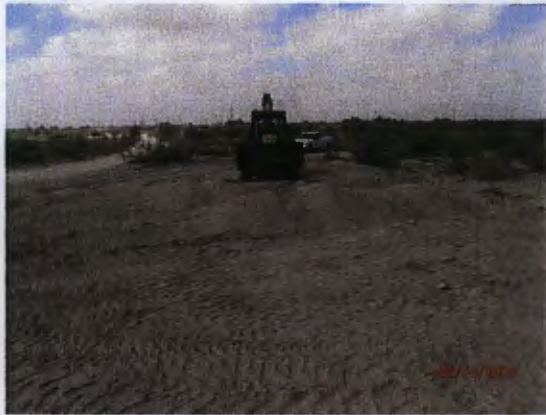
Contouring the site with blow sand,
facing south 6/13/2013

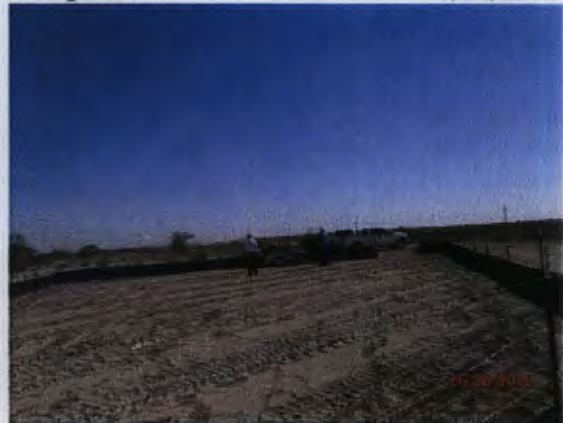
Spreading amendments, facing north 6/26/2013

Fertilizer <input checked="" type="checkbox"/>	Hay <input type="checkbox"/>	Other <input checked="" type="checkbox"/>
Type:		20 bags of BioNhanche, 2 bags of Potting Soil, 1 bag of Manure.
Lbs/acre:

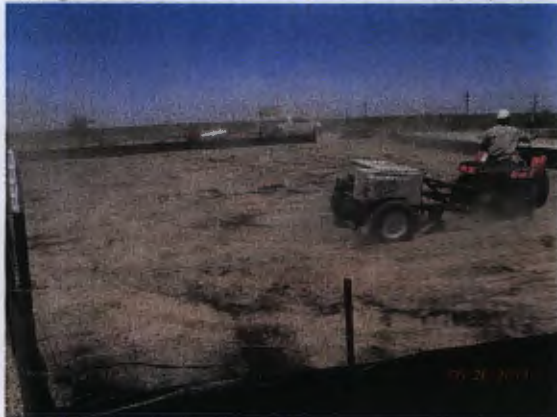
Spreading seed, facing north 6/26/2013

Custom seed mix <input checked="" type="checkbox"/>	Prescribed mix <input type="checkbox"/>	Seed mix name: 20 lbs Sudan Grass. 15 lbs Blue Grama. 15lbs Black Grama	Seeding date: 6/26/2013
Broadcast <input checked="" type="checkbox"/>			
Method: Mechanical Seeder			
Soil conditions during seeding: Dry <input checked="" type="checkbox"/> Damp <input type="checkbox"/> Wet <input type="checkbox"/>			
Photos attached <input checked="" type="checkbox"/>	Observations:		
Number of photos:	The Seed Was Tilled into the Soil

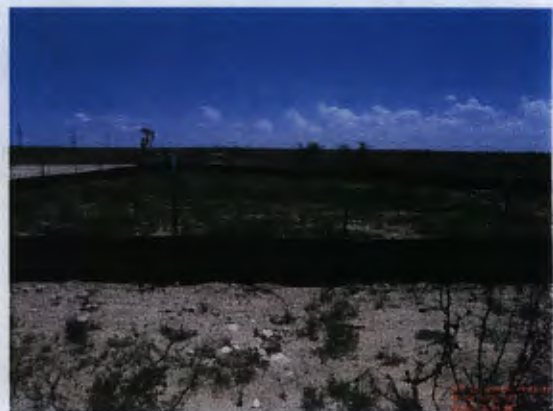
Site complete, facing east 8/6/2013
