From: Hansen, Edward J., EMNRD
Sent: Tuesday, September 10, 2013 3:53 PM
To: Hack Conder (hconder@riceswd.com)
Cc: Leking, Geoffrey R, EMNRD; Laura Pena (lpna@riceswd.com); Katie Jones <kjones@riceswd.com> (kjones@riceswd.com); Scott Curtis (scurtis@riceswd.com)
Subject: Remediation Plan (1R427-360) Termination - ROC EME C-10 EOL Site

RE: Termination Request
EME C-10 EOL (1R427-360): UL/C, Sec. 10, T21S, R36E
RICE Operating Company – Eunice Monument Eumont SWD System

EME C-10 EOL (1R427-360)
Unit Letter C, Section 10, T-21-S, R-36-E

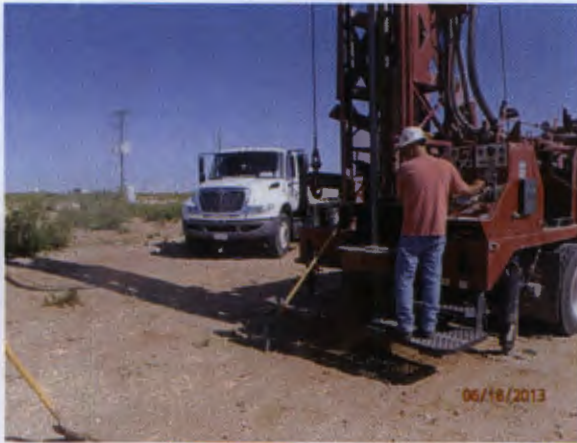
Installing SB-1, facing northwest 6/18/13

To further investigate the depth of chloride presence, a soil bore was initiated on June 18, 2013 at 8 ft east of the former junction box site. The boring was advanced to a depth of 40 ft below ground surface (bgs) with soil samples collected every 5 ft. Each sample was field titrated for chlorides and field screened using a PID for hydrocarbons, resulting in concentrations that did not change with depth. The 15 ft and 40 ft samples were sent to a commercial laboratory for analysis. The 15 ft samples resulted in a chloride concentration of 400 mg/kg and concentrations of GRO and DRO below detectable limits. The 40 ft sample resulted in a chloride concentration of 224 mg/kg and concentrations of GRO and DRO below detectable limits. The entire bore hole was plugged with bentonite to ground surface.

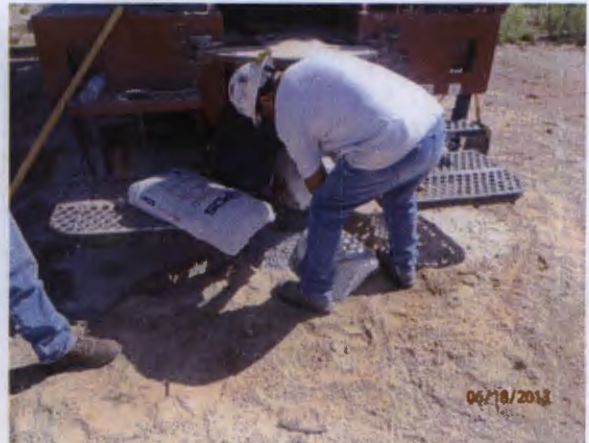
Plugging SB-1 in total with bentonite 6/18/13

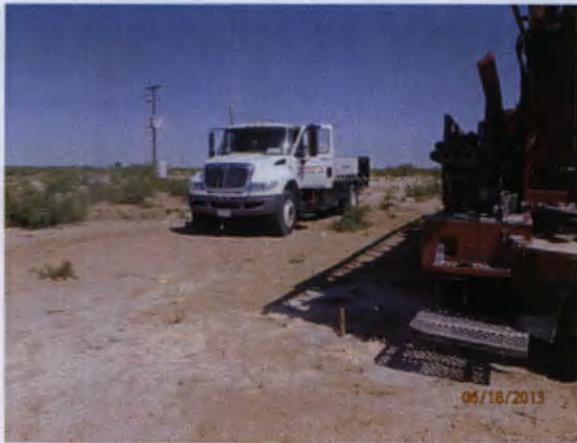
SB-1 completed, facing northwest 6/18/13
