1R - 426-214

RE: CAP Report and Termination Request  
BD F-26 vent (1R426-214): Unit Letter F, Section 26, T21S, R37E  
RICE Operating Company – Blinebry Drinkard (BD) SWD System

## ***BD F-26 vent***

**BD F-26 vent (1R426-214)**  
**Unit Letter F, Section 26, T21S, R37E**

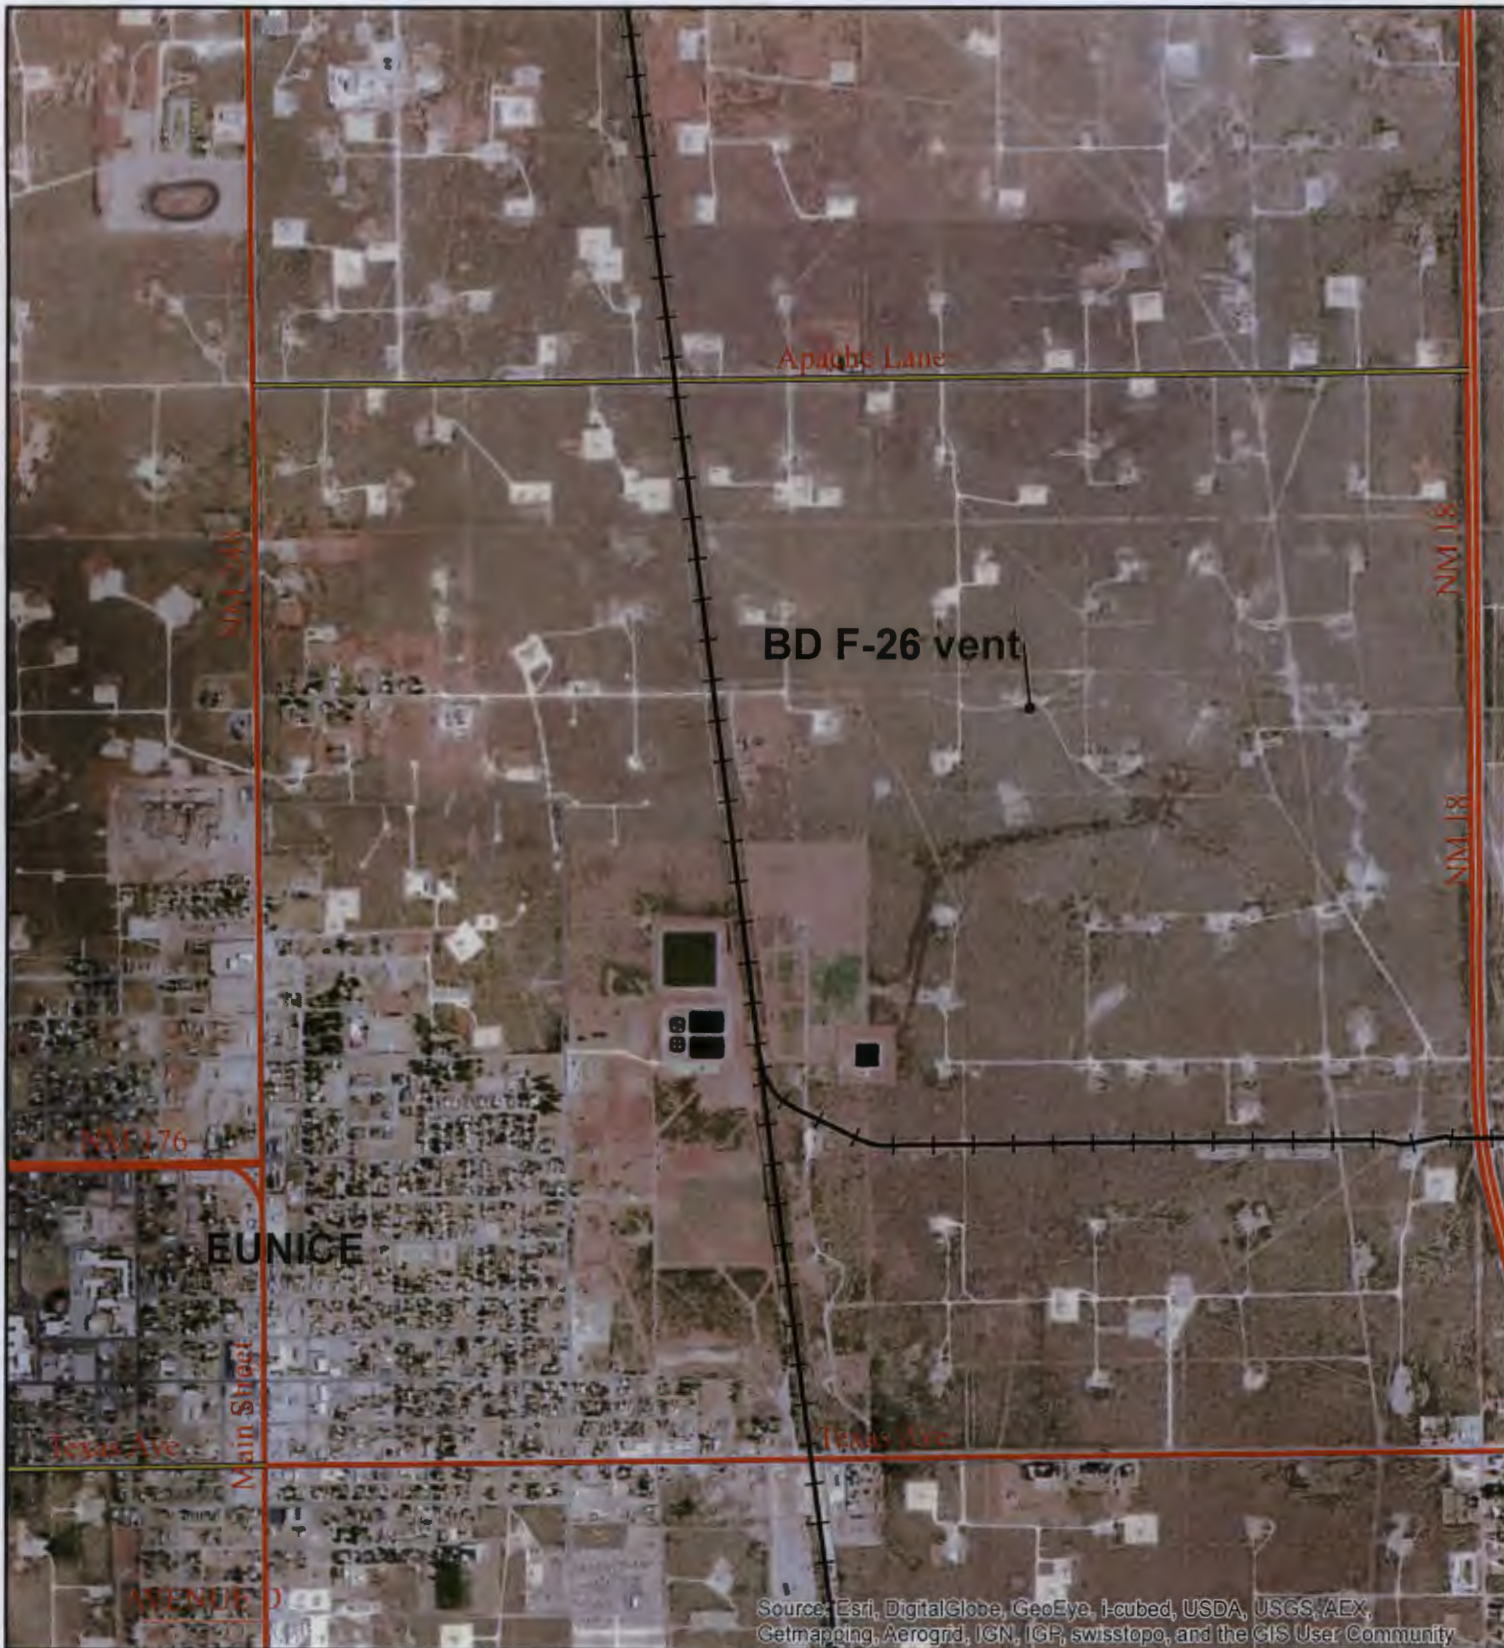
### **Figure 1**

U/ N, Section 20, T21S, R37E  
LEA COUNTY, NM

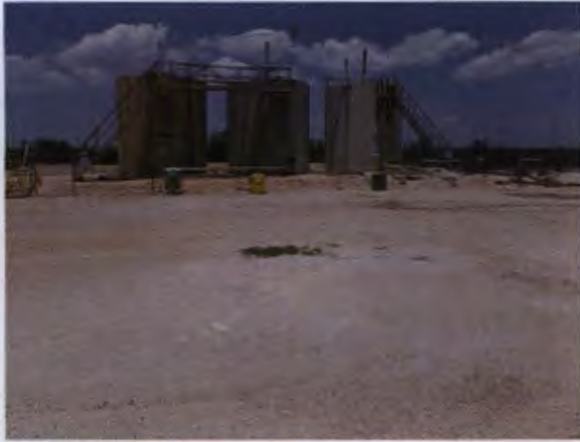
Site prior to excavation,  
facing north 6/17/2013

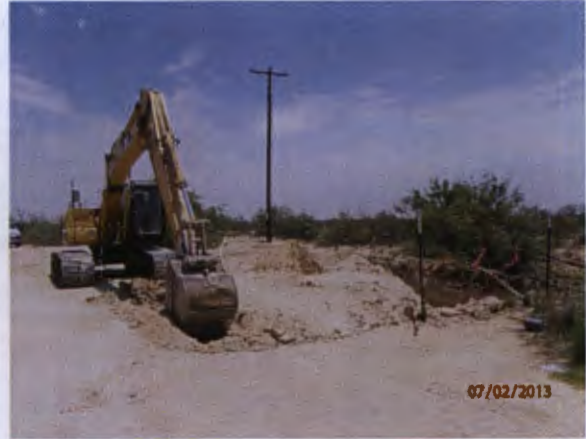
Excavating,  
Facing southeast 7/2/2013

Beginning on July 1, 2013, RECS personnel were on site to begin the excavation for the 20-mil reinforced polyethylene liner installation. The site was excavated to 43 ft x 30 ft, as shown on the attached Figure 2, to a depth of 5 ft. A total of 276 yards of excavated soil was taken to a NMOCD approved facility for disposal, and a total of 228 yards of clean soil were imported to serve as pad and backfill material. The imported blow sand was used to pad the bottom of the excavation to protect the liner from punctures. The liner was installed and properly seated into the excavation at approximately 4.5 ft bgs. The remainder of the blow sand was used to pad above the liner and to backfill the excavation. A sample of the imported soil was field tested for hydrocarbons and returned a result of 74.4 ppm. The sample was then taken to a commercial laboratory for analysis of chlorides, which returned a result below detectable limit. The excavation was backfilled to ground surface and contoured to the surrounding area.

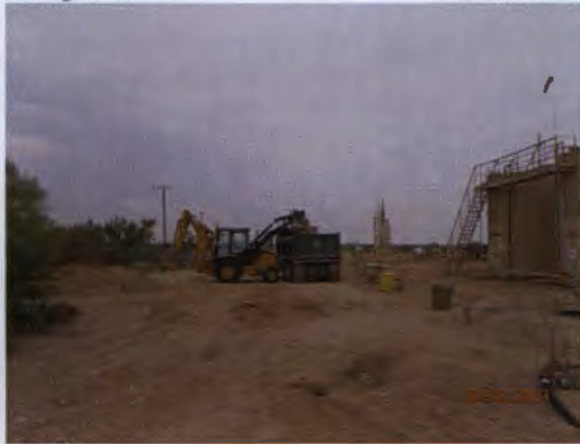
Exporting soil,  
facing west 7/2/2013

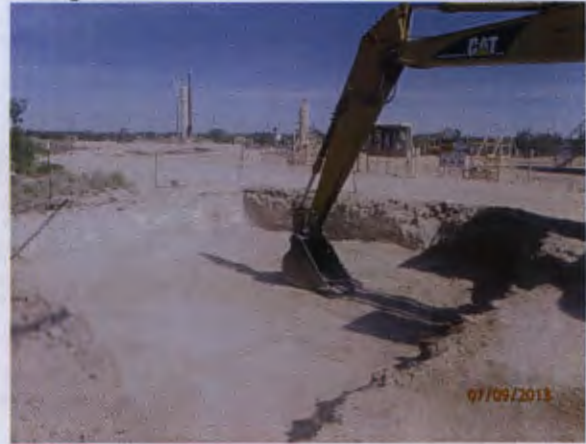
Excavation final,  
facing northwest 7/9/2013

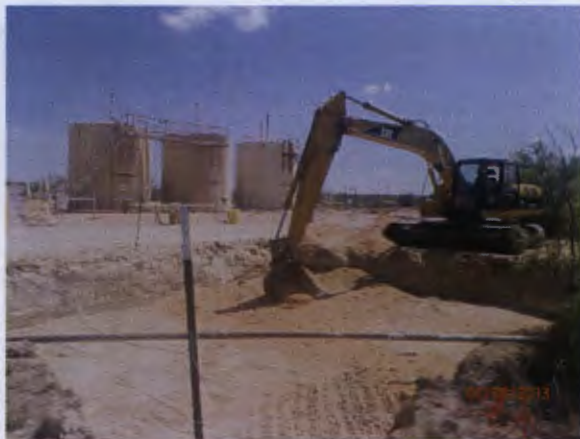
Installing 6" bottom sand pad,  
facing northeast 7/9/2013

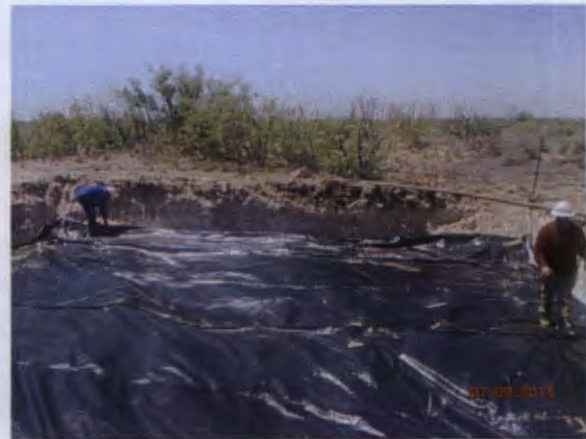
Installing liner,  
Facing south 7/9/2013

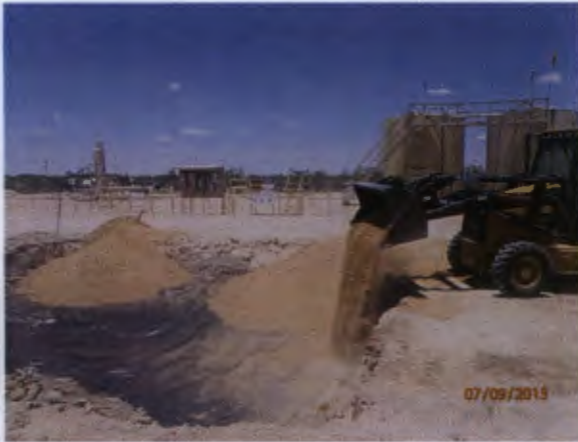
Padding liner with blowsand,  
Facing northwest

7/9/2013

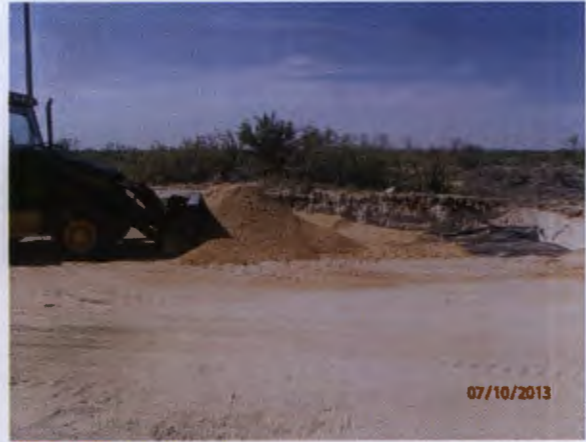
Backfilling excavation,  
Facing south

7/10/2013

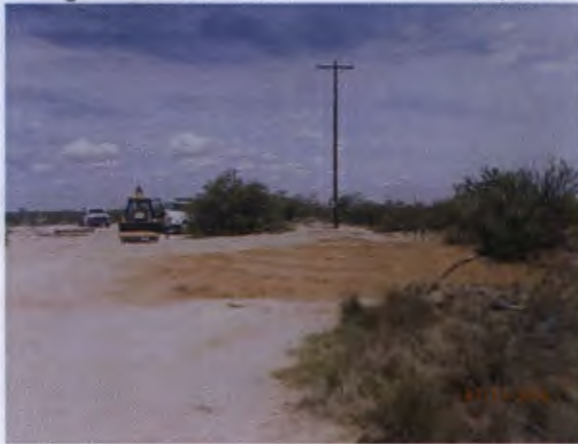
Final complete,  
facing east

7/11/2013

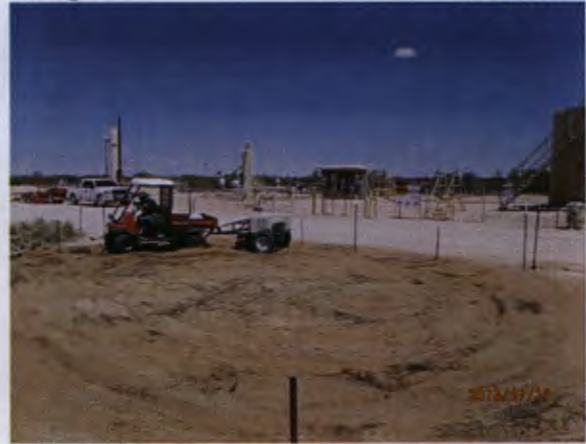
Spreading seed,  
facing northwest

7/12/2013

Silt net fencing was placed around the backfilled area to provide protection from wind erosion and maintain seed integrity. On July 11 and 12, 2013, the site was disked and soil amendments were added to the top soil portions of the site. The site was seeded with a blend of native vegetation and is beginning to recover. The lab result, PID sheet, revegetation form, and photo documentation are included in Appendix B.

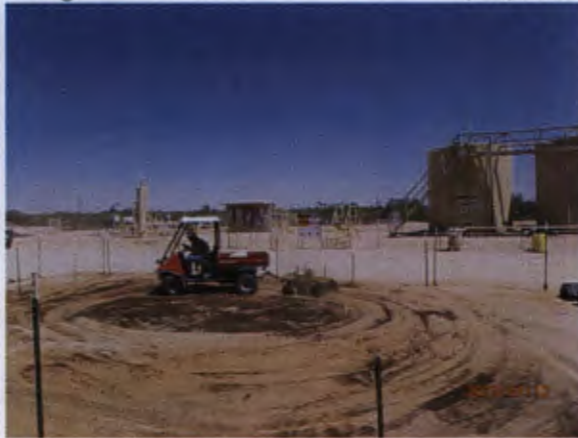
Tilling seed,  
facing northwest

7/12/2013

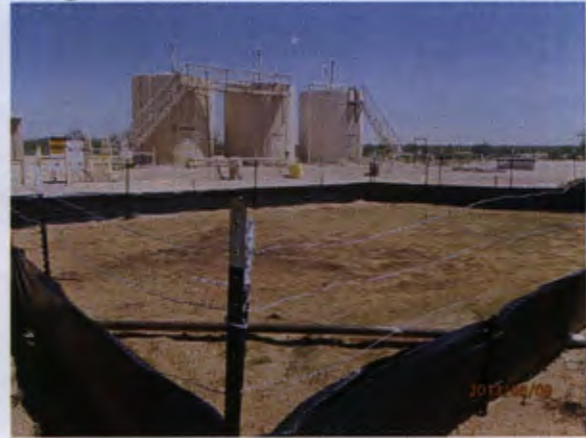
Site complete with vegetation,  
facing north

8/9/2013
