Subject: Remediation Plan (1R427-146) Termination - ROC EME Gullully A EOL Site

**EME Gullully A EOL Site**

Unit Letter O, Section 24, T20S, R36E, NMPM, Lea County, New Mexico

EME Gullully A EOL (1R427-146): UL/O, Sec. 24, T20S, R36E

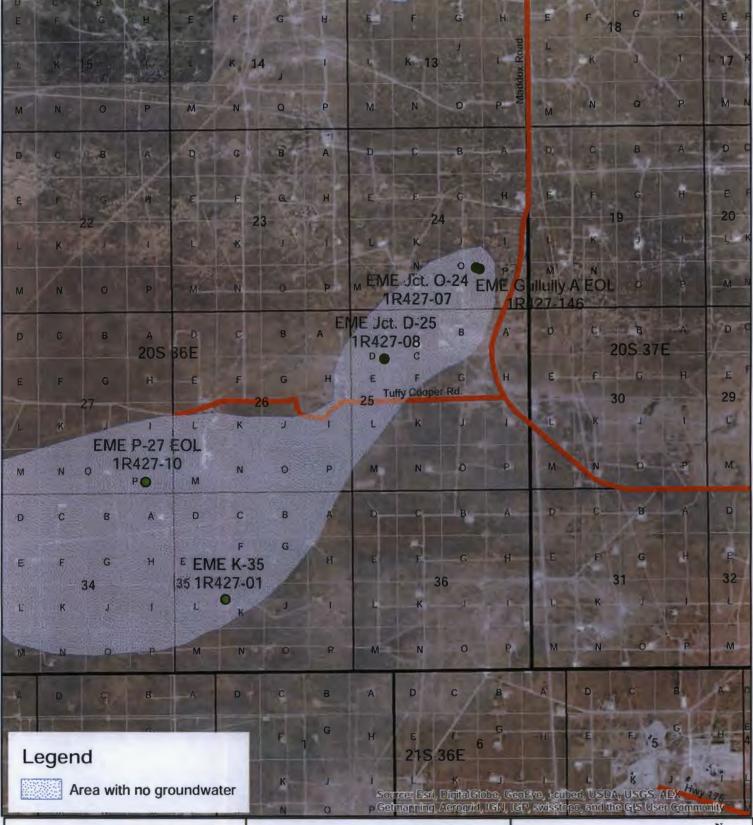
# Sites in Area of No Groundwater

The Gullully A EOL site is located within an area of no groundwater. A plat showing this site in relation to the other sites proven to have no groundwater has been attached. The closest site is EME Jct. O-24 (1R427-07), which is approximately 40 feet to the northwest of the Gullully A EOL site. A soil bore was drilled at Jct. O-24 to a depth of 70 ft bgs, and the red bed was encountered at approximately 60 ft bgs. After a 48 hour holdover period, the bore was gauged by Harrison & Cooper, Inc., and the moisture content at that depth was non-detectable. A letter of no groundwater from Harrison & Cooper, Inc. for the EME Jct. O-24 is attached. Letters of no groundwater for three additional sites in the area [EME Jct. D-25 (1R427-08), EME P-27 EOL (1R427-10), and EME K-35 (1R427-01)] are also attached.

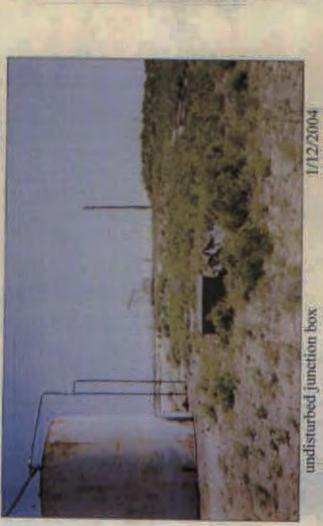
undisturbed junction box

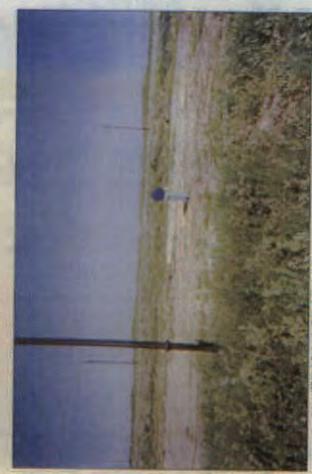
6/16/2004

seeding backfilled site

backfilling excavation

backfilled with the blended soil to ground surface and contoured to the surrounding area. On 8/4/2004, the site was seeded with a blend of native vegetation.

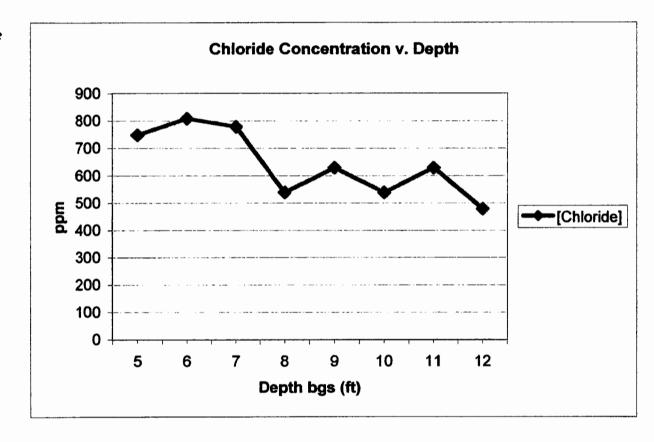
# Vertical Delineation at Source

Depth bgs (ft)	[Cl <sup>-</sup> ] ppm
5	749
6	809
7	779
8	539
9	629
10	539
11	629
12	479

Depth to groundwater here is ambiguous. USGS maps indicate that the site is located on a hydrogeologic boundary line to the north of which groundwater depth is ~36 ft and 117 ft to the south.

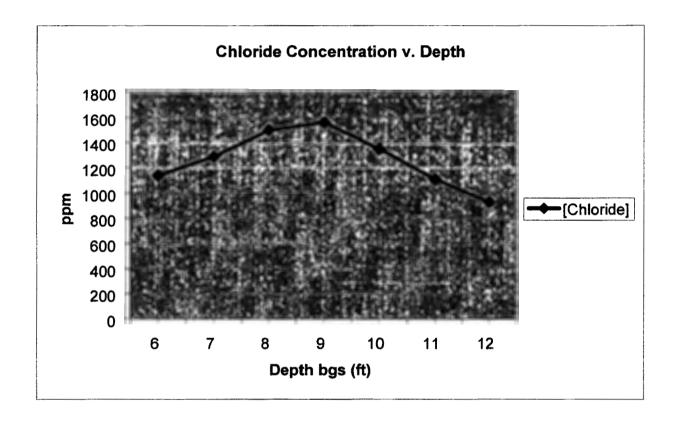
15 ft West of box

Digitally bys ((fi)	i Kariomiki
6	1139
7	1289
8	1499
9	1559
10	1349
11	1109
12	929

Depth to groundwater here is ambiguous. USGS maps indicate that the site is located on a hydrogeologic boundary line to the north of which groundwater depth is ~36 ft and 117 ft to the south.

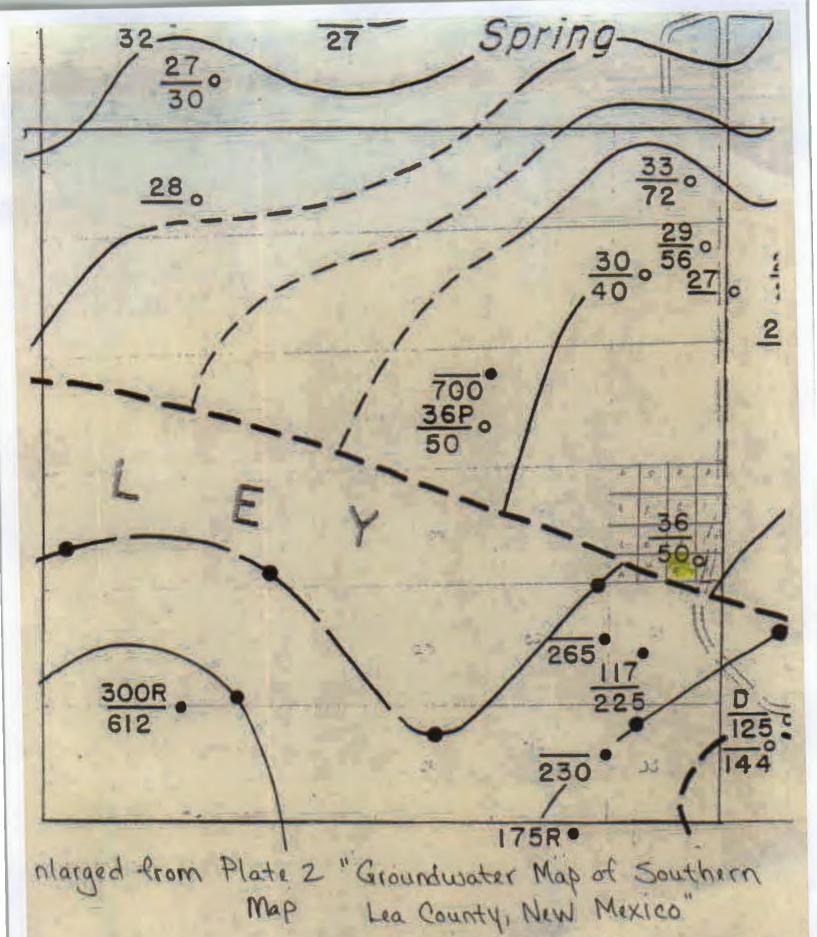
from USGS book "Goology + Groundwater Conditions in Southern Lea County, New Mixico

Wishelman of Mclobach 1961

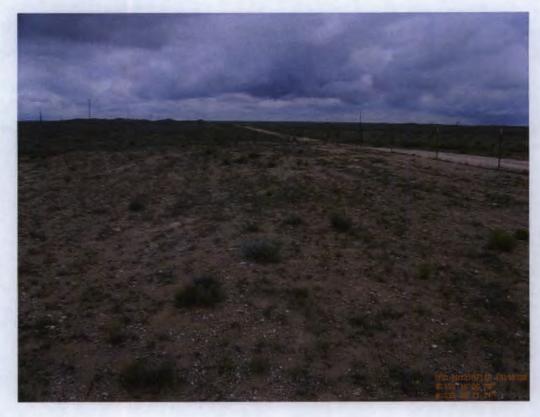
7/18/2013

Vegetation has rebounded at this site so no further action is warranted. Vegetation above the liner will also provide a natural infiltration barrier for the site since plants capture water through their roots thereby reducing the volume of water moving through the vadose zone to groundwater. A junction box is no longer required at this site.

Facing north-northeast

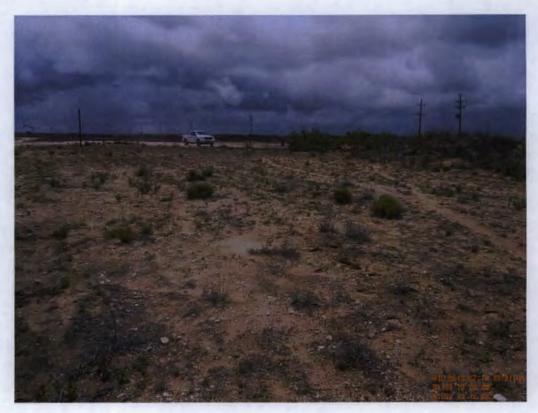
Facing southwest
