Re: **Rice Operating Company**  
Groundwater Recovery  
Corrective Action Plan (CAP) Progress Report & Termination Request  
BD N-18 Below Grade Tanks (BGT) - East BGT and West BGT  
**NMOCD Case No. 1R-500** UL-N, Sec 18, T22S, R37E

This letter is to summarize remedial work completed for the Rice Operating Company (ROC) BD N-18 BGT project. This project is located approximately 4 miles southwest of Eunice.

***BD***  
***N-18 BGT***  
UL/ N SECTION 18  
T22S - R37E  
LEA COUNTY, NM

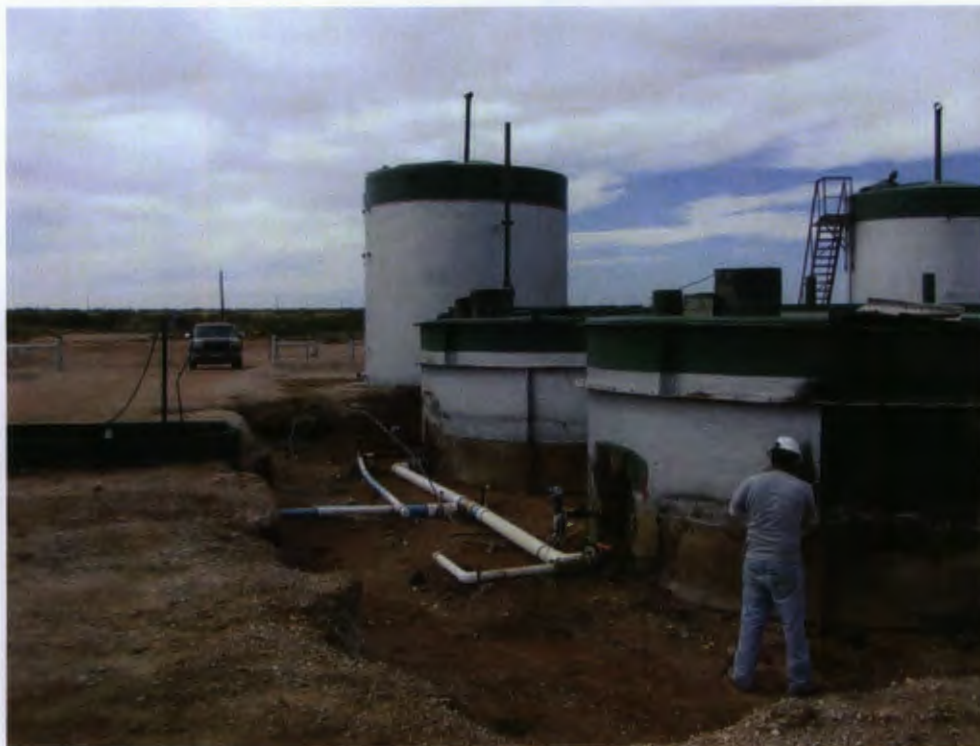
Photograph B– View during soil augering under east tank, looking northwest.

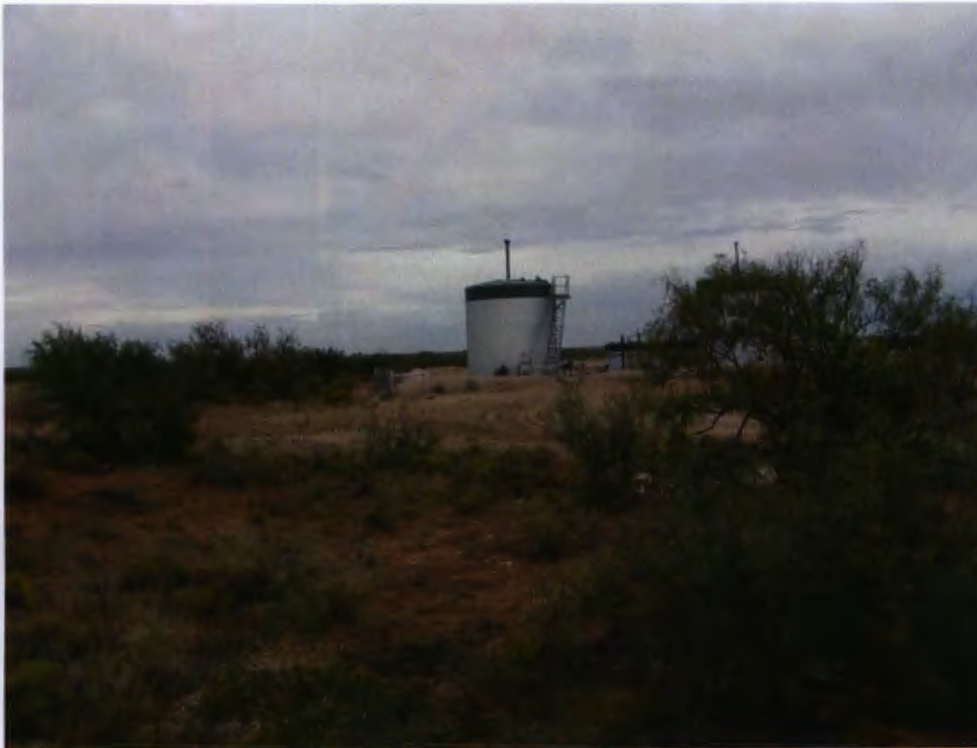
Photograph C – View of “natural background” soil sampling area.

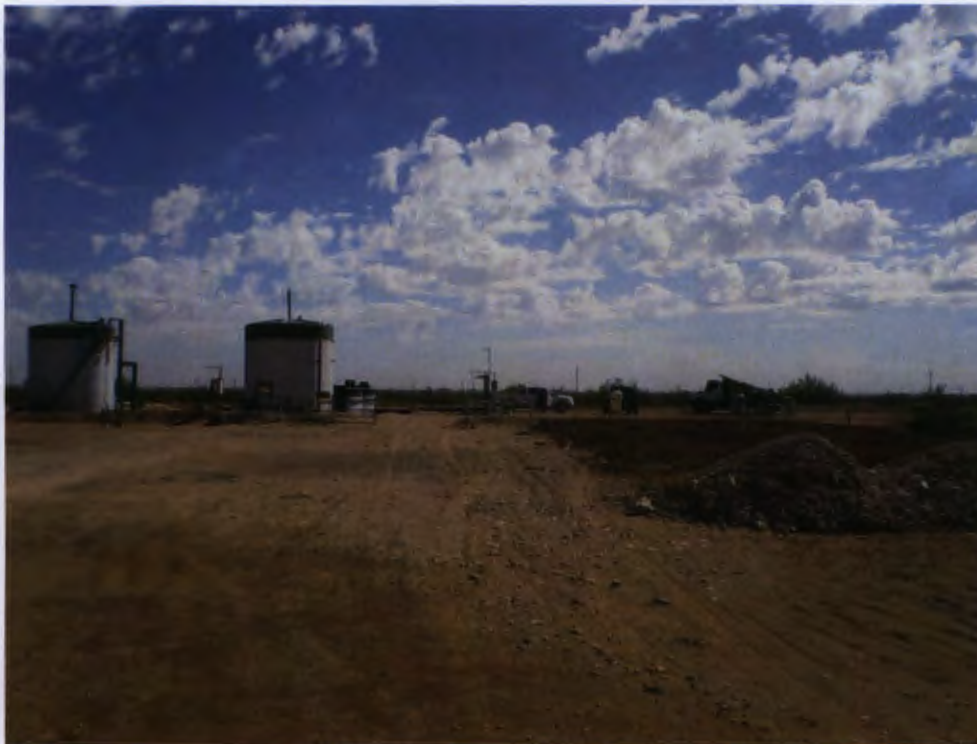
Photograph D – View east toward BD N-18 SWD. Excavated soil is on the right.

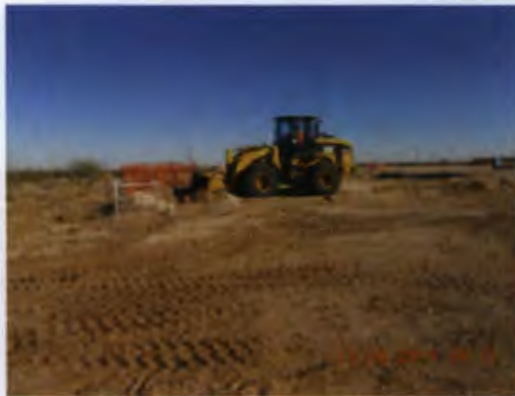
11/30/2011

excavating the site,  
facing east

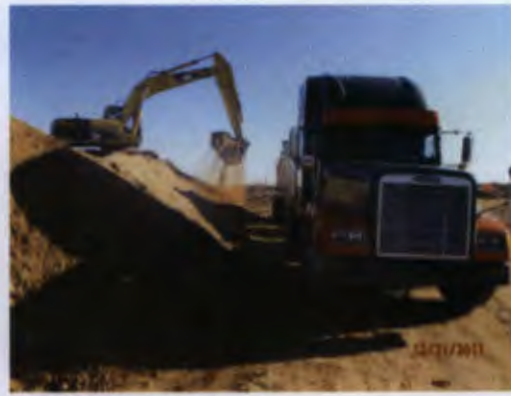
12/21/2011

exporting excavated soil,  
facing south

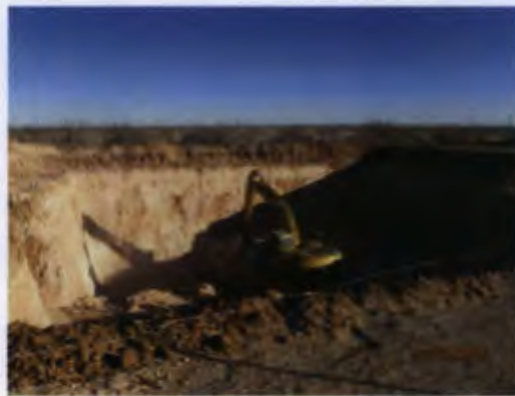
1/20/2012

excavating the 98'x98' area to 30' bgs,  
facing northwest

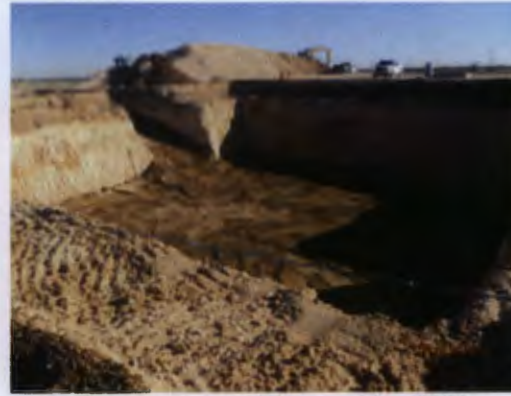
1/23/2012

excavation complete to 27' bgs with a 6" blow  
sand pad installed, facing southeast

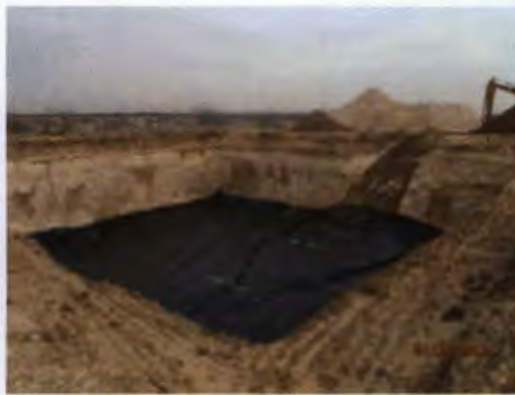
1/24/2012

98'x98' 20 mil reinforced liner installed at 26.5',  
facing northeast

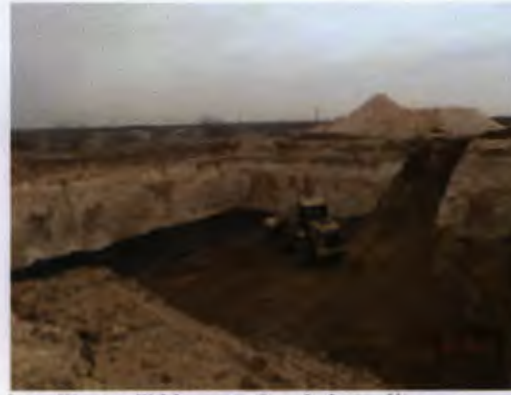
1/24/2012

installing a 6" blow sand pad above liner,  
facing northeast

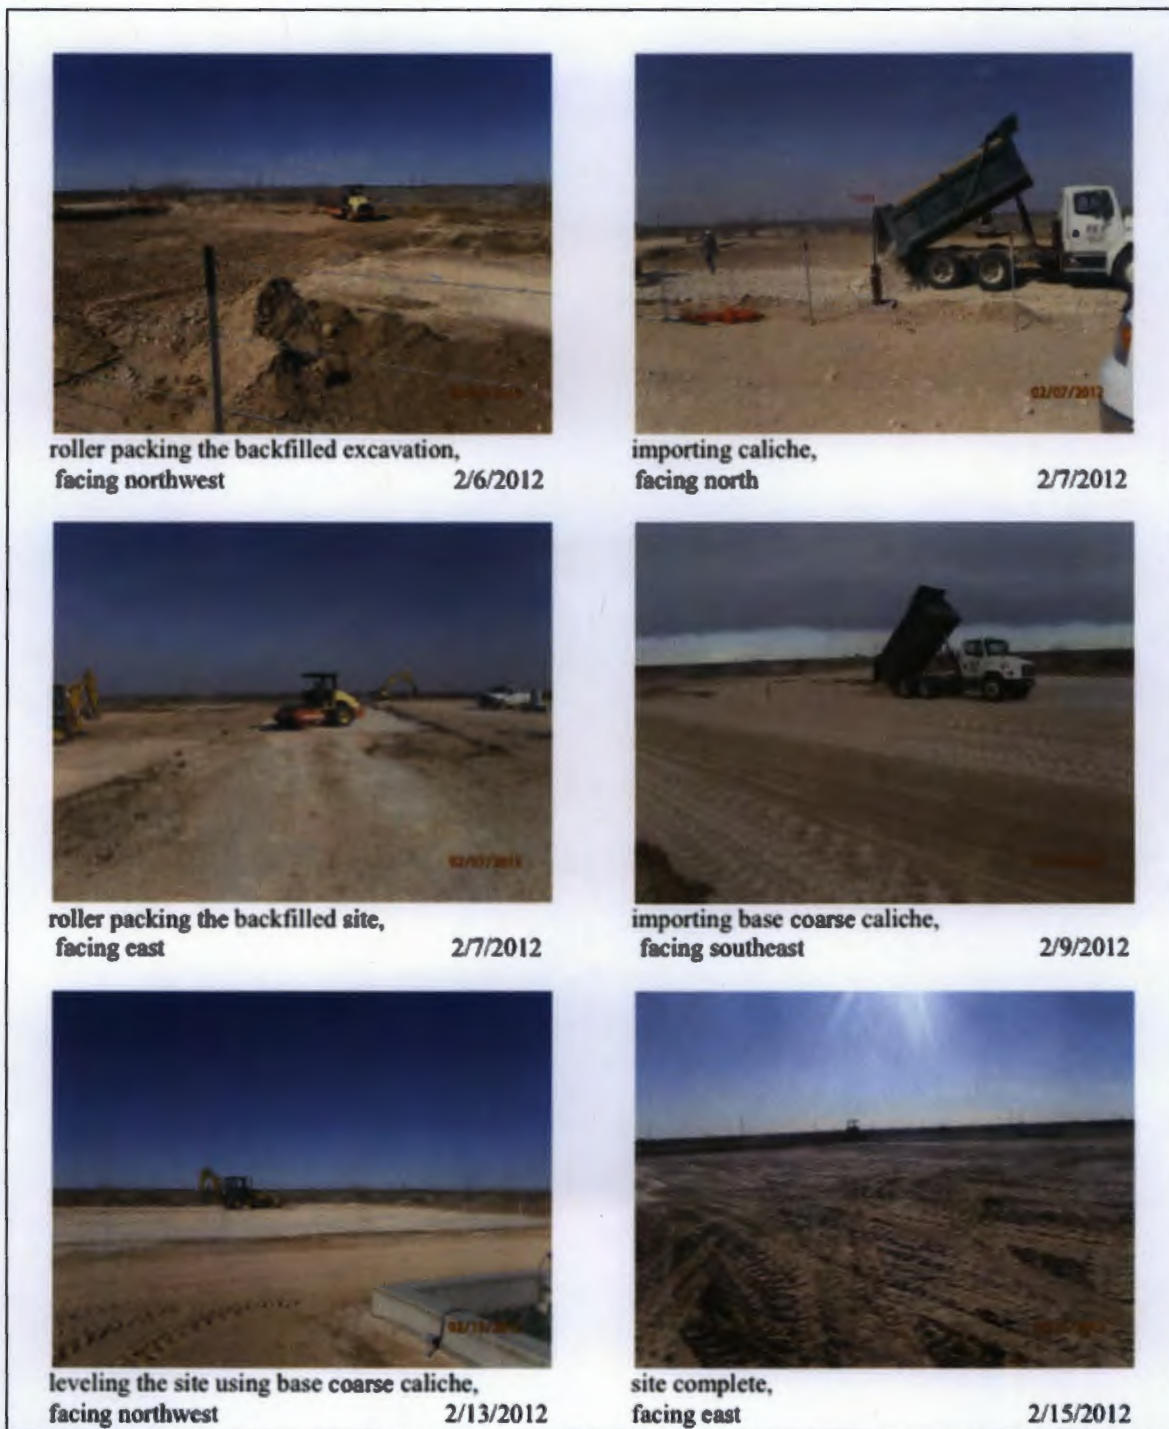
Figure 4c – Photographic record of soil excavation and installation of double synthetic liner system.
