**RE: CAP Report and Termination Request  
Rice Operating Company – BD SWD System  
BD Jct. P-30 west (1R426-127): UL/P sec. 30 T21S R37E  
BD P-30 EOL (1R426-218): UL/P sec. 30 T21S R37E**

## **Corrective Action Plan Report**

**BD Jct. P-30 west (1R426-127) and BD P-30 EOL (1R426-218)  
Unit Letter P, Section 30, T21S, R37E**

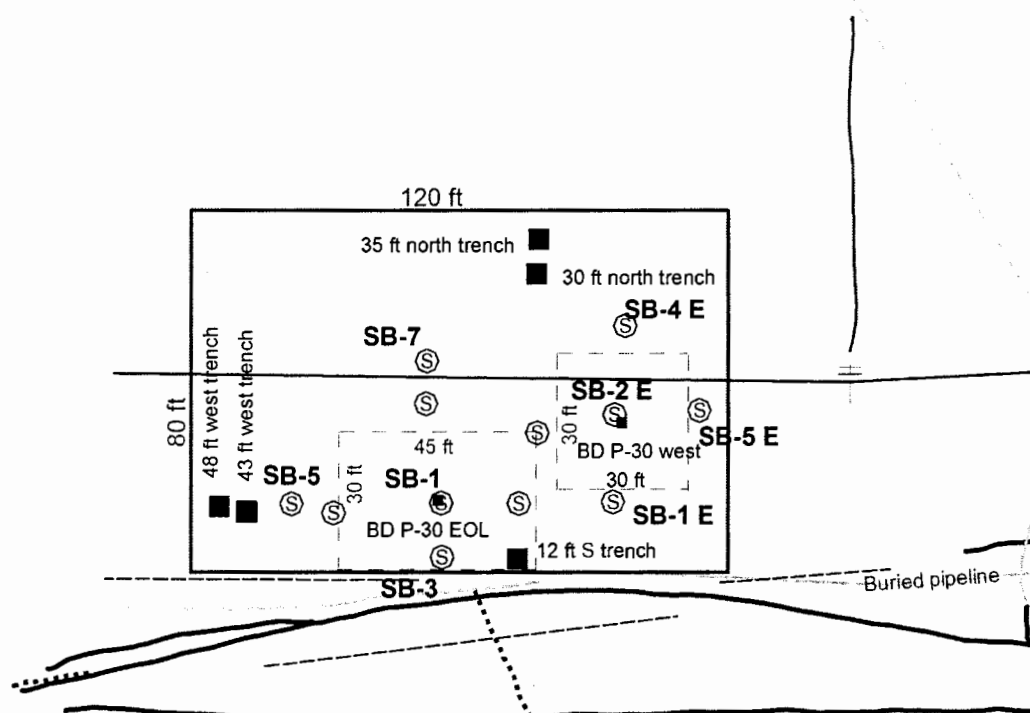
Figure 3

# NMOCD Approved Liner

DGW = 97 ft

To address the vadose zone, ROC proposed to excavate the site to the dimensions of 120 ft x 80 ft and properly seat a 20-mil reinforced poly liner at approximately 4-5 ft bgs. The liner would cover the existing clay layers installed at 6.5 ft bgs measuring 30 ft x 30 ft at the BD jct. P-30 west site and 30 ft x 45 ft at the BD P-30 EOL site. The soils placed above the liner would have a laboratory chloride reading no greater than 500 mg/kg and a field PID reading below 100 ppm. Excavated soils would be evaluated for use as backfill and any soils requiring disposal would be properly disposed of at a NMOCD approved facility. Upon completion of backfilling, the site would be seeded with a native vegetative mix and soil amendments will be added as needed. Vegetation above the liner would also provide a natural infiltration barrier for the site since plants capture water through their roots thereby reducing the volume of water moving through the vadose zone to groundwater.

On July 12<sup>th</sup>, 2013, RECS personnel were on site to begin the Corrective Action Plan work. The site was excavated to 80 ft x 120 ft to a depth of 5 ft bgs (Figure 3). A total of 2,300 yards of excavated soil was disposed of at a NMOCD approved facility. At the base of the excavation, a 20-mil reinforced poly liner was installed and properly seated at a depth of 5 ft bgs. Since the site contained primarily sandy/silty soils without appreciable rock, it was not necessary to pad either the top or bottom of the liner. Approximately 2,256 yards of soil was imported to the site to serve as backfill. A sample of this imported soil was field tested for hydrocarbons and returned a result of 1.7 ppm. The sample was then taken to a commercial laboratory and returned a chloride result of non-detect. The excavation was backfilled with the imported soil and contoured to the surrounding location.

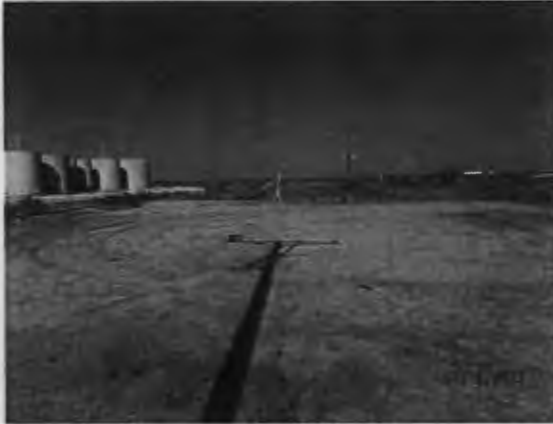
Site prior to excavation, facing west 7/16/2013

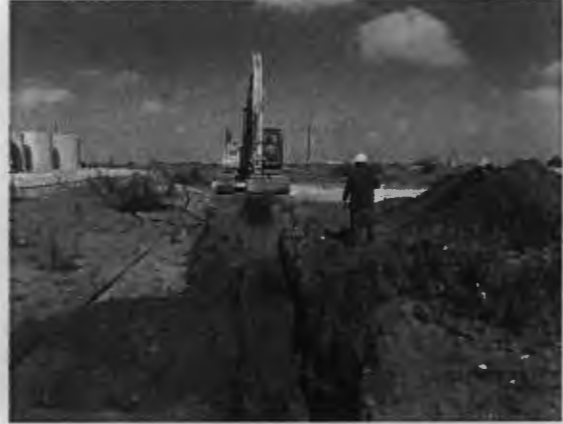
Excavating, facing west 7/16/2013

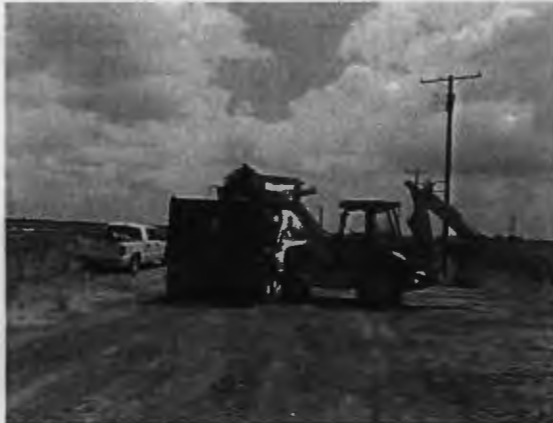
Exporting soil, facing east 7/16/2013

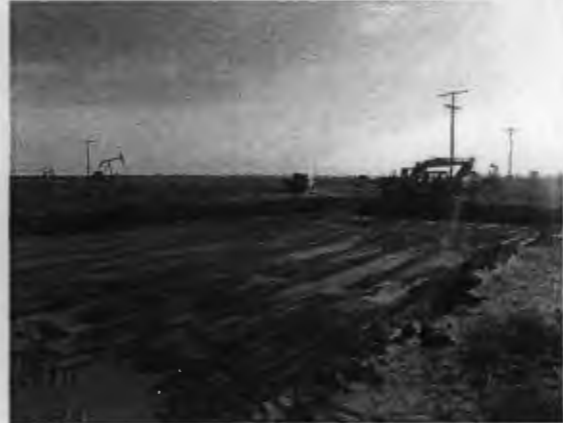
Excavation final, facing northeast 7/30/2013

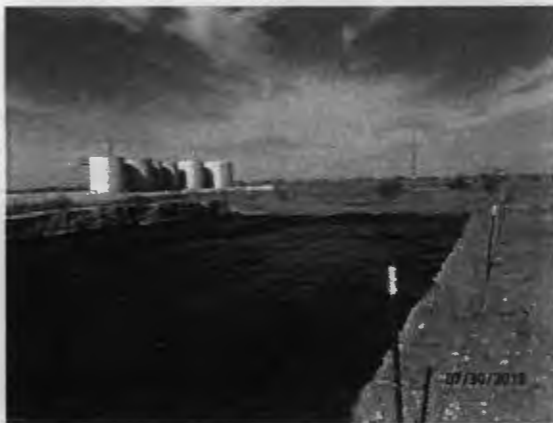
Liner complete, facing southwest 7/30/2013

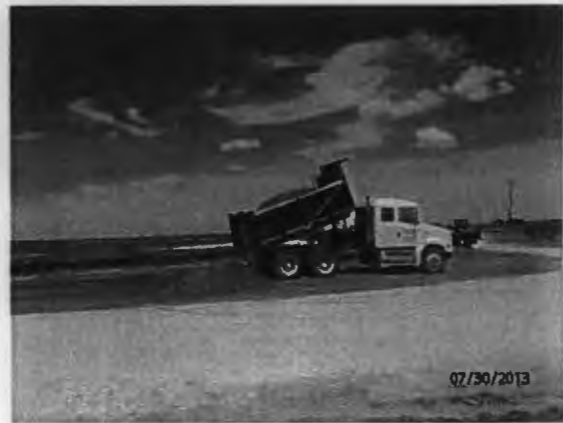
Importing, facing east 7/30/2013

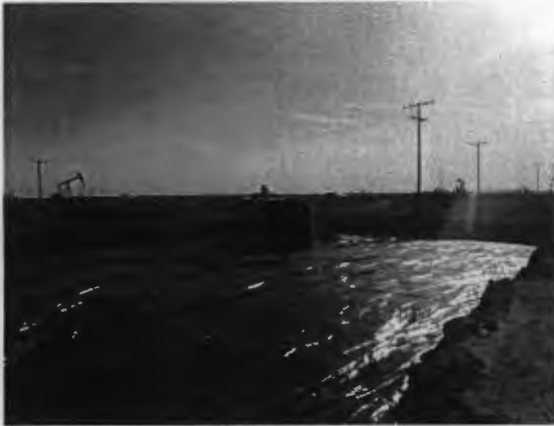
**Backfilling above the liner, facing northeast  
7/31/2013**

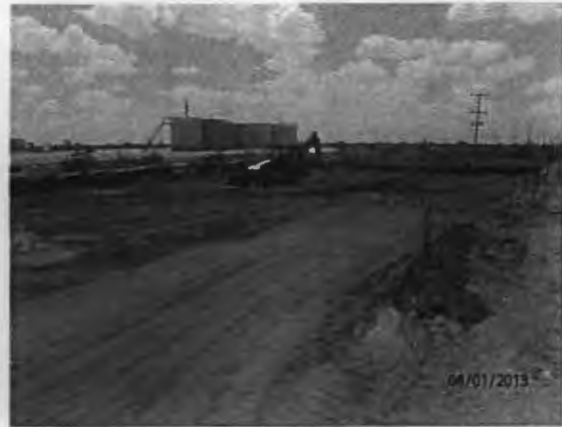
**Backfilling excavation, facing southwest  
8/1/2013**

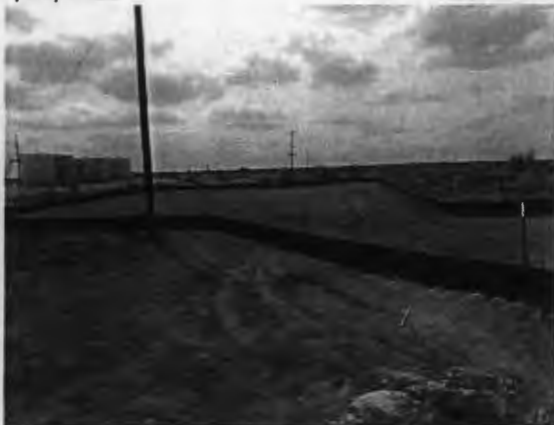
**Silt net fence complete, facing west 8/28/2013**

On August 30<sup>th</sup>, 2013, the site was prepared for seeding. The soil was tilled and amendments were added to the soil. The site was then seeded with a blend of native vegetation. A silt net fence was placed around the site to negate erosion and maintain seed integrity. Documentation for these CAP activities can be found in Appendix A.

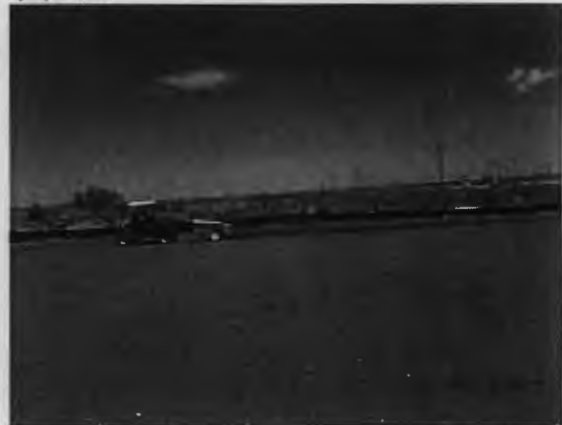
**Spreading amendments, facing north 8/30/2013**

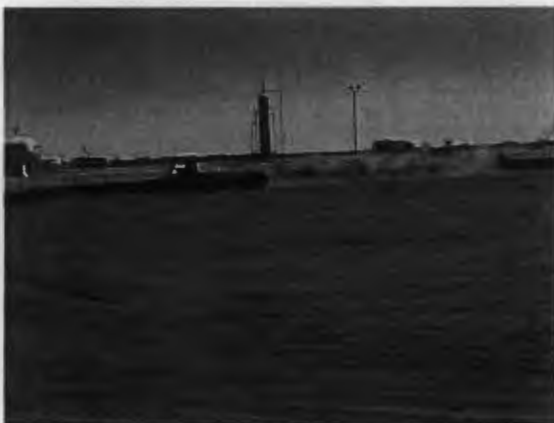
**Spreading seed, facing south 8/30/2013**

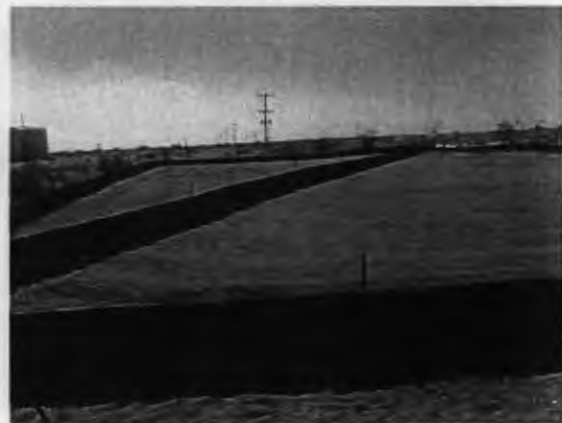
**Site complete with vegetation, facing west  
9/3/2013**
