**RE: Initial CAP Report & Soil Closure Request**

Rice Operating Company – Vacuum SWD System

**Vacuum Jct. D-31-2:** UL/D, Sec. 31, T17S, R35E (formerly Vacuum Jct. C-31-2)

**NMOCD Case Number: 1R425-80**

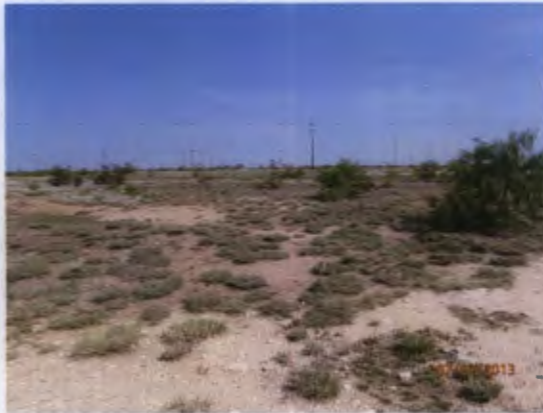
Site prior to excavation,  
facing northwest

7/2/2013

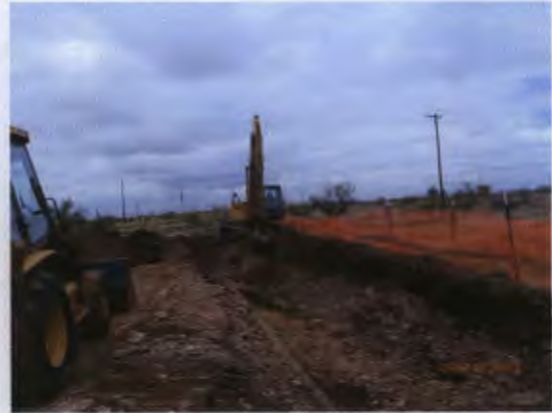
Excavating the site,  
facing northeast

9/11/2013

The site was excavated to a depth of 3.5 ft bgs on the east and west side of the non-ROC pipeline. Each excavation was padded with approximately 6 inches of imported pond bottom, and a 20-mil reinforced liner was installed and properly seated in each excavation. The west excavation measured approximately 65 ft by 75 ft by 31 ft, and the east excavation measured approximately 39 ft by 27 ft. The top of the liners were padded with an additional 6 inches of imported pond bottom. The excavations were then backfilled with imported pond bottom and contoured to the surrounding area with imported blow sand. A composite sample of the blow sand was analyzed by a commercial laboratory, resulting in a chloride concentration below detectable limit. The sample was also field analyzed for hydrocarbon, resulting in a PID reading of 2.0 ppm. A composite sample of the pond bottom was analyzed by a commercial laboratory, resulting in a chloride concentration below detectable limit. The sample was also field analyzed for hydrocarbon, resulting in a PID reading of 1.6 ppm. Amendments were added to the soil, and the site was seeded with a blend of native vegetation. Approximately 632 cu yards of excavated soil were properly disposed of at a NMOCD approved facility, and approximately 788 cu yards of material were imported to be utilized as backfill.

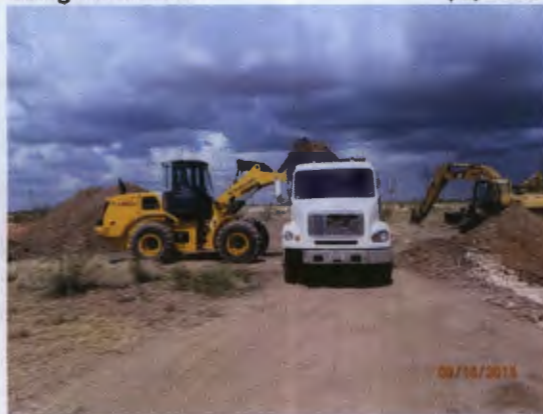
Exporting excavated soil,  
Facing north

9/16/2013

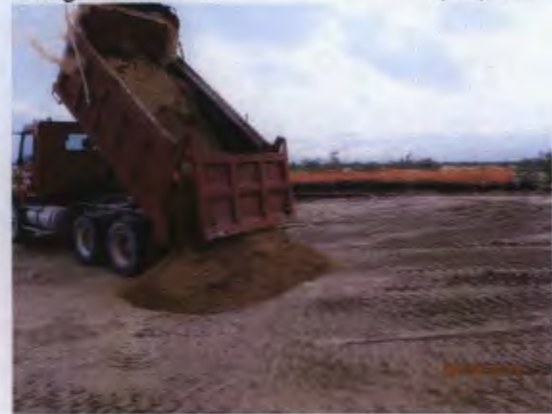
Importing blow sand,  
facing east

9/19/2013

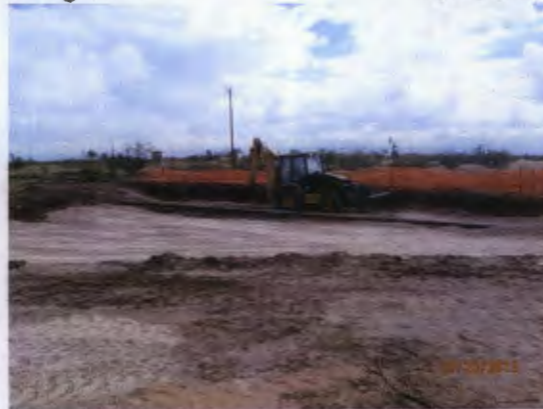
Padding the excavation with pond bottom,  
facing east

9/20/2013

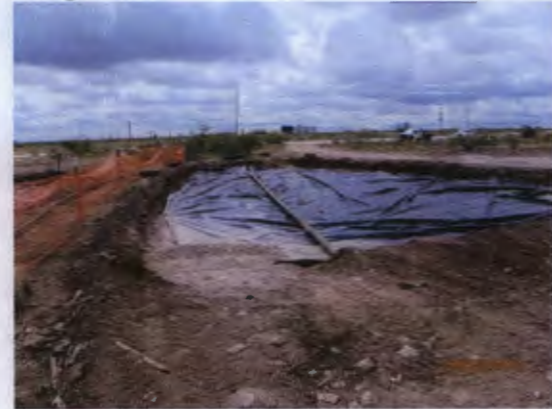
20-mil, reinforced liner installed,  
facing southwest

9/20/2013

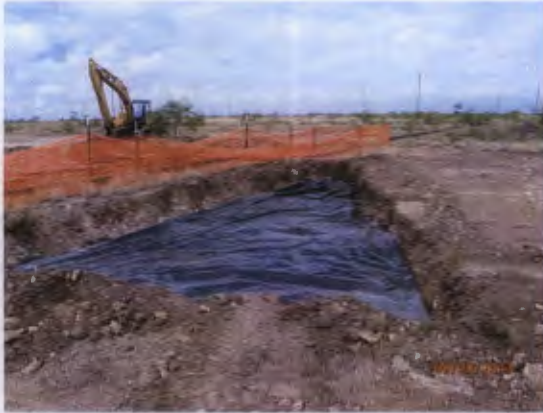
20-mil, reinforced liner installed,  
facing north 9/20/2013

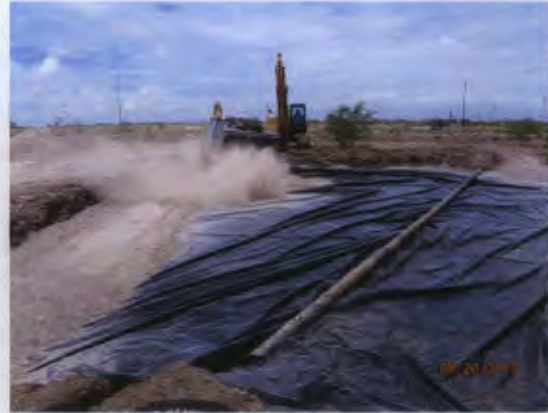
Padding above the liner with pond bottom,  
facing east 9/20/2013

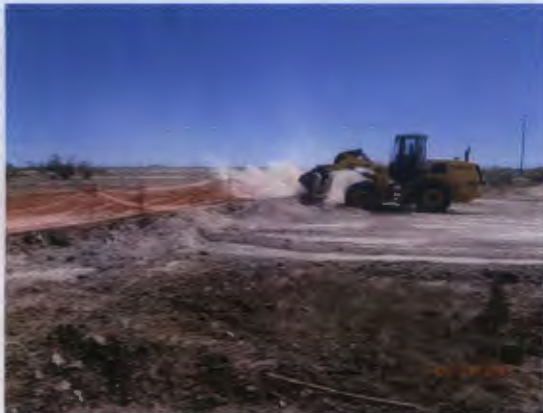
Backfilling the excavation,  
facing south 9/23/2013

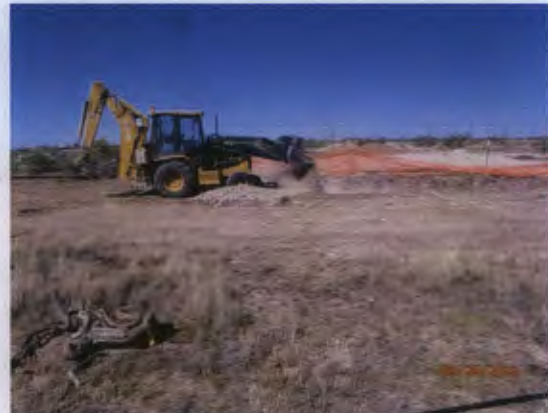
Padding the second 20-mil, reinforced liner with  
pond bottom and backfilling, facing east 9/24/2013

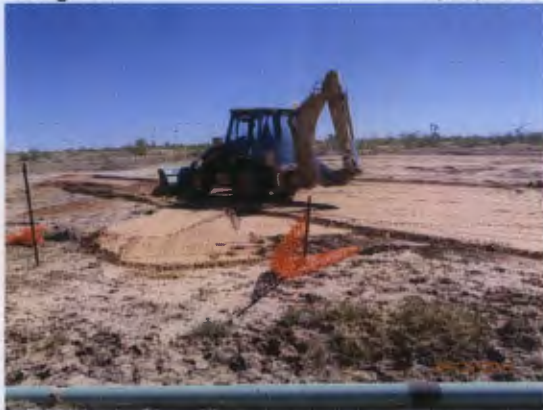
Spreading blow sand,  
facing east 9/25/2013

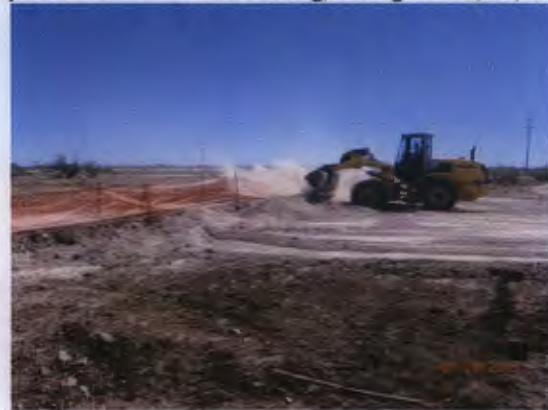
Backfilling the excavation,  
facing south 9/23/2013

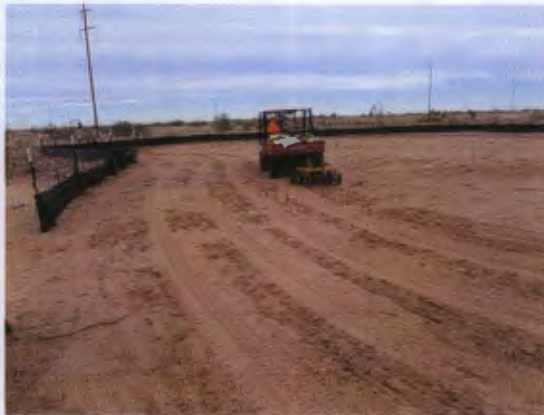
**Discing the backfilled excavation,  
facing west** 10/30/2013

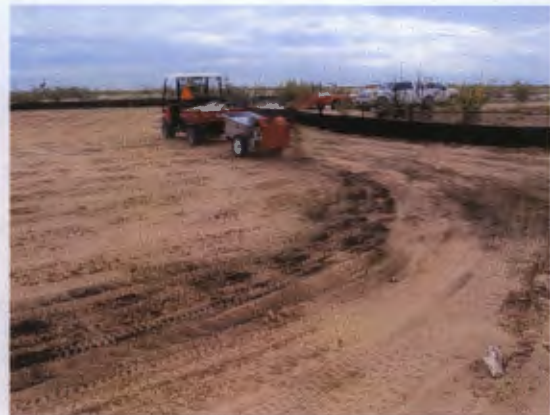
**Adding amendments to the soil,  
facing southeast** 10/30/2013

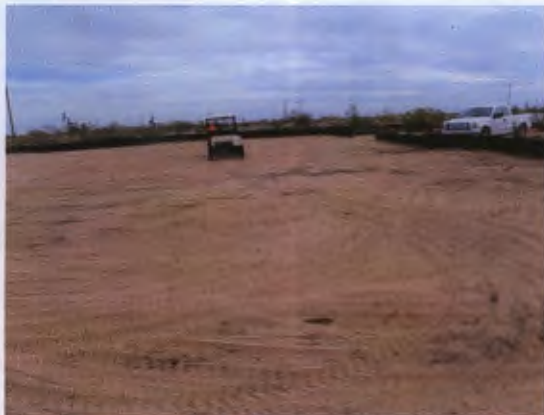
**Seeding the backfilled site,  
facing west** 10/30/2013

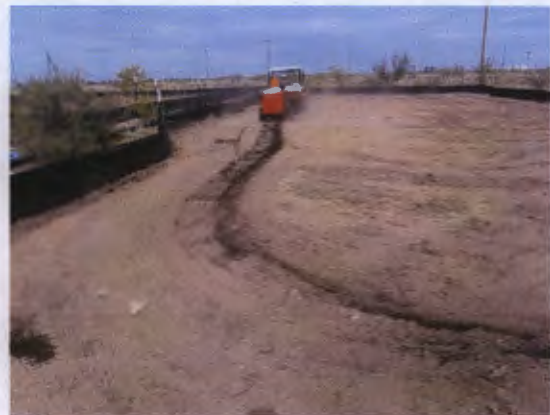
**Adding amendments to the soil,  
facing north** 10/30/2013

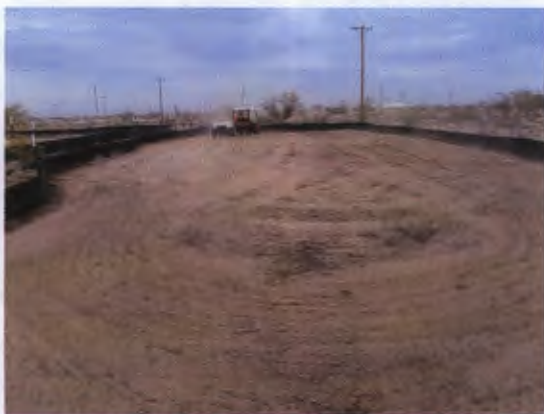
**Seeding the Site, facing north** 10/30/2013

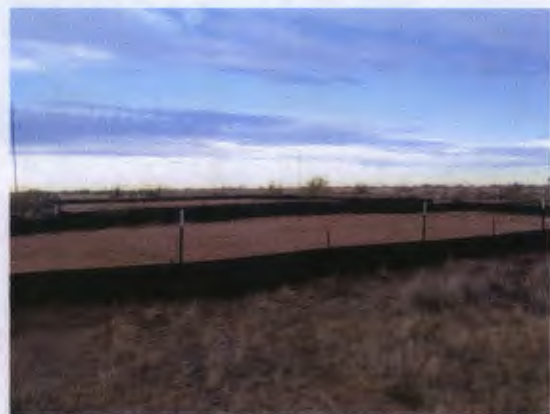
**Site complete,  
facing northwest** 10/30/2013
