**GENERAL
CORRESPONDENCE**

Re: Hydrostatic Test Discharge Permit
Permit: HIP-124
Enterprise Products Operating, LLC
Western Expansion Pipeline III, Segment 2A
Locations: Unit H of Section 5, Township 20 North, Range 5 West, NMPM,
McKinley County, New Mexico

**RE: Enterprise Products Operating LLC
Submittal of Notice of Intent to Discharge Hydrostatic Test Water
Western Expansion Pipeline III, Segment 2A
McKinley and Sandoval Counties, New Mexico**

**Subject: Submittal of a Notice of Intent to Perform Hydrostatic Test
 WEP III – Segment 2A
 McKinley and Sandoval Counties, New Mexico**

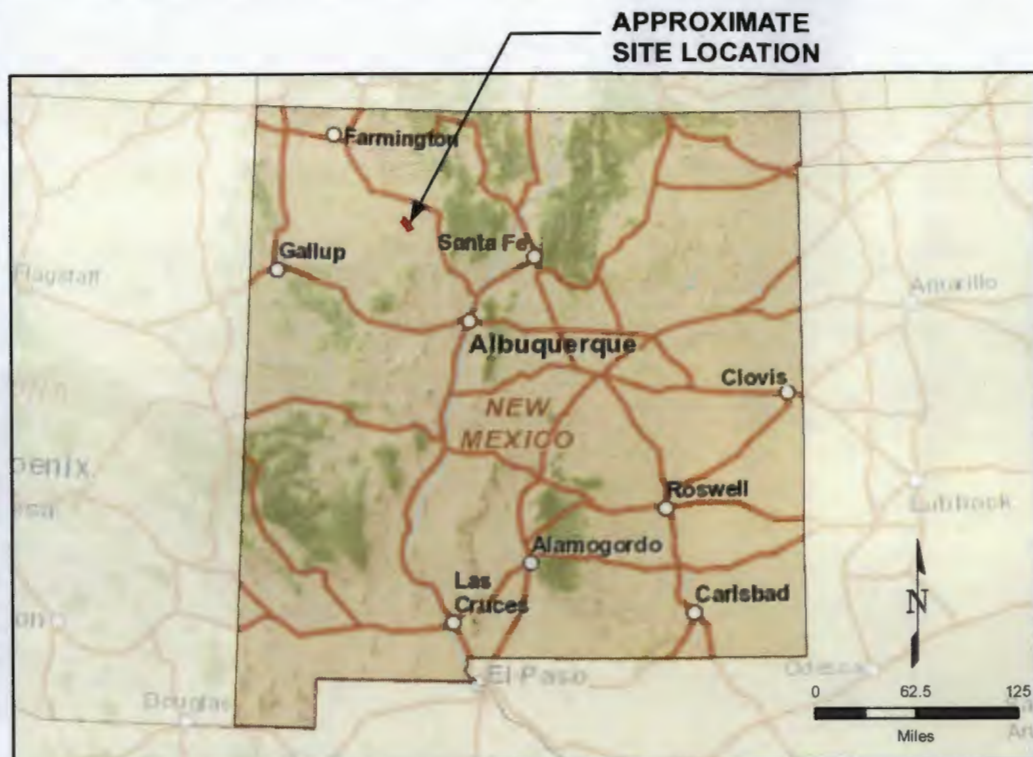
PROJECT NO.: 134288	NEW ENTERPRISE PIPELINE		FIGURE 1
DRAWN: AUG 2013	WEP III SEGMENT 2A		
DRAWN BY: KFH	ENTERPRISE PRODUCTS OPERATING LLC		
CHECKED BY: ES	MCKINLEY AND SANDOVAL COUNTIES, NEW MEXICO		
FILE NAME: Seg2A_Figure1.mxd	ORIGINATOR: K. HAGAN	DRAWING CATEGORY:	
	APPROVED BY: ES	1

- Figure 1 – Regional map showing topography, the pipeline section undergoing testing, and the hydrostatic test water discharge location.
- Figure 2 – Site-specific map showing the hydrostatic test water discharge area.

- DISCHARGE LOCATION
- MILE POST
- APPROXIMATE SEGMENT OF PIPELINE TO BE HYDROSTATICALLY TESTED

- The Enterprise Western Expansion Pipeline (WEP) III line is a new, welded, steel 16-inch diameter line. The section to be hydrostatically tested, Segment 2A of the WEP III pipeline, is 8.7 miles or 46,150 feet long (Figure 1);

- The source water for the hydrostatic testing is the Horn well (latitude 35.965984°, longitude -107.176570°)
- The water will be placed into the pipeline at approximately MP 350.2 (Figure 1) on or about October 22, 2013. Hydrostatic testing of Segment 2A will be conducted from MP 341.5 to 350.2. After the testing, the water will be discharged at MP 350.2 on or about November 1, 2013.

The discharge location is located in the SE/4 of the NE/4 of Section 5, Township 20 North, Range 5 West (Figure 1). The latitude and longitude coordinates are provided in *item b*.

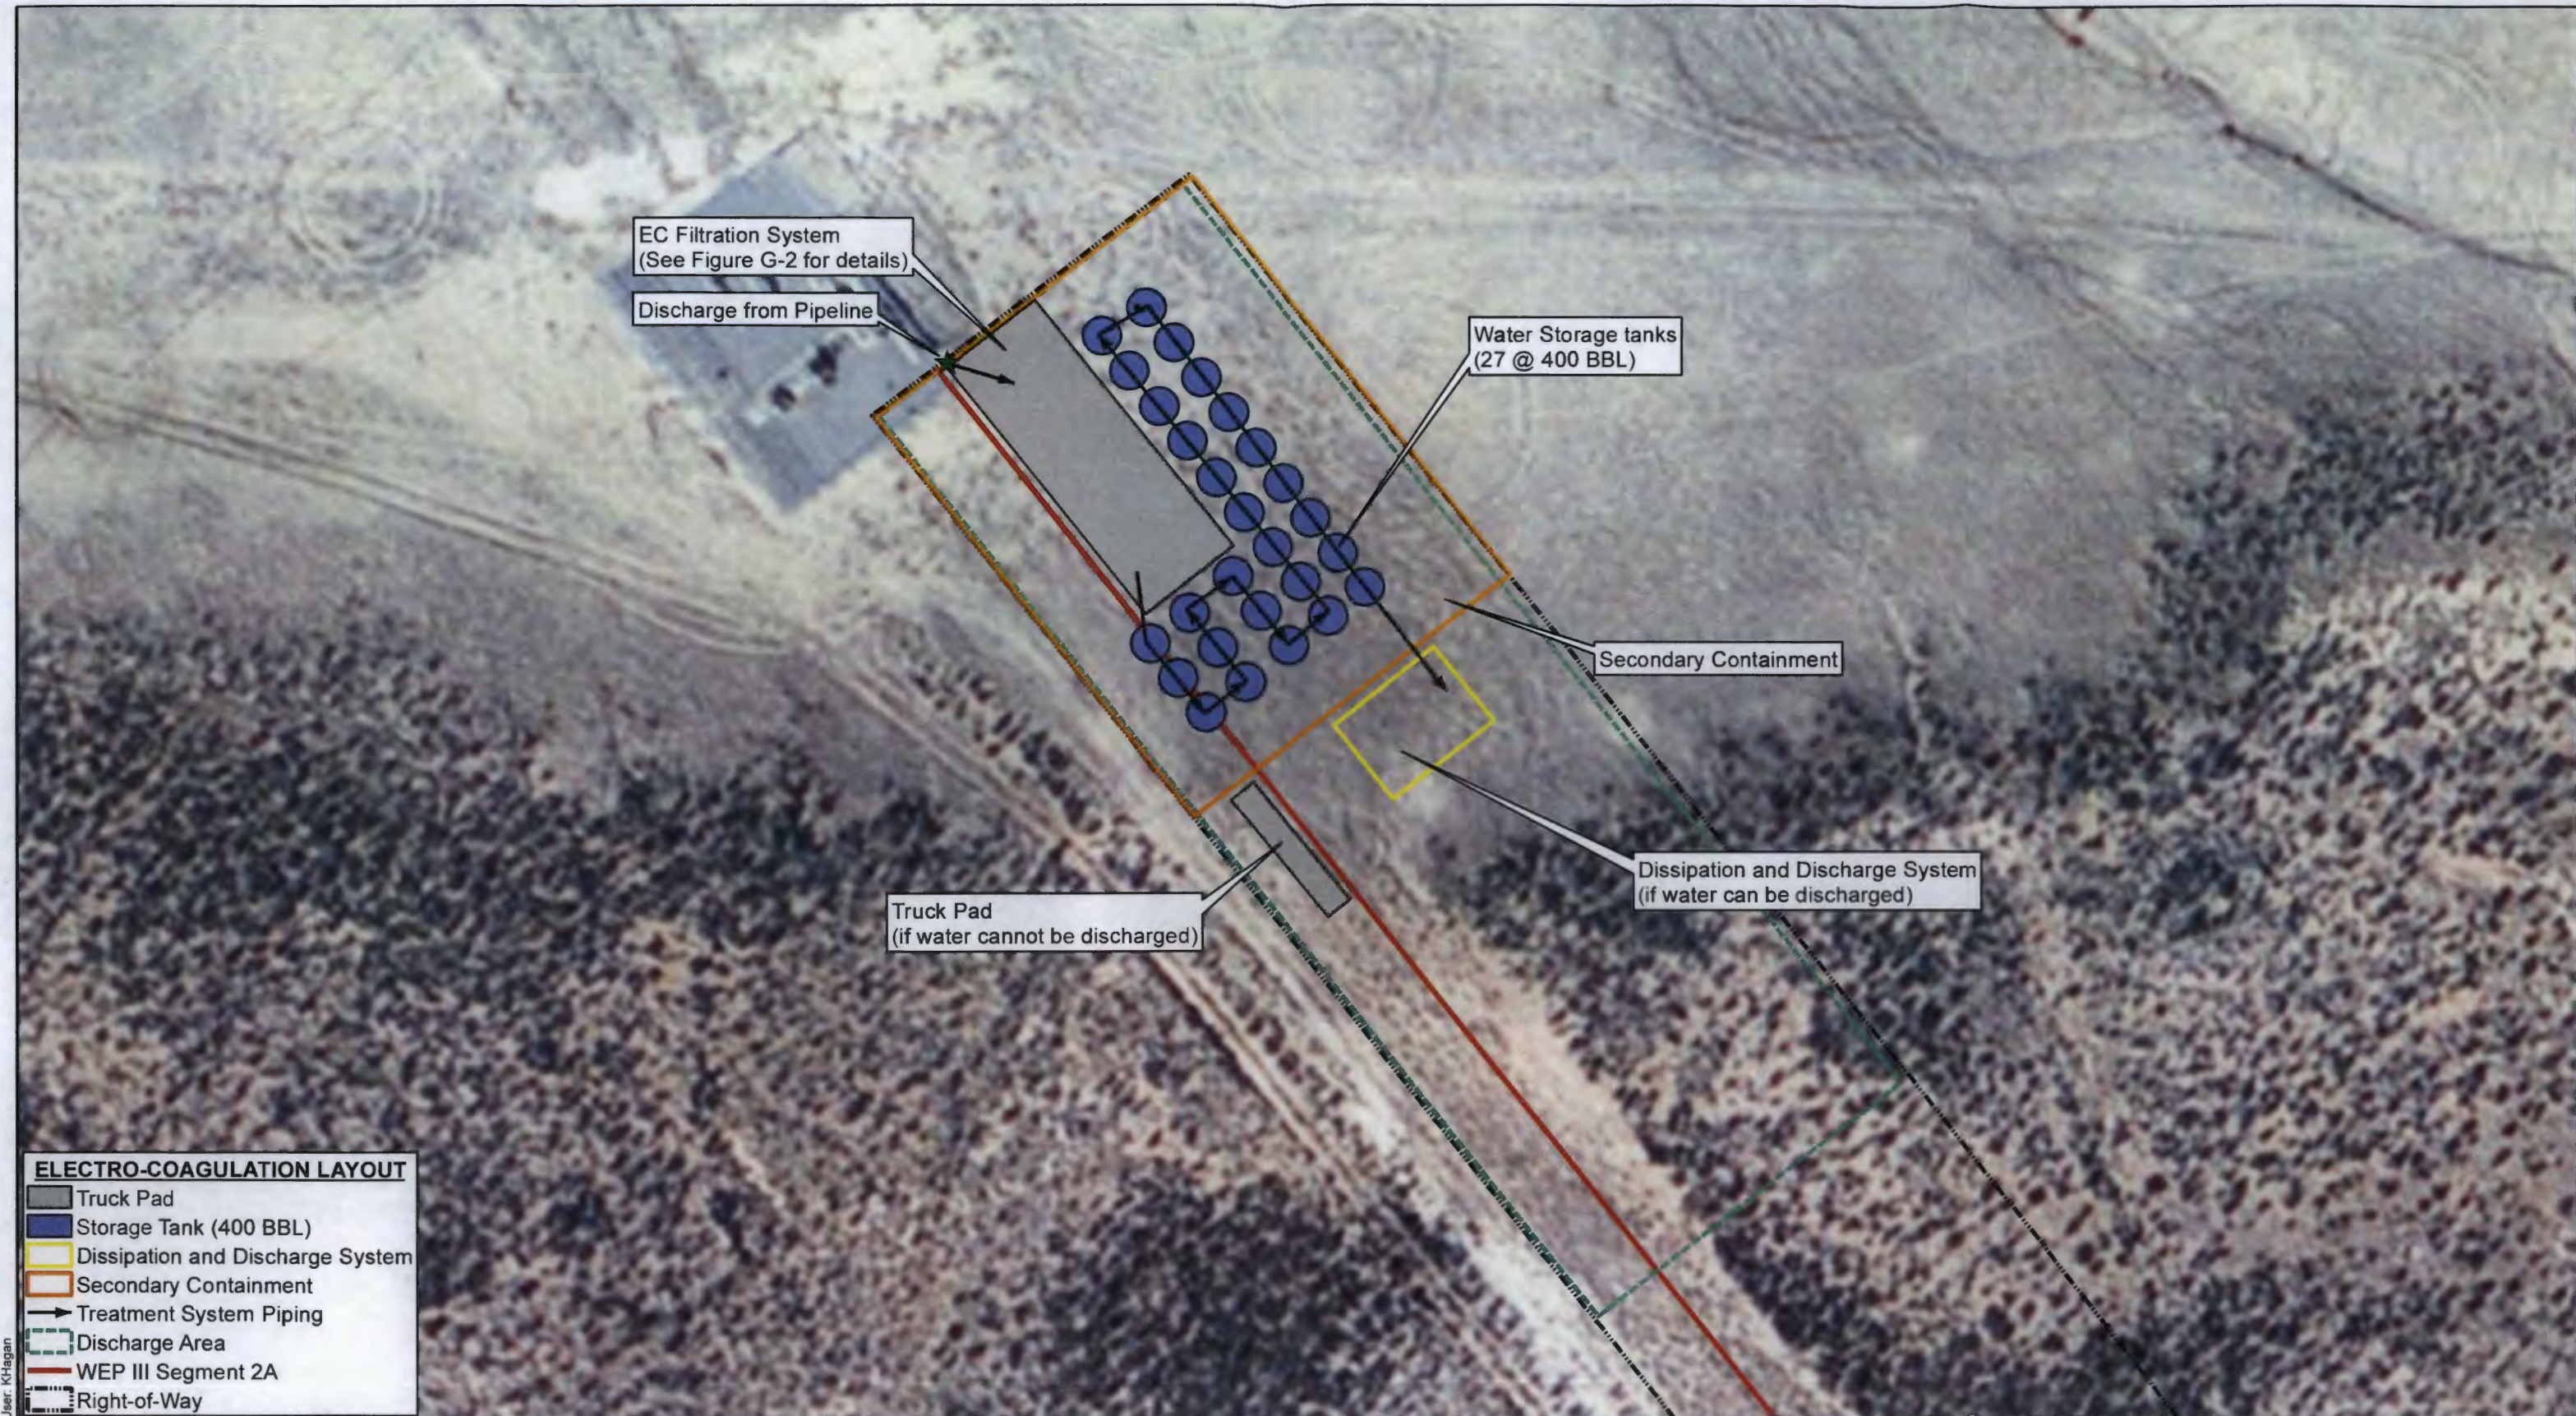
FIGURE
G-1

ELECTRO-COAGULATION LAYOUT

ELECTRO-COAGULATION TREATMENT AND DISCHARGE LOCATION, WEP III SEGMENT 2A
