**NM1 - 5**

**SUMP  
REPLACEMENT**

# BASIN DISPOSAL, INC.

RE: Loading Area Sump Retrofit Summary Report 5A

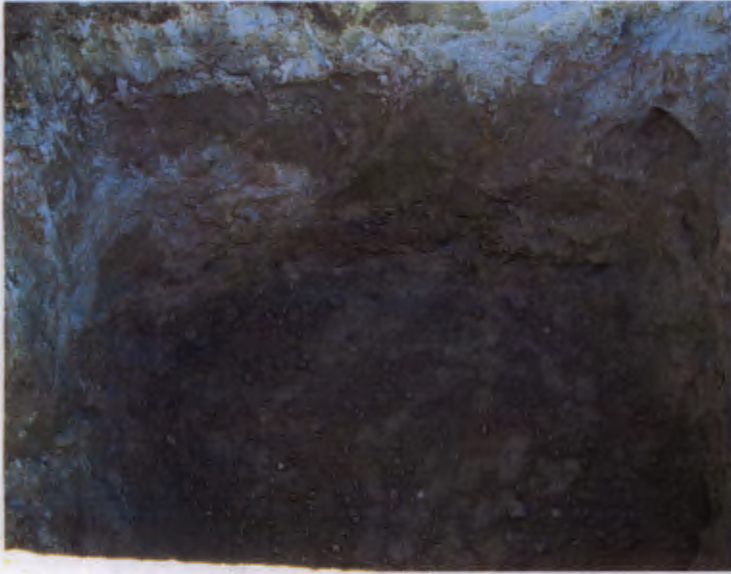
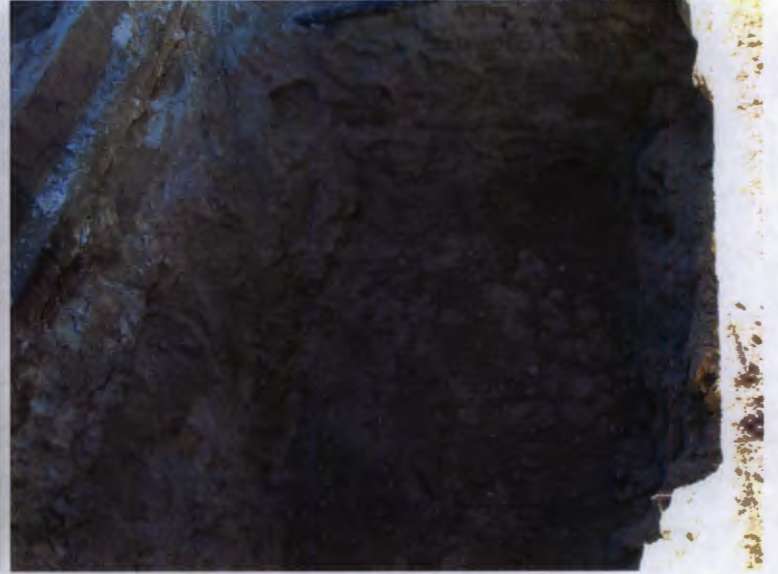
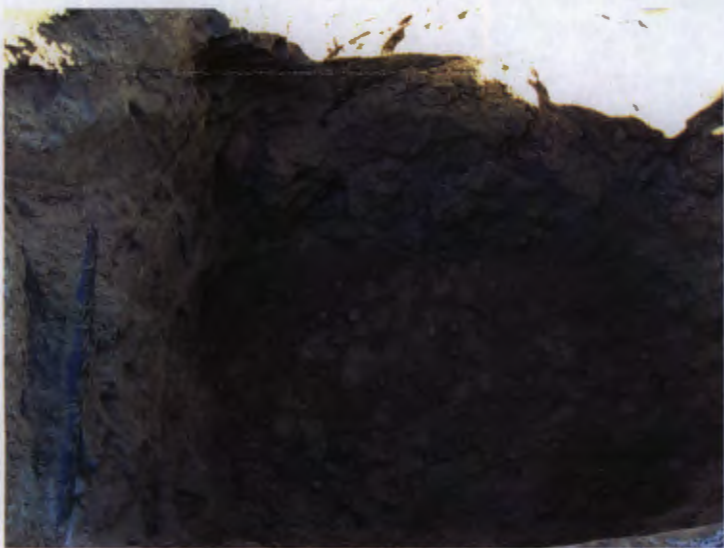
Attachment B, Photos of dirt surrounding the existing single walled tank

Photo Documentation of the soils beneath the existing below-grade tank and photo documentation of the installation of the new below grade tank are included in Attachments A & B.

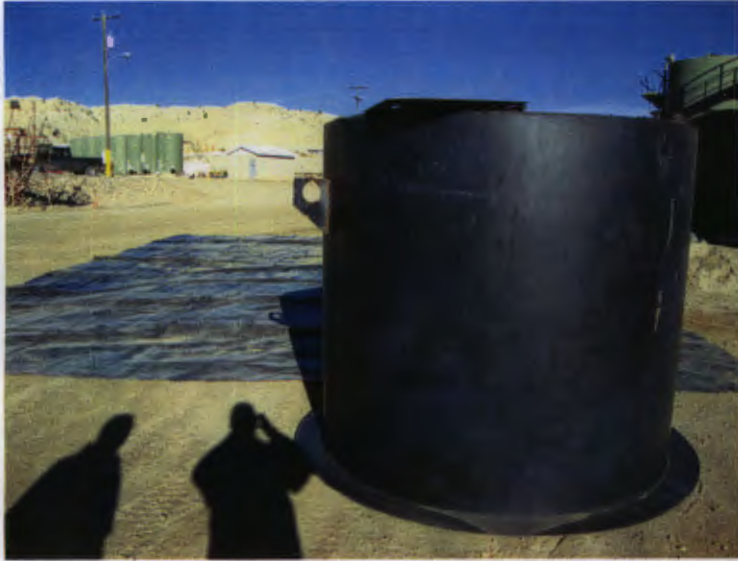
New Double Walled Tank

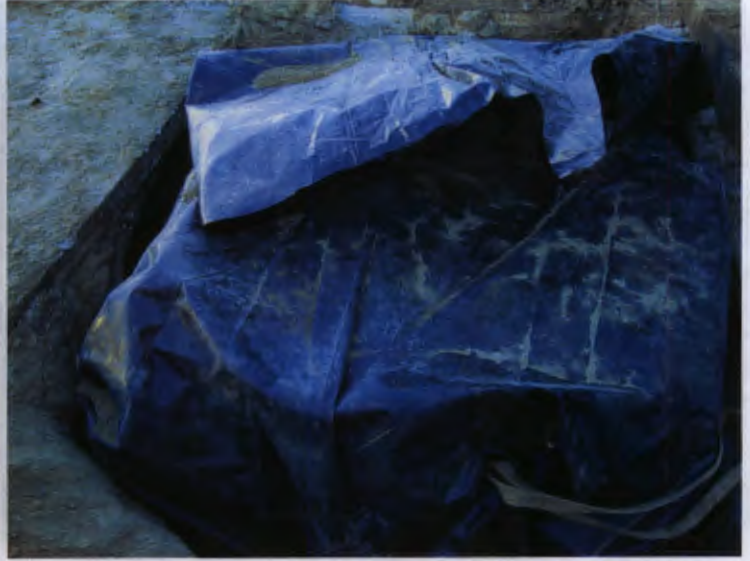
New Double Walled Tank wrapped in a liner

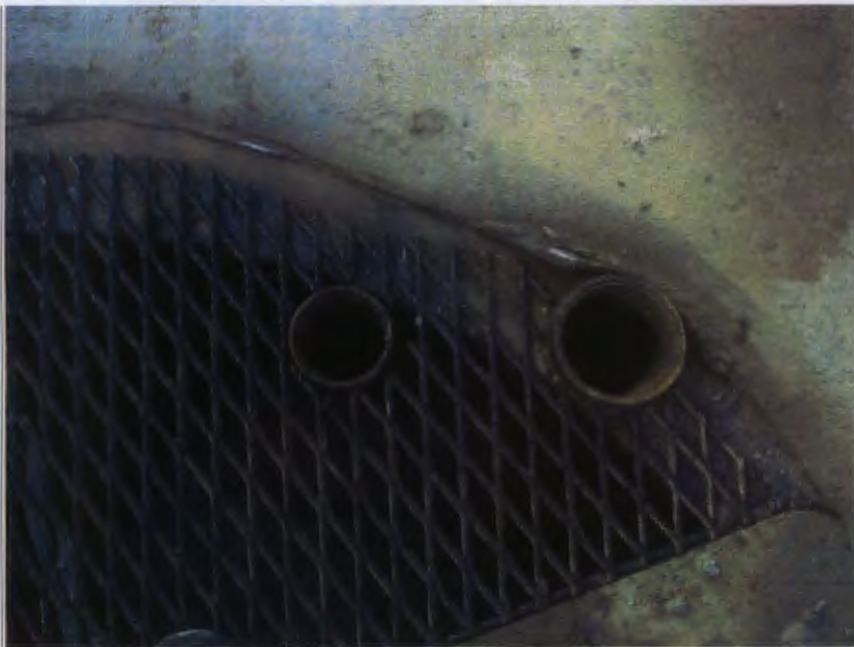
New Double Walled Tank installed. Pictures shows the pipe to check the level of the tank, the pipe to check the secondary containment for leaks, and the liner surrounding the tank
