RE: Termination Request  
EME M-10 (1R427-118): UL/M, Sec. 10, T21S, R36E  
RICE Operating Company – Eunice Monument Eumont (EME) SWD System

**RICE OPERATING COMPANY  
JUNCTION BOX FINAL REPORT**

**EME M-10 (1R427-118)**  
UL/M, Section 10, T21S, R36E

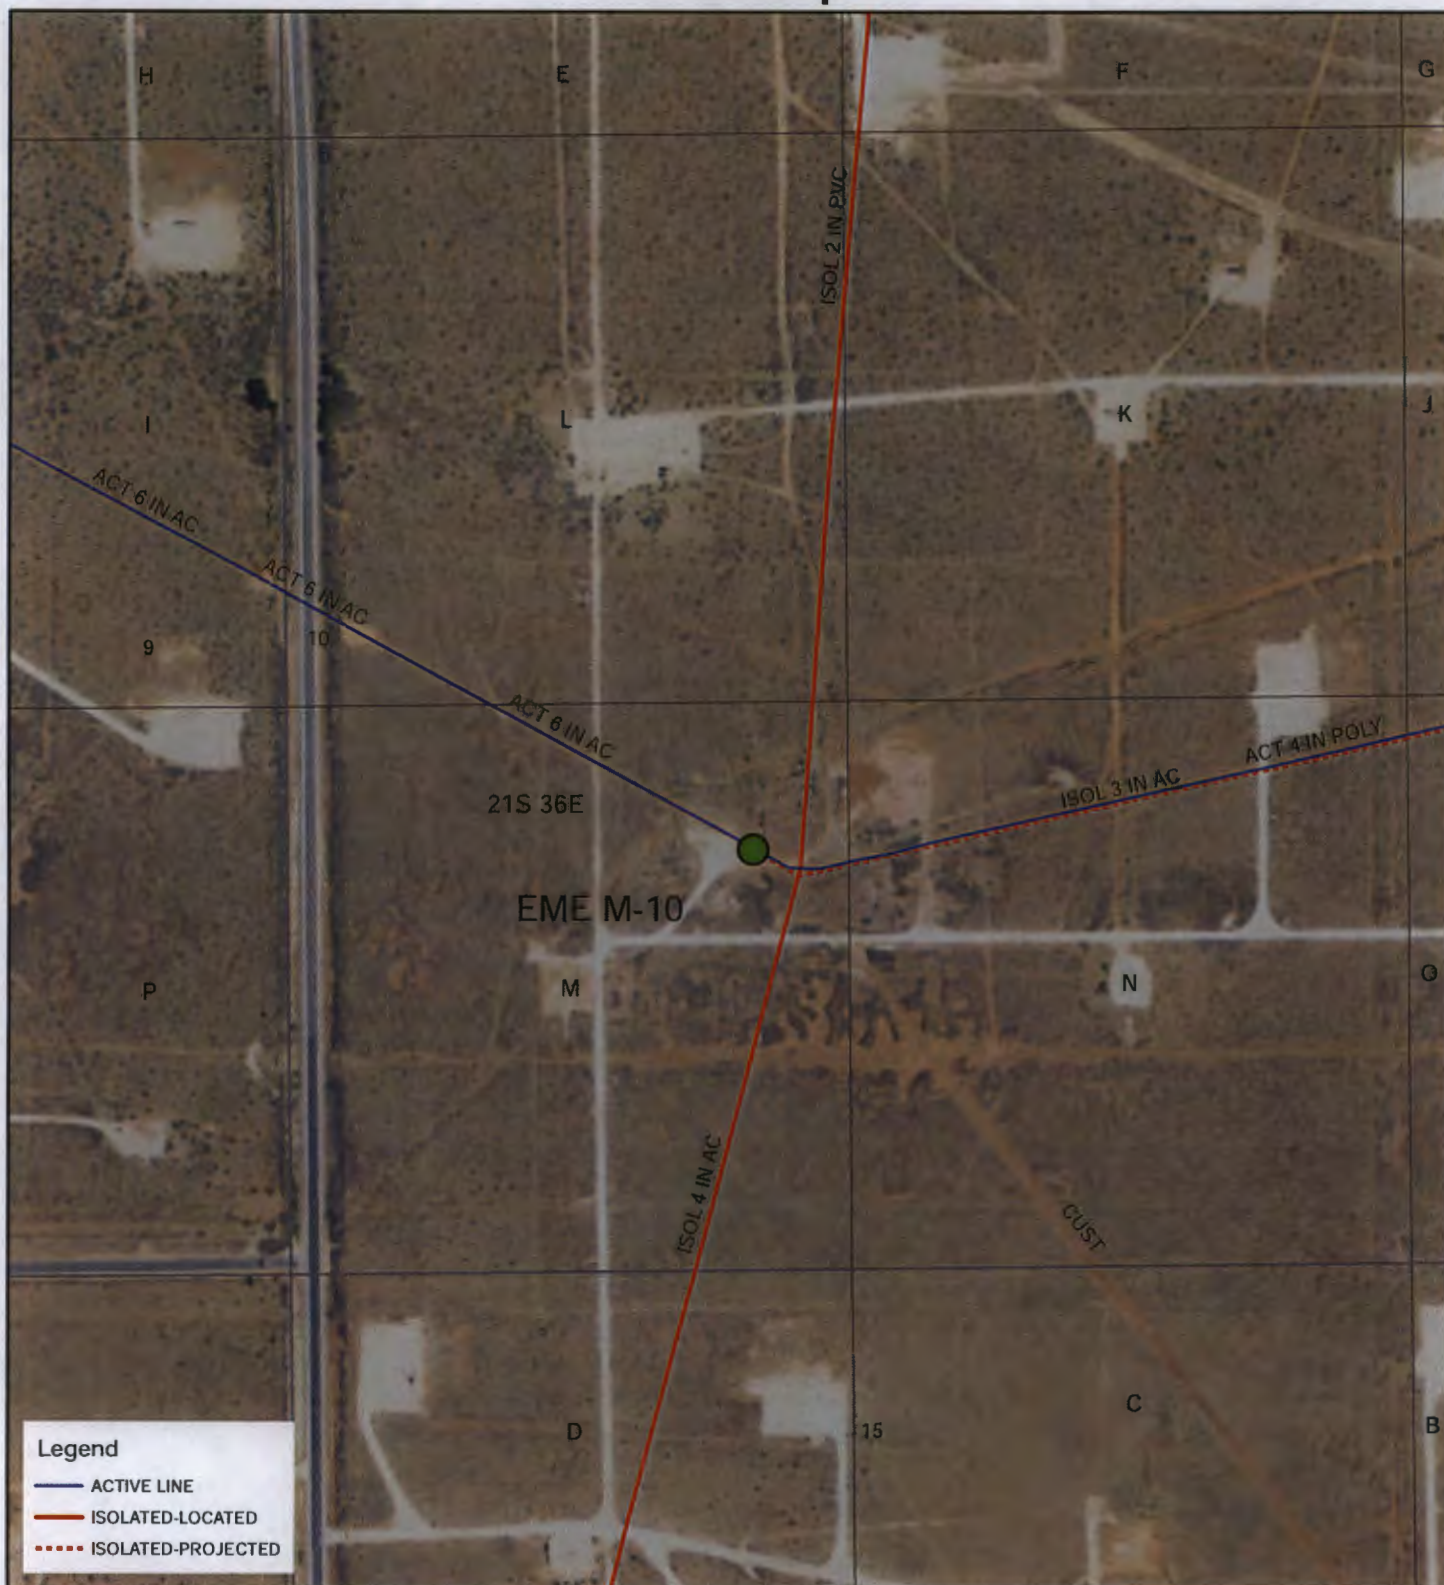
# Area Map

- ACTIVE LINE
- ISOLATED-LOCATED
- ... ISOLATED-PROJECTED

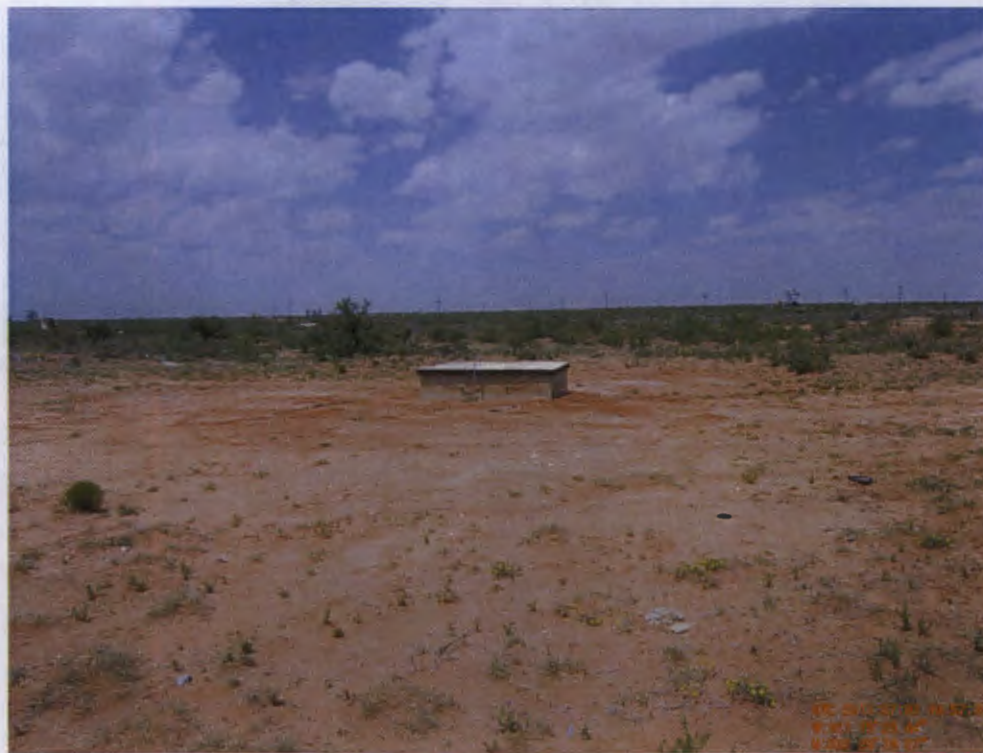
Facing north

Vegetation has rebounded at this site; vegetation will act as an evapo-transpiration barrier that will also inhibit the downward migration of chlorides and hydrocarbons. Plants capture water through their roots and so reduce the amount of water infiltrating below the root zone.
