1R - 427-53

RE: Termination Request  
EME G-9 (1R427-53): UL/G, Sec. 9, T21S, R36E  
RICE Operating Company – Eunice Monument Eumont (EME) SWD System

**RICE OPERATING COMPANY  
JUNCTION BOX FINAL REPORT**

**EME G-9 (1R427-53)**  
Unit Letter G, Section 9, T21S, R36E

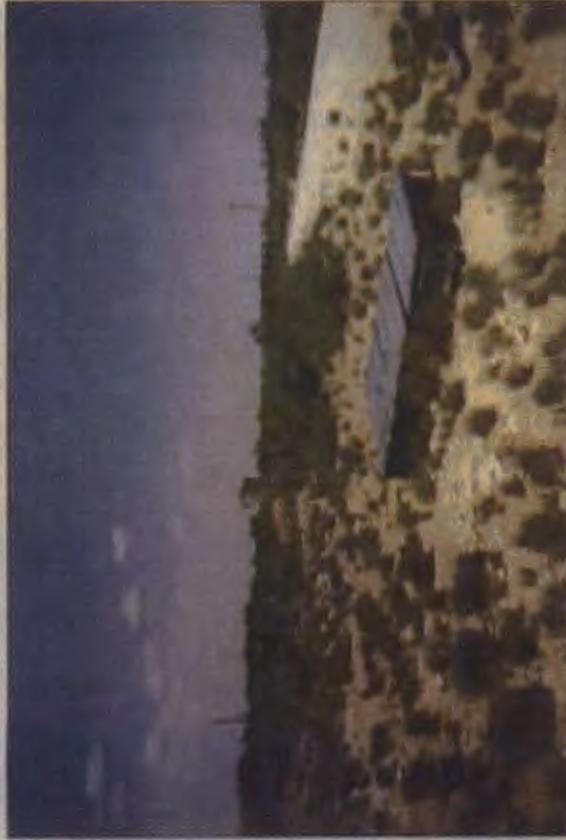
6/26/2003

Undisturbed junction box

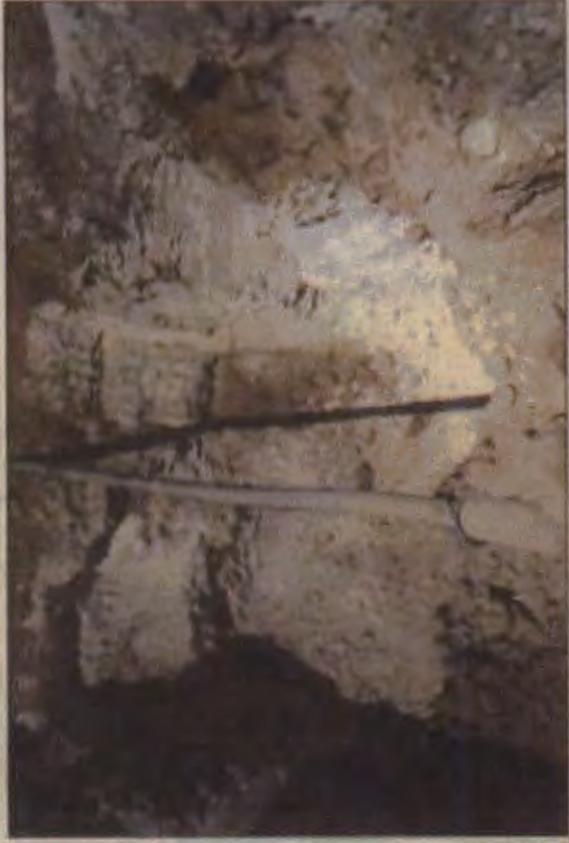
Excavation Sept. 2003

**General Description of Remedial Action:** This junction box site was excavated and delineated for chloride and TPH impact to 25 x 30 x 14 ft deep. Chloride concentrations decreased vertically and laterally. TPH concentrations were well below NMOCD guidelines. The excavated soil was blended and then backfilled into the hole, the surface was contoured to the surrounding landscape. The surface has been re-seeding with a blend of native vegetation and will be monitored for growth. This junction has been eliminated so a new box is not required at this site.

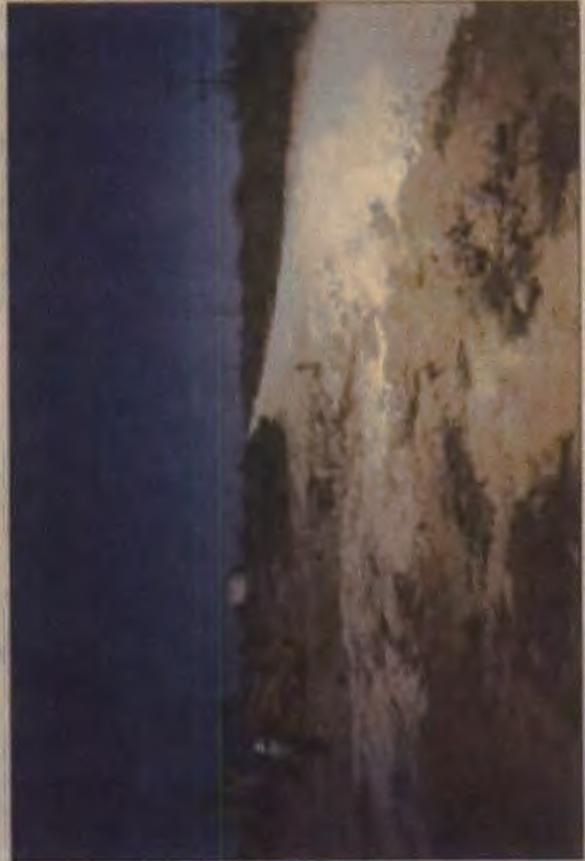
Excavation Sept. 2003

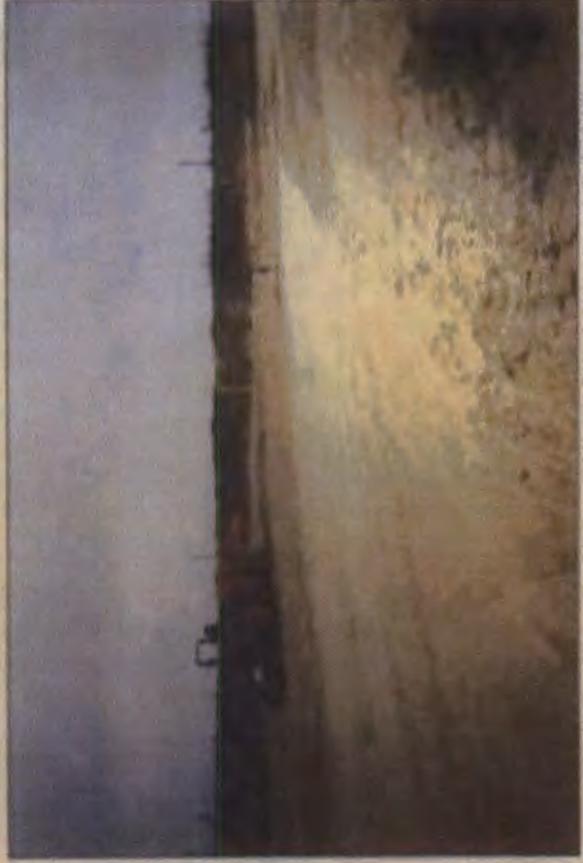
12/12/2003

Seeding disturbed area of backfilled site

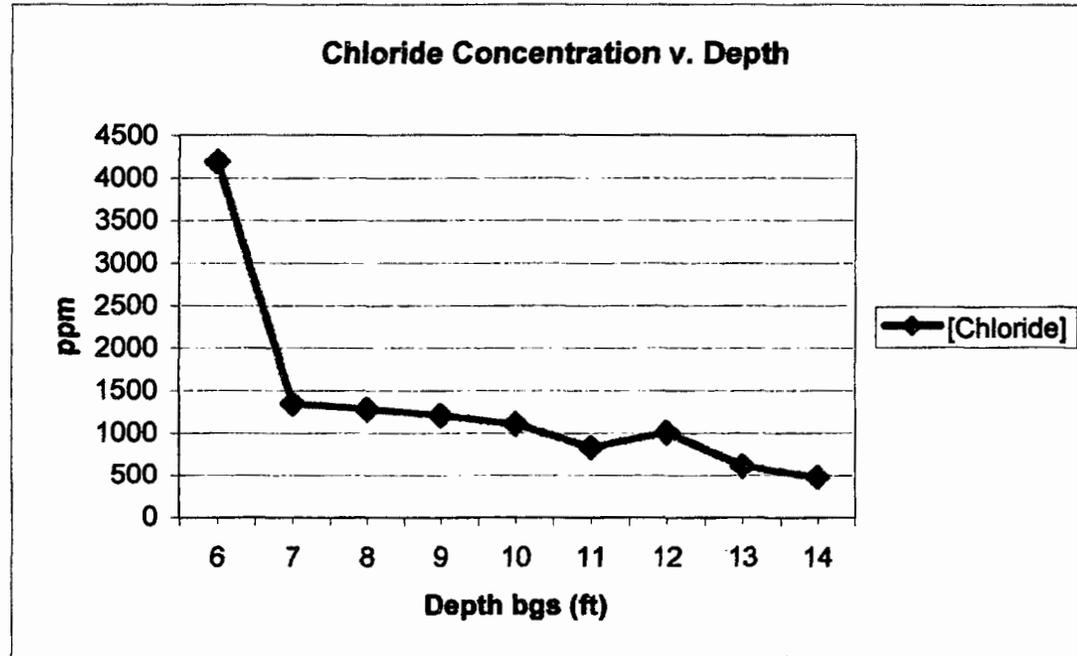
**CHLORIDE CONCENTRATION CURVE**

Depth bgs (ft)	[Cl <sup>-</sup> ] ppm
6	4193
7	1349
8	1281
9	1209
10	1106
11	834
12	1010
13	612
14	481

Groundwater = 157 ft

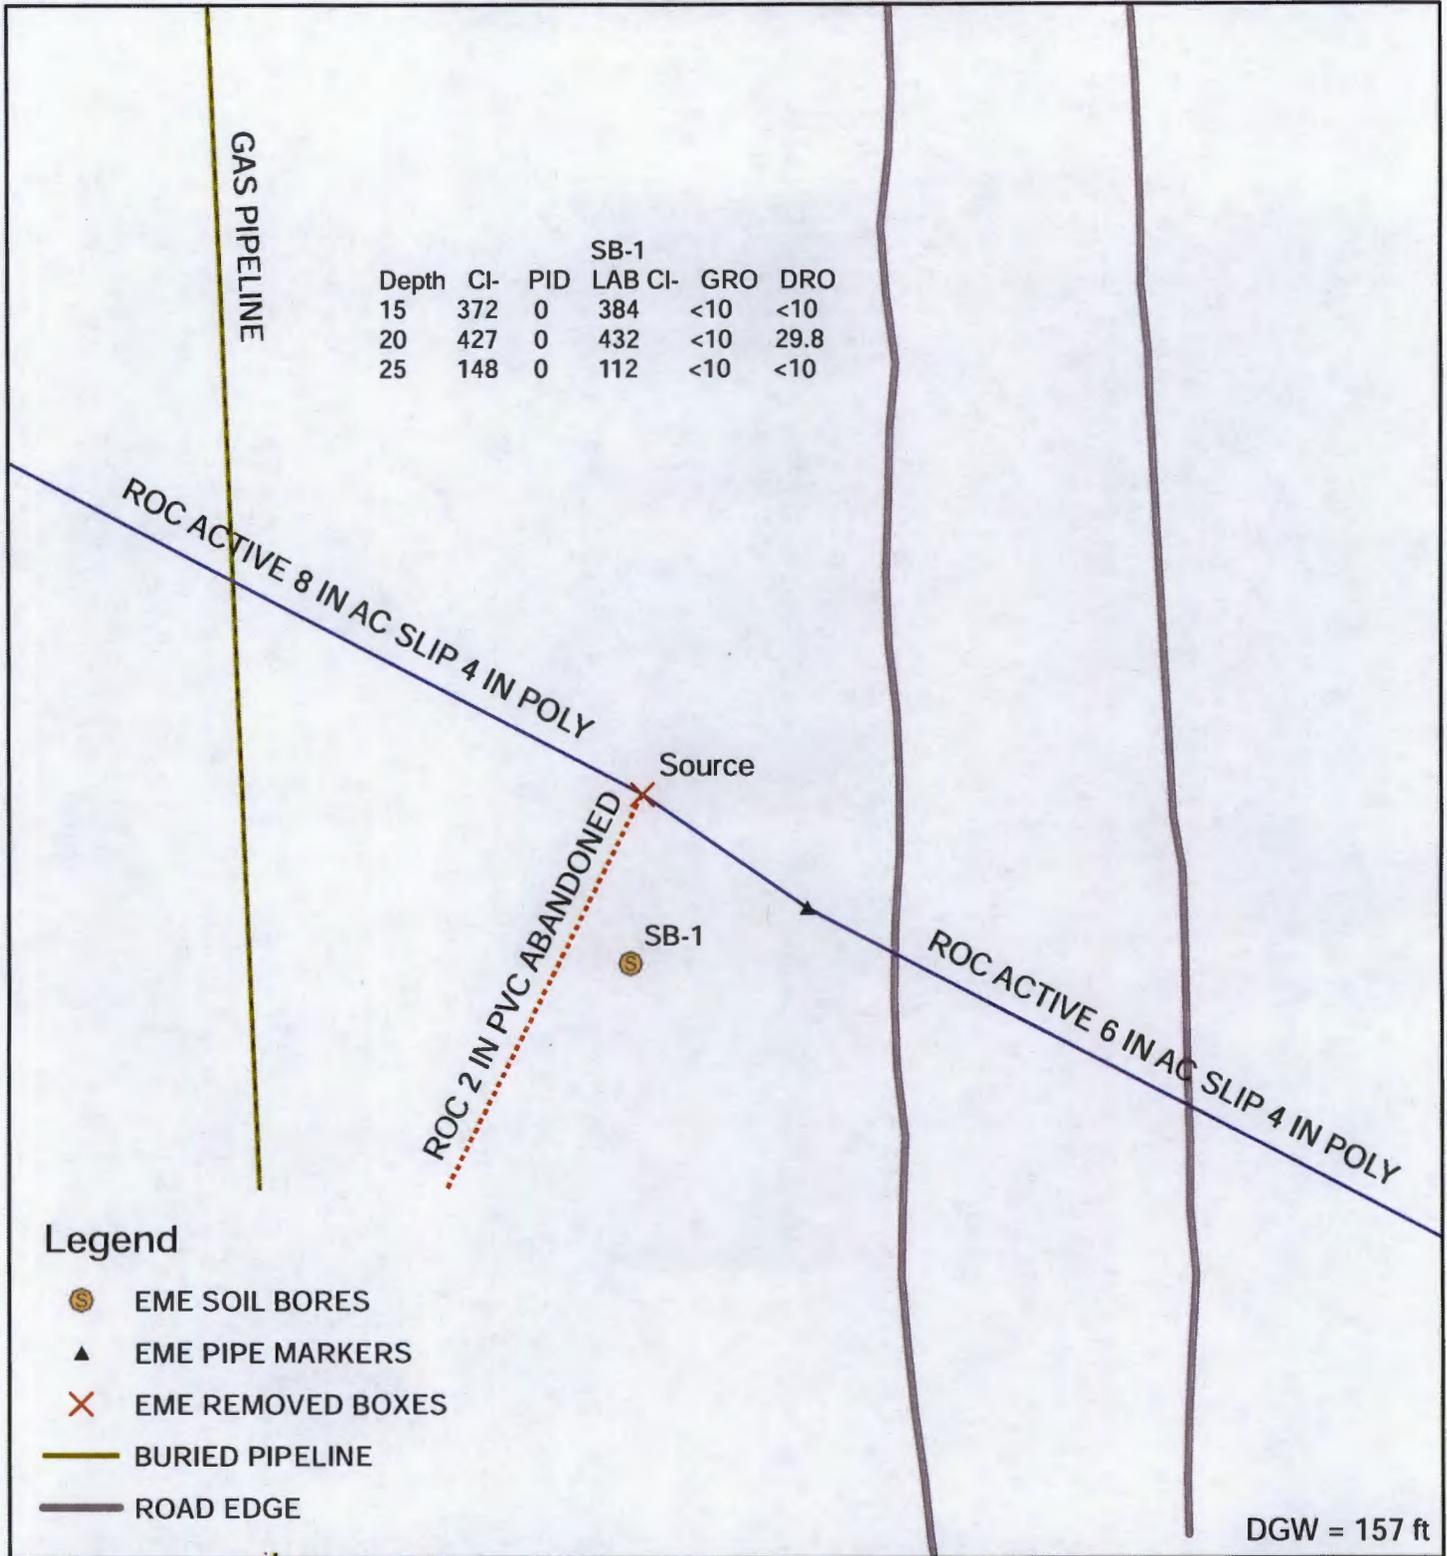
**EME G-9  
(1R427-53)**

To further investigate the depth of chloride presence, a soil bore was initiated on September 23, 2013 at 9 ft south of the former junction box site. The boring was advanced to a depth of 25 ft below ground surface (bgs) with soil samples collected every 5 ft. Each sample was field titrated for chlorides and field screened using a PID for hydrocarbons, resulting in low concentrations. The 15 ft, 20 ft and 25 ft samples were sent to a commercial laboratory for analysis. The 15 ft

samples resulted in a chloride concentration of 384 mg/kg and concentrations of GRO and DRO below detectable limits. The 20 ft sample resulted in a chloride concentration of 432 mg/kg, a GRO concentration below detectable limits and a DRO concentration of 29.8 mg/kg. The 25 ft sample resulted in a chloride concentration of 112 mg/kg and concentrations of GRO and DRO below detectable limit. The entire bore hole was plugged with bentonite to ground surface.

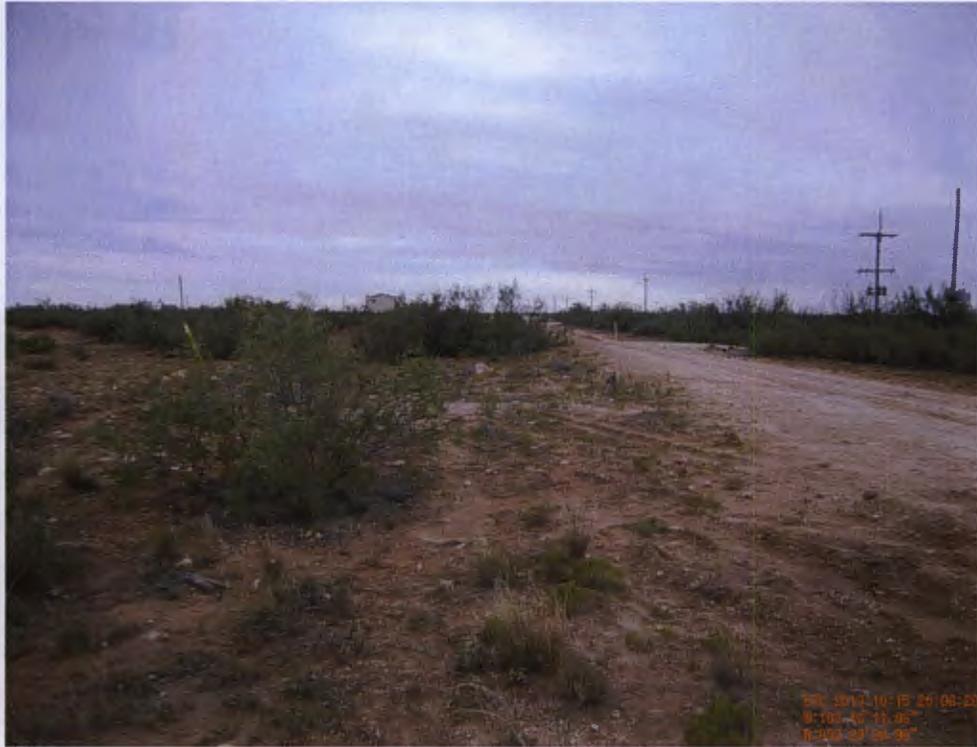
10/15/2013

Vegetation has rebounded at this site; vegetation will act as an evapo-transpiration barrier that will also inhibit the downward migration of chlorides and hydrocarbons. Plants capture water through their roots and so reduce the amount of water infiltrating below the root zone.

Facing north

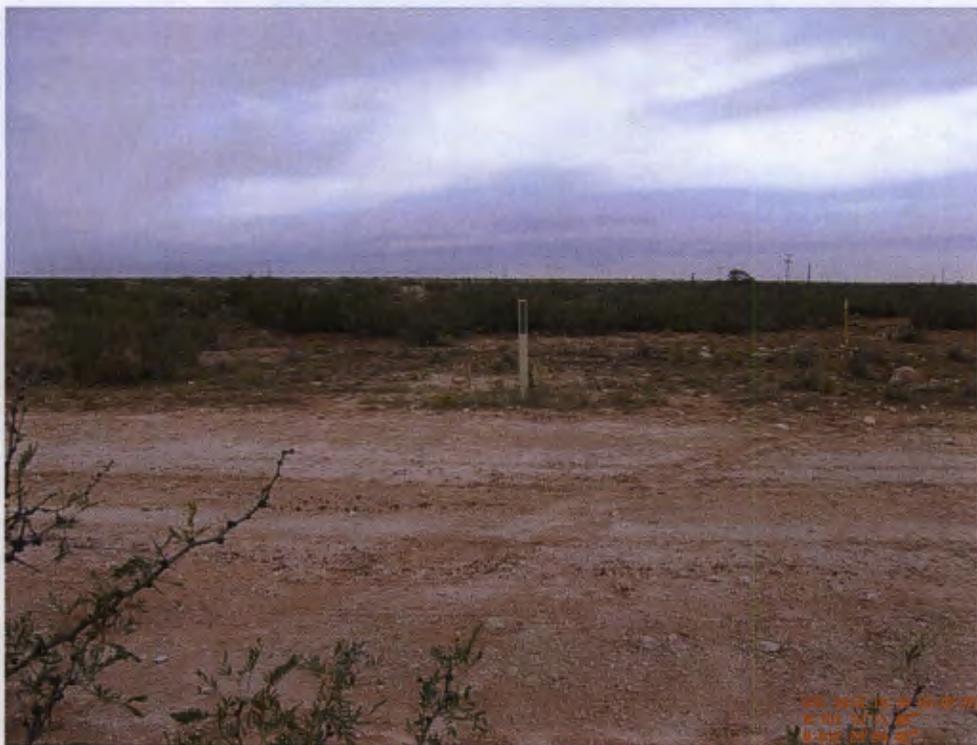
10/15/2013

Facing west
