**From:** Lowe, Leonard, EMNRD  
**Sent:** Tuesday, April 01, 2014 9:14 AM  
**To:** Hack Conder (hconder@riceswd.com)  
**Cc:** kjones@riceswd.com  
**Subject:** Approved Termination Request (1R-427-233) - EME Cooper 'E' EOL

**Termination Request Approved  
for the EME Cooper 'E' EOL (1R427-233)  
Unit Letter A Section 4, T20S, R37E, NMPM, Lea County, New Mexico**

RE: Termination Request  
EME Cooper 'E' EOL (1R427-233): UL/A, Sec. 4, T20S, R37E  
RICE Operating Company – Eunice Monument Eumont (EME) SWD System

RICE OPERATING COMPANY  
JUNCTION BOX FINAL REPORT

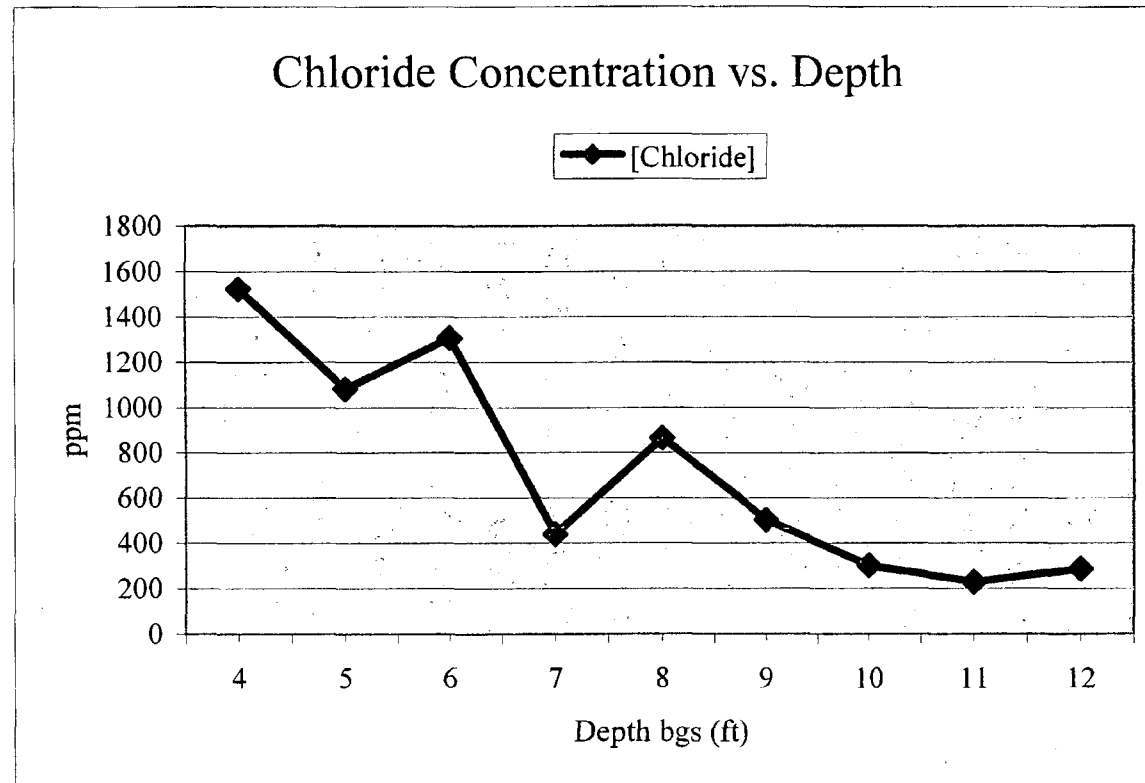
# EME Cooper 'E' EOL

15 ft NORTH of junction

Depth bgs (ft)	[Cl <sup>-</sup> ] ppm
4	1524
5	1082
6	1307
7	440
8	865
9	503
10	302
11	229
12	287

Groundwater = 27 ft

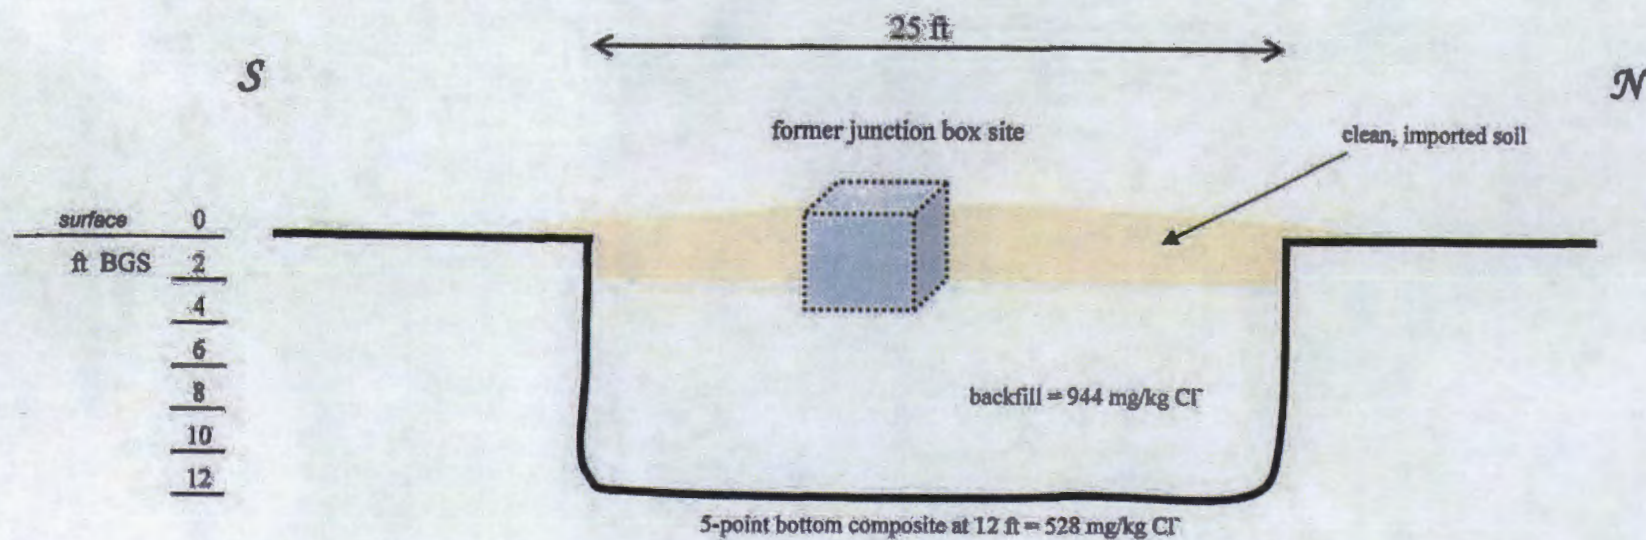
Excavation Cross-Section

25 x 20 x 12-ft-deep

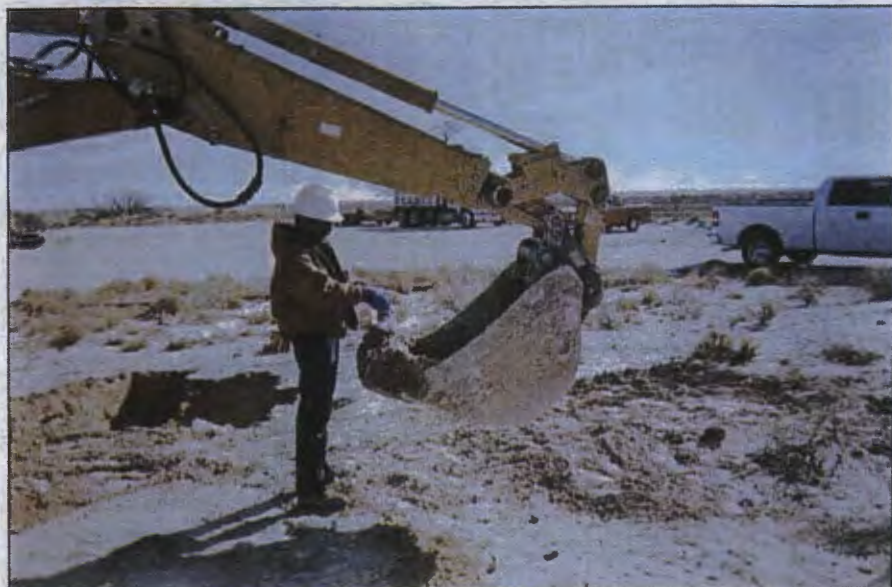
beginning backhoe sample collection at former box site 12/27/2006

This junction was eliminated with the pipeline replacement program. After the box lumber was removed, a backhoe was used to collect soil samples at regular intervals. Chloride field tests and organic vapor readings using a PID were performed on each sample throughout the 25 x 20 x 12-ft-deep excavation. Composite samples from the final excavation were collected for laboratory analysis and confirmed that hydrocarbon was not detected. Chloride concentrations exhibited a trend of decline with depth. The excavated soil was blended on site and returned to the excavation. 36 cubic yards of clean topsoil was imported to fill the remaining 2 ft of the excavation. The topsoil was contoured to the surrounding terrain and seeded with a blend of native vegetation. The seed has been watered and will be monitored for growth.

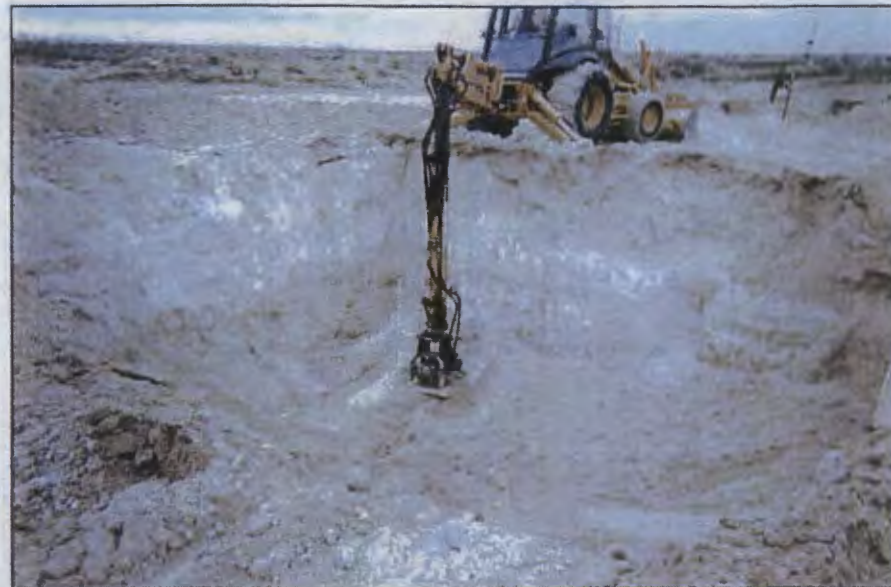
compacting backfill in 25 x 20 x 12 ft excavation 1/29/2007

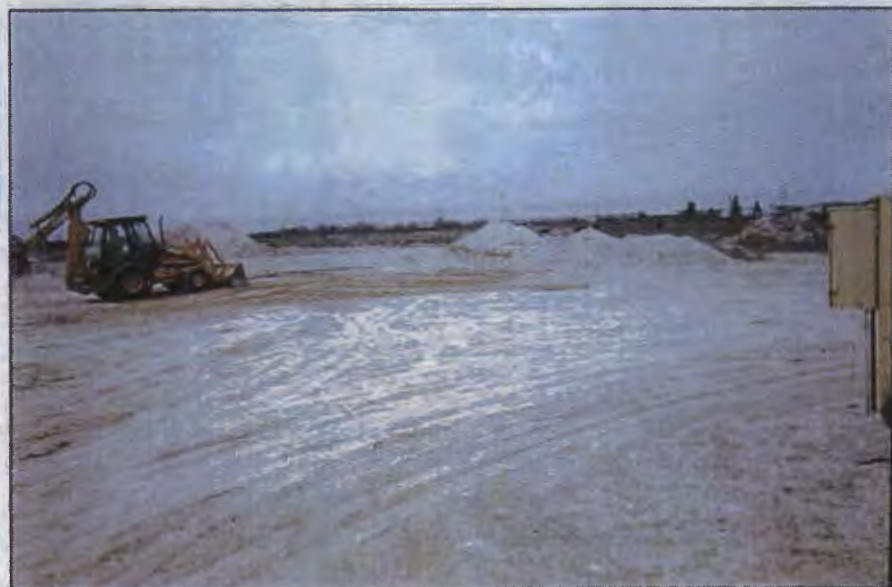
spreading clean, imported soil on top of backfilled site 1/30/2007

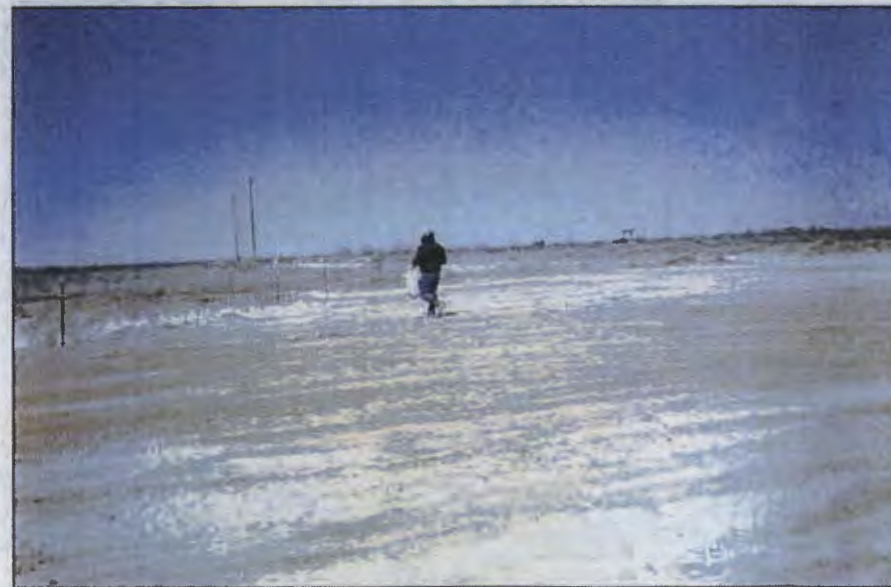
seeding disturbed surface of backfilled site 2/2/2007

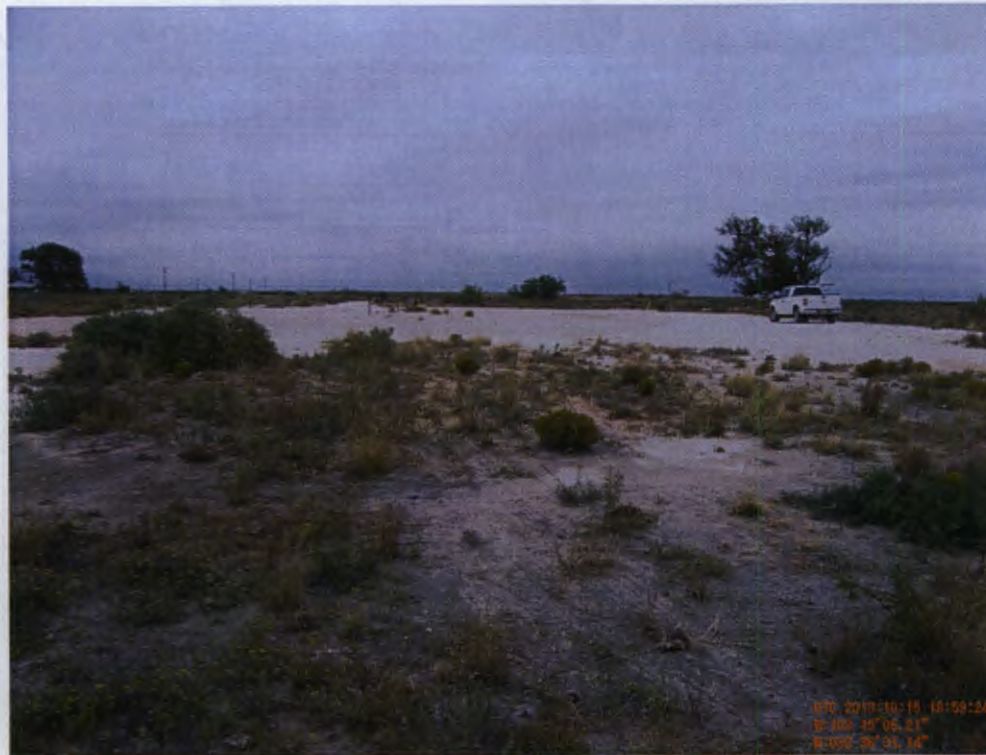
Facing east

Vegetation has rebounded at this site; vegetation will act as an evapo-transpiration barrier that will also inhibit the downward migration of chlorides and hydrocarbons. Plants capture water through their roots and so reduce the amount of water infiltrating below the root zone.
