**Termination Request Approved
for the EME Jct. I-1 (1R427-254)
Unit Letter I Section 1, T20S, R37E, NMPM, Lea County, New Mexico**

RE: Termination Request

EME Jct. I-1 (1R427-254): UL/I, Sec. 1, T20S, R37E

RICE Operating Company – Eunice Monument Eumont (EME) SWD System

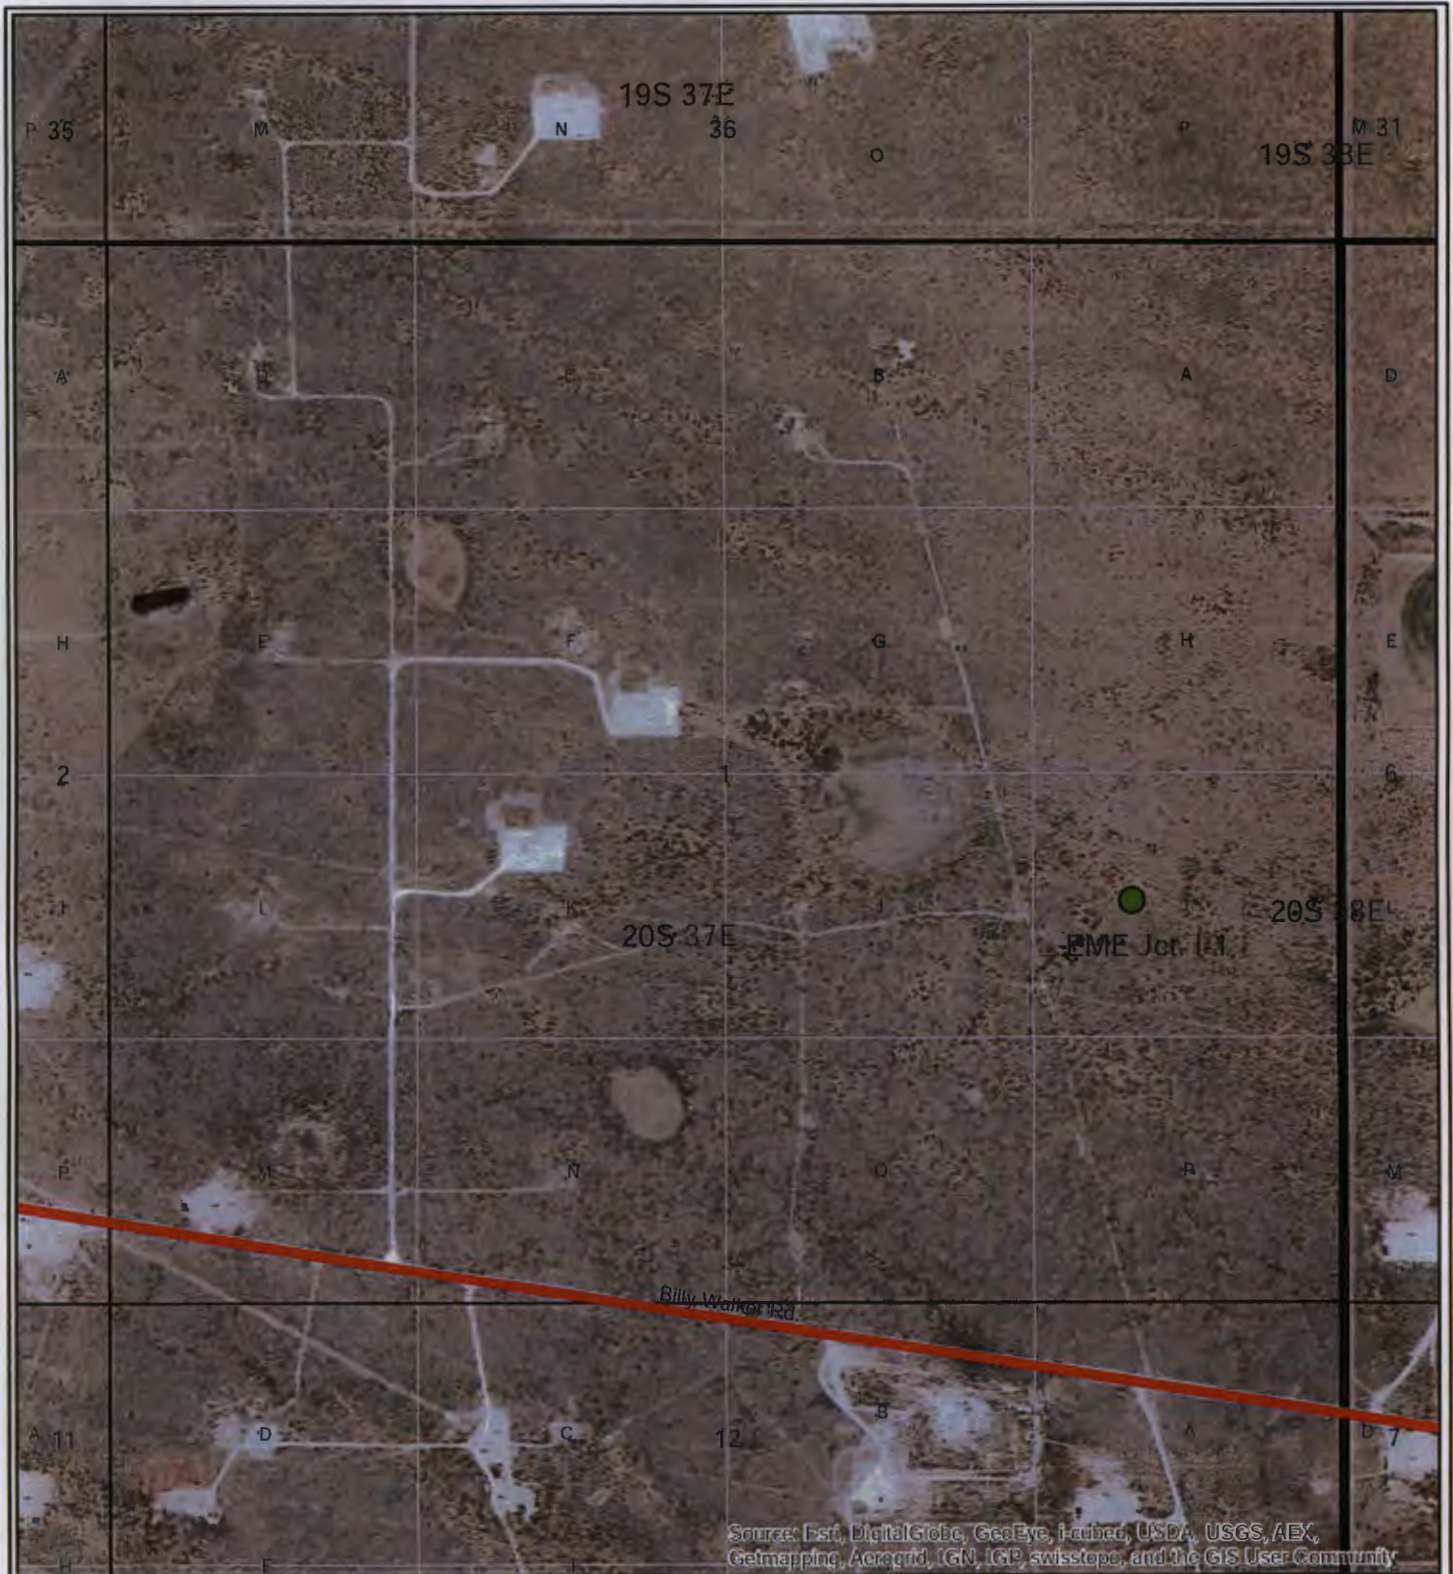
AREA MAP

EME Jct. I-1

1R427-254
UL/I
Sec. 1-T20S-R37E

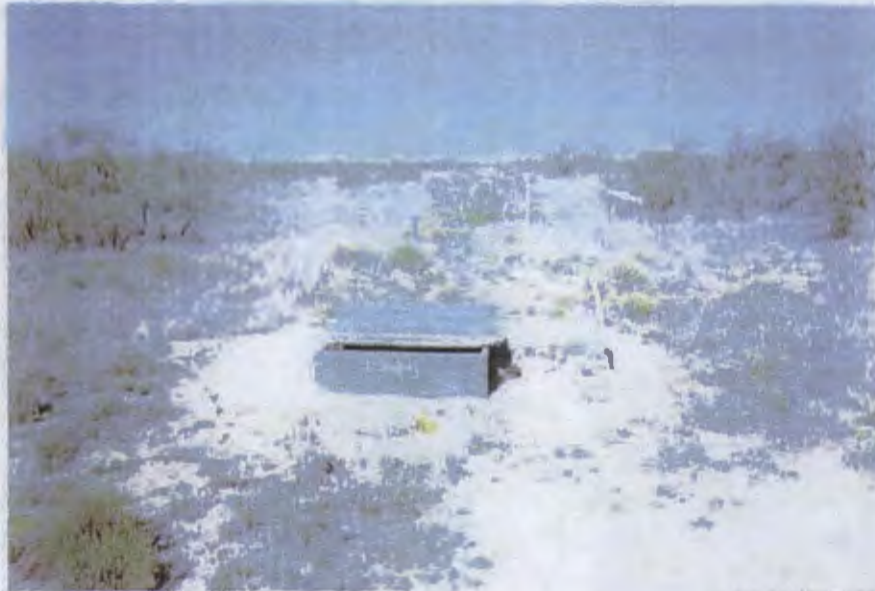
undisturbed junction box

9/18/2008

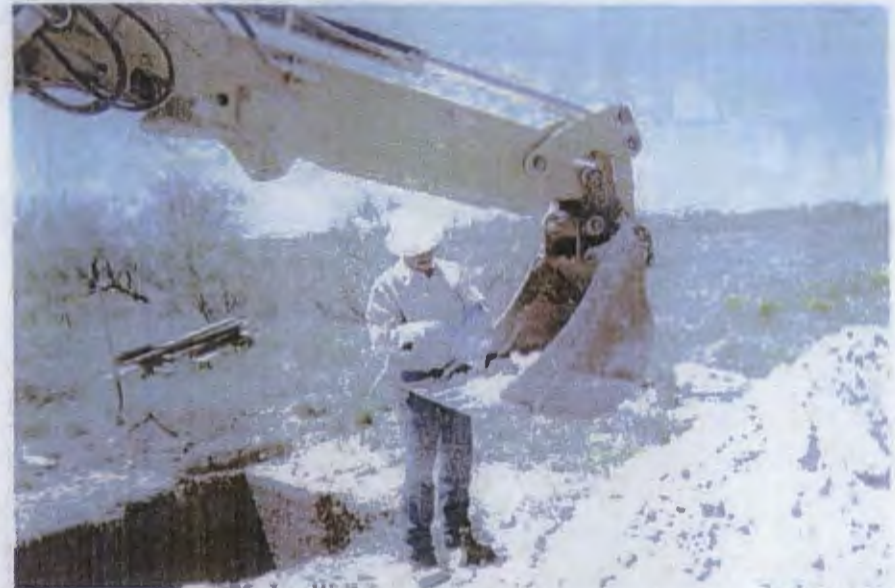
collecting a soil sample

9/18/2008

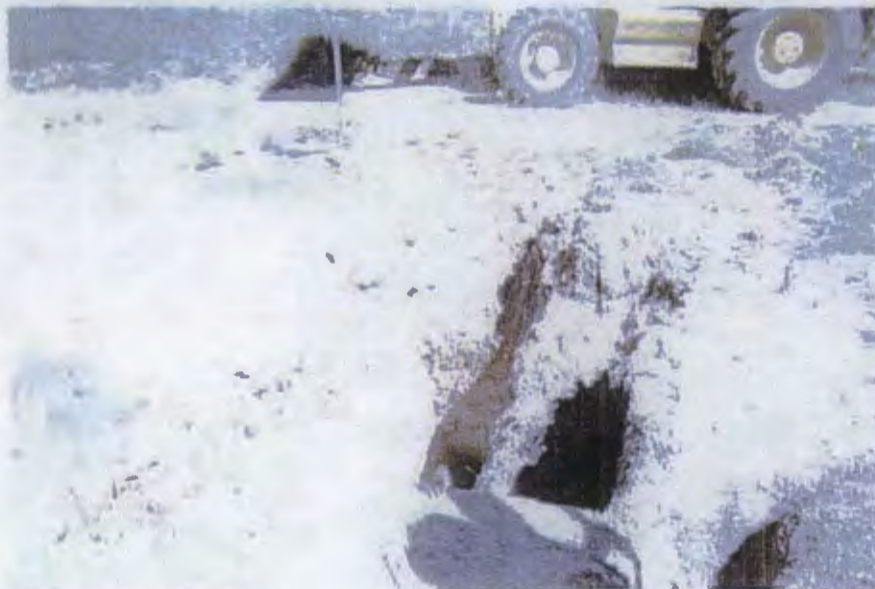
site prior to backfill

9/18/2008

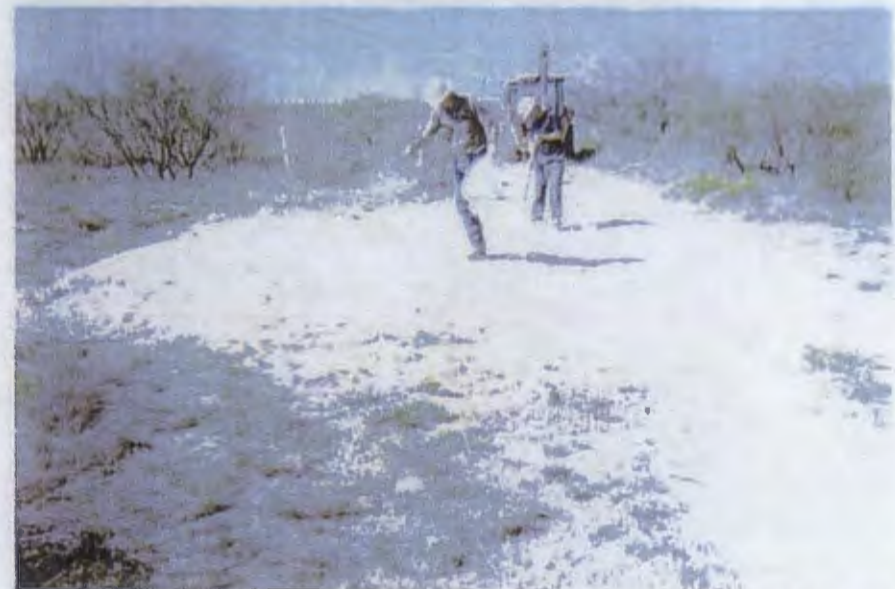
seeding backfilled site

9/29/2008

General Description of Remedial Action: This junction was eliminated during the pipeline replacement/upgrade program. After the former junction box was removed, an investigation was conducted using a backhoe to collect soil samples at regular intervals producing a 5x3x15-ft-deep excavation. Chloride field tests performed on each sample yielded generally low concentrations that decreased with depth. Organic vapors were measured using a PID, which also yielded low concentrations. The deepest sample, 15 ft BGS, was analyzed by a commercial laboratory for chloride and TPH, which confirmed low concentrations. The excavated soil was returned to the excavation and clean blow sand was used as a top cap and to contour the site to the surrounding area. On 9/29/2008, the site was seeded with a blend of native vegetation and is expected to return to a productive capacity at a normal rate.

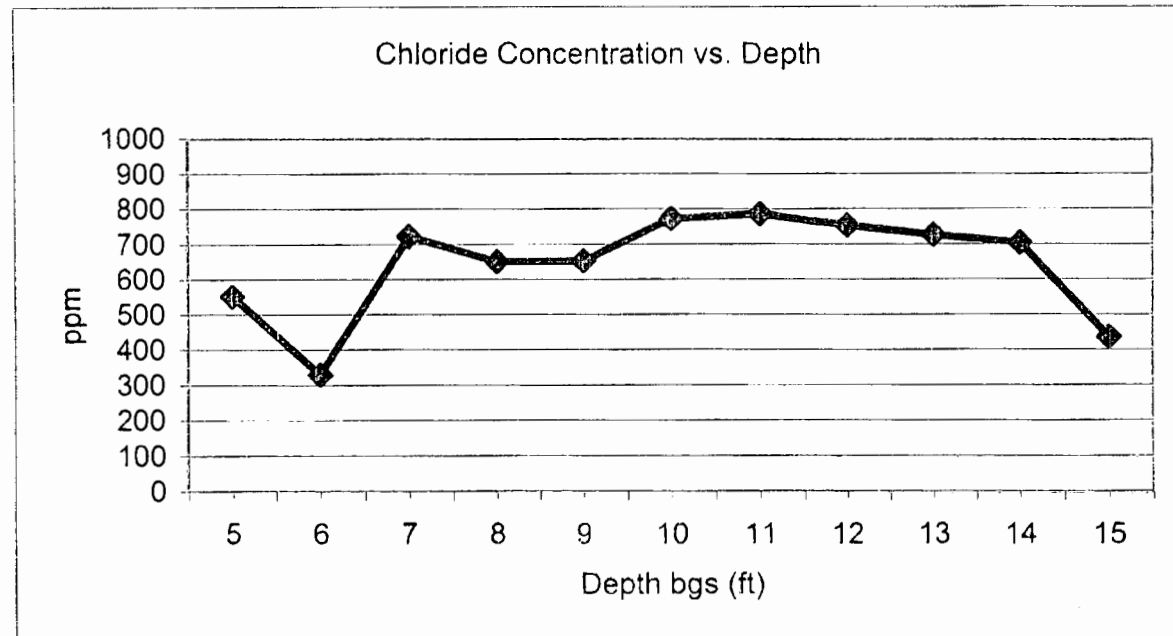
CHLORIDE CONCENTRATION CURVE

Backhoe samples at the junction (source)

Depth bgs (ft)	[Cl ⁻] ppm
5	552
6	329
7	722
8	651
9	652
10	772
11	785
12	753
13	727
14	704
15	436

Groundwater = 55 ft

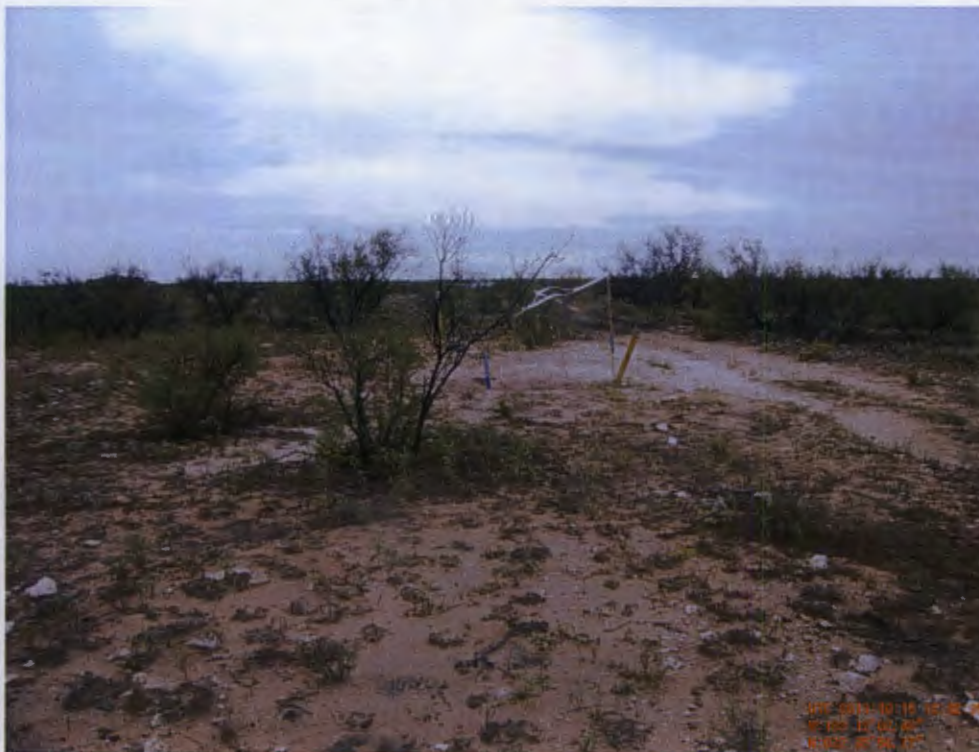
Facing north

10/15/2013

Since there is no groundwater at the site, the former junction box will in no way contribute to the degradation of groundwater. Vegetation has rebounded at this site; vegetation will act as an evapo-transpiration barrier that will also inhibit the downward migration of chlorides and hydrocarbons. Plants capture water through their roots and so reduce the amount of water infiltrating below the root zone.

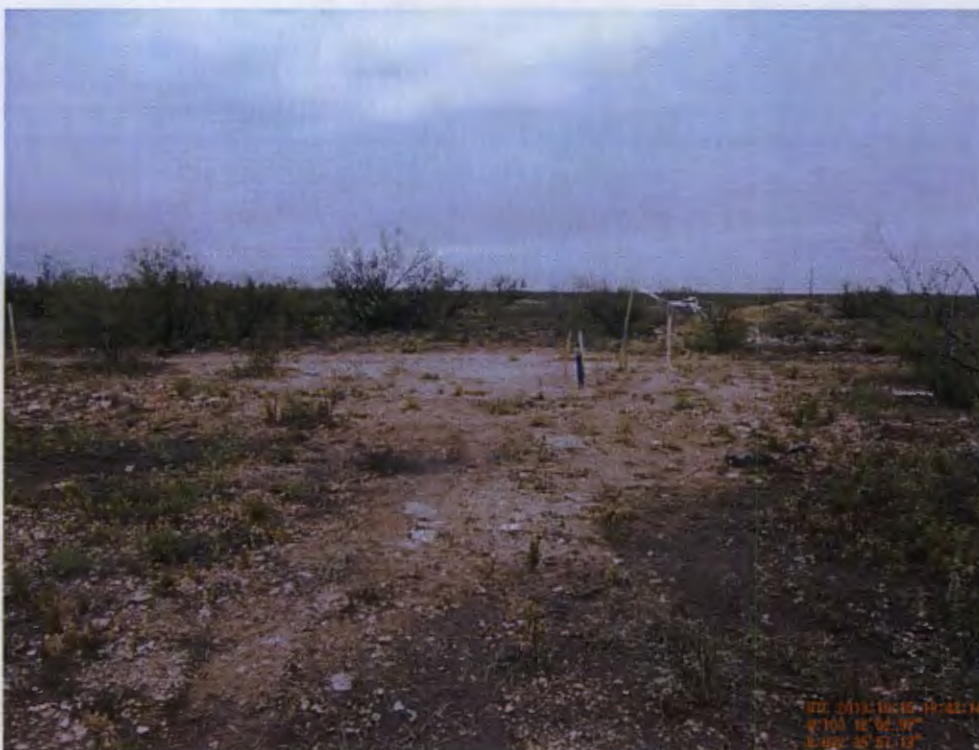
Facing east

10/15/2013
