**Termination Request Approved
for the EME L - 1 (1R427-67)
Unit Letter L Section 1, T20S, R37E, NMPM, Lea County, New Mexico**

RE: Termination Request
EME L-1 (1R427-67): UL/L, Sec. 1, T20S, R37E
RICE Operating Company – Eunice Monument Eumont (EME) SWD System

**RICE OPERATING COMPANY
JUNCTION BOX FINAL REPORT**

EME L-1 (1R427-67)
Unit Letter L, Section 1, T20S, R37E

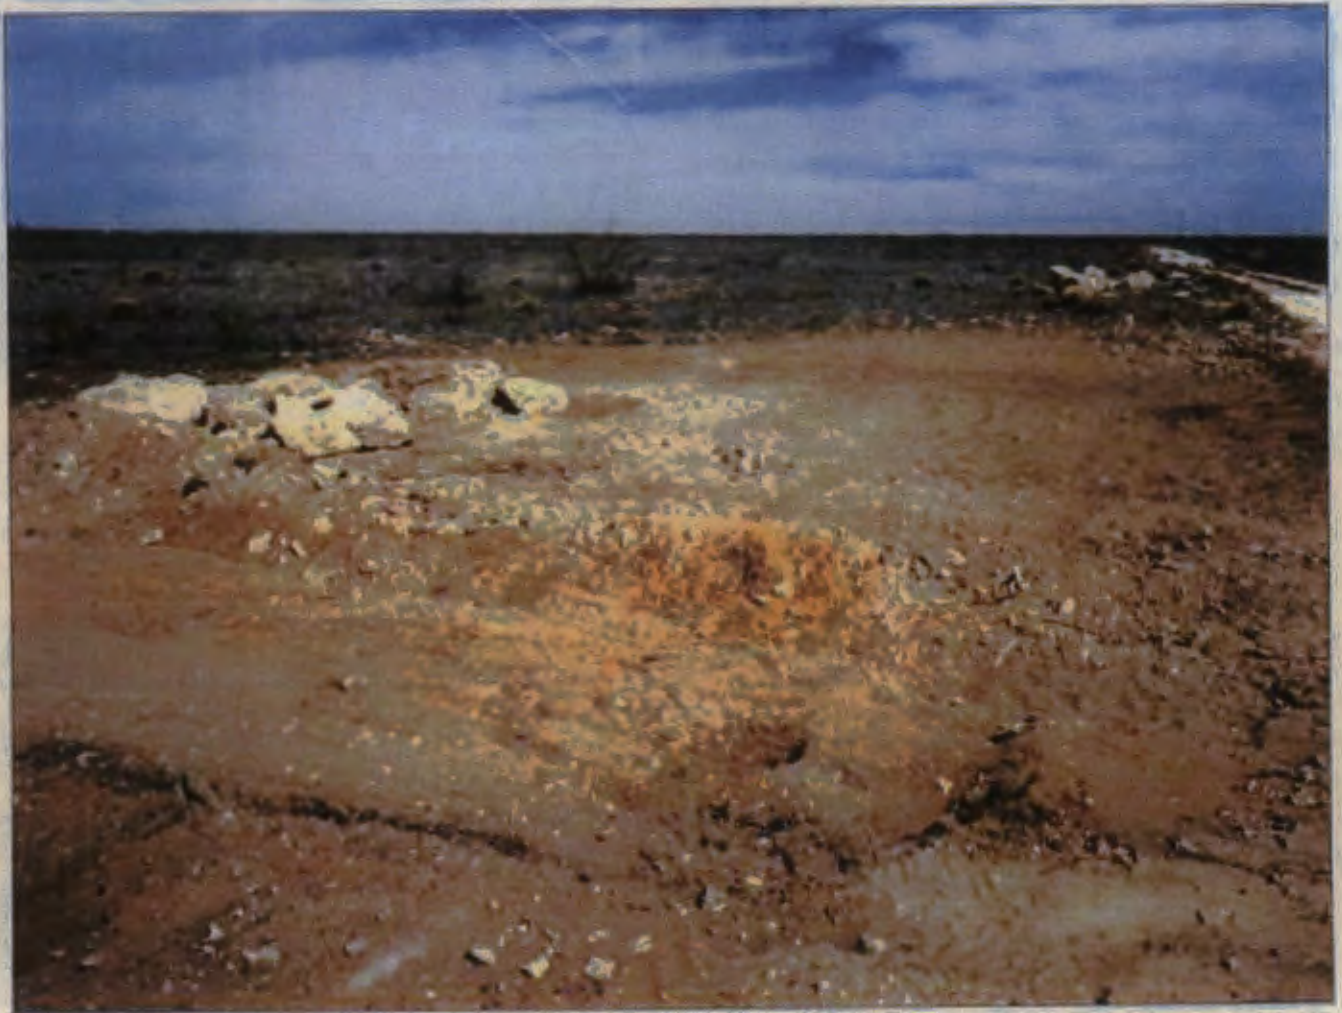
EME 1-1 Junction Box Upgrade

Remediation Complete

No Junction Box

Found impact below NMOCD guidelines. Backfilled with blended soil. This site is no longer a junction and does not require a box. Natural attenuation will remediate the remaining hydrocarbon.

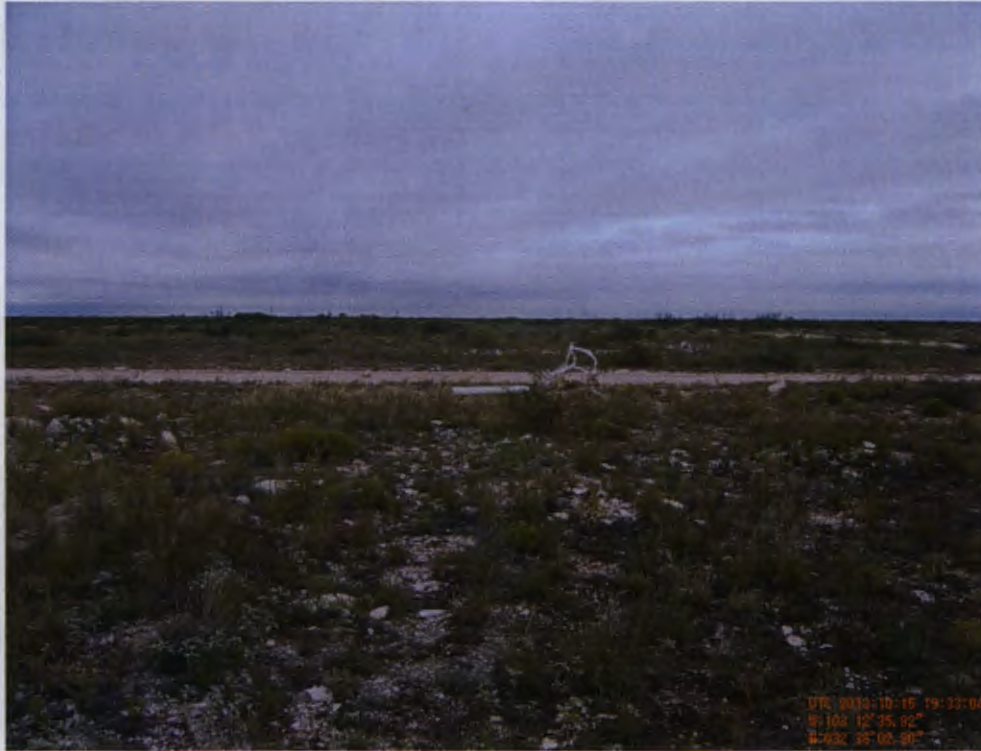
Facing east

Vegetation has rebounded at this site; vegetation will act as an evapo-transpiration barrier that will also inhibit the downward migration of chlorides and hydrocarbons. Plants capture water through their roots and so reduce the amount of water infiltrating below the root zone.
