RE: Termination Request
EME Jct. J-34 (1R427-195): UL/J, Sec. 34, T19S, R36E
RICE Operating Company – Eunice Monument Eumont SWD System

Junction Box Report

**RICE OPERATING COMPANY
JUNCTION BOX FINAL REPORT**

EME Jct. J-34 (1R427-195)
UL/J, Section 34, T19S, R36E

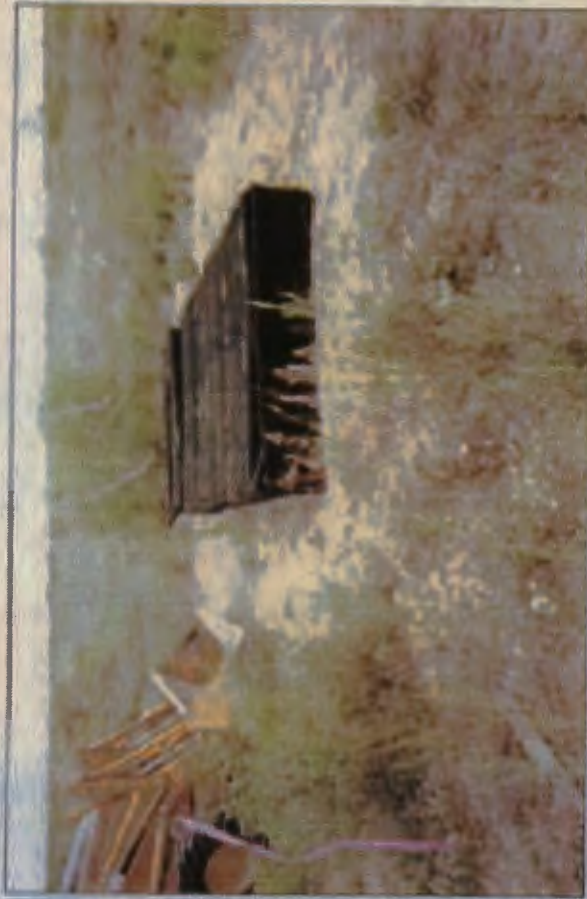
undisturbed junction box prior to excavation

This junction has been eliminated. After the box materials were removed, a vertical delineation trench was made with a backhoe at the former box site and soil samples were collected every foot of depth from 2 to 6 ft BGS. Chloride field tests were performed on the samples and yielded very low concentrations similar to background level. There were no physical indications of impact and all PID field screenings were 0.0 ppm. Lab analysis on the 6 ft deep sample confirmed field tests and all constituents were below the laboratory's detection limits. The excavated soil was blended on site and then backfilled into the trench and contoured to the surrounding surface. The disturbed surface was then seeded with a blend of native vegetation and is expected to return to productive capacity at a normal rate.

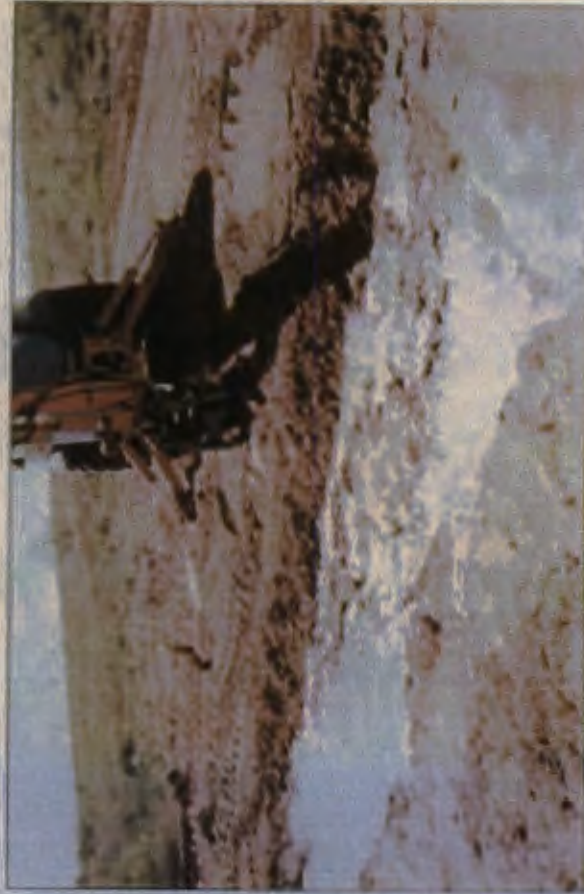
backfilling delineation trench

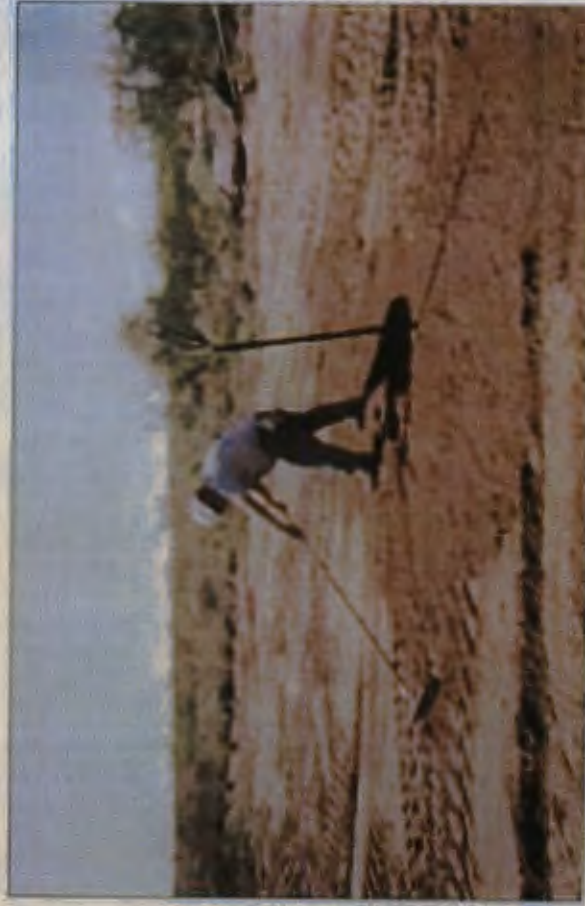
seeding disturbed surface

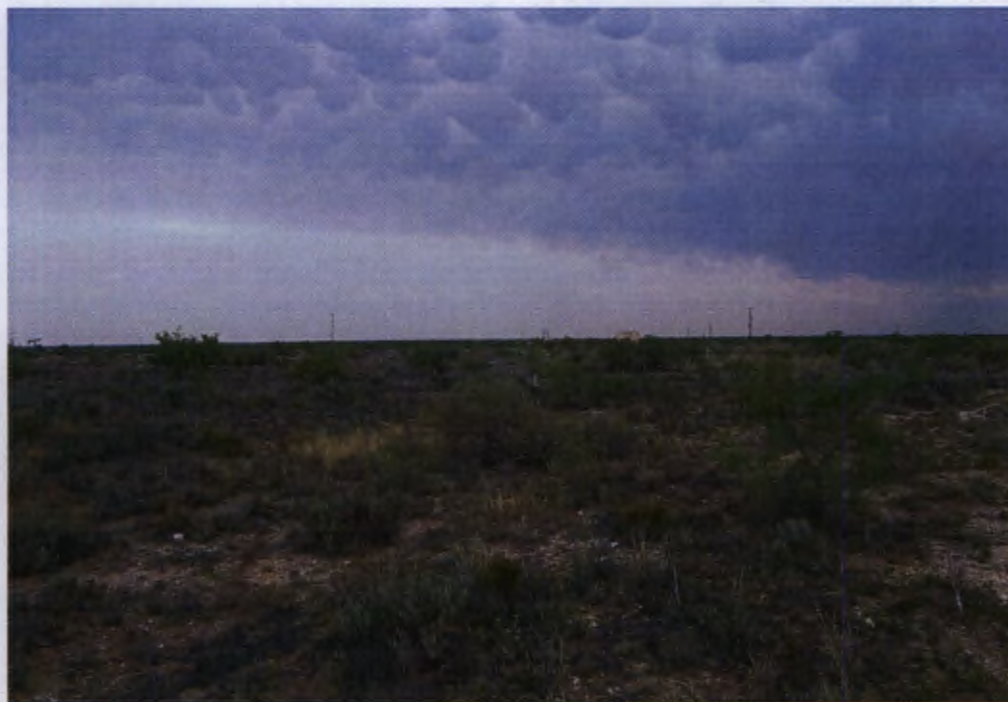
Facing South

Vegetation has rebounded at this site; vegetation will act as an evapo-transpiration barrier that will also inhibit the downward migration of chlorides and hydrocarbons. Plants capture water through their roots and so reduce the amount of water infiltrating below the root zone. A junction box is no longer needed at this site.
