BD Jct. N-30
2013

**RICE OPERATING COMPANY
JUNCTION BOX DISCLOSURE* REPORT**

SWD SYSTEM	JUNCTION	UNIT	SECTION	TOWNSHIP	RANGE	COUNTY	BOX DIMENSIONS - FEET		
							4.5	4.5	2
Blinebry-Drinkard (BD)	Jct. N-30	N	30	22S	38E	Lea	Moved 125' east

RE: JUNCTION BOX UPGRADE REPORT for 2013
BD SWD SYSTEM
Lea County, New Mexico

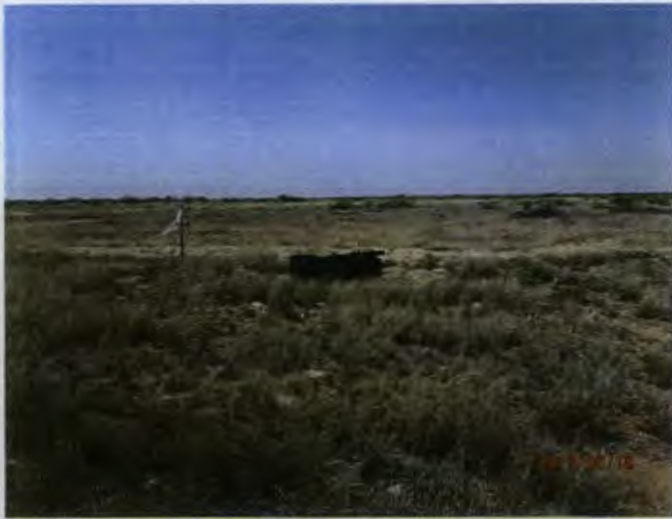
Site prior to excavation, facing south 6.18.13

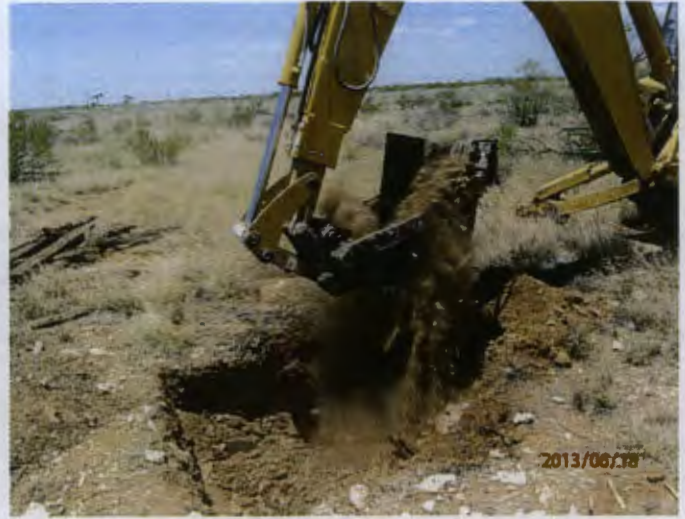
Digging vertical, facing north 6.18.13

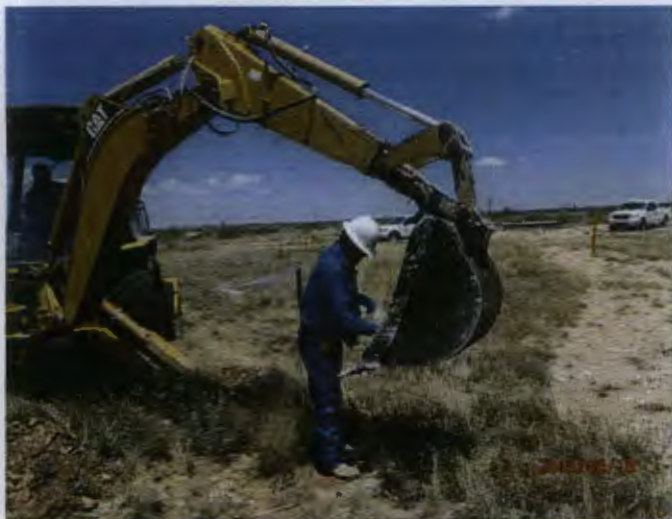
Collecting sample, facing east 6.18.13

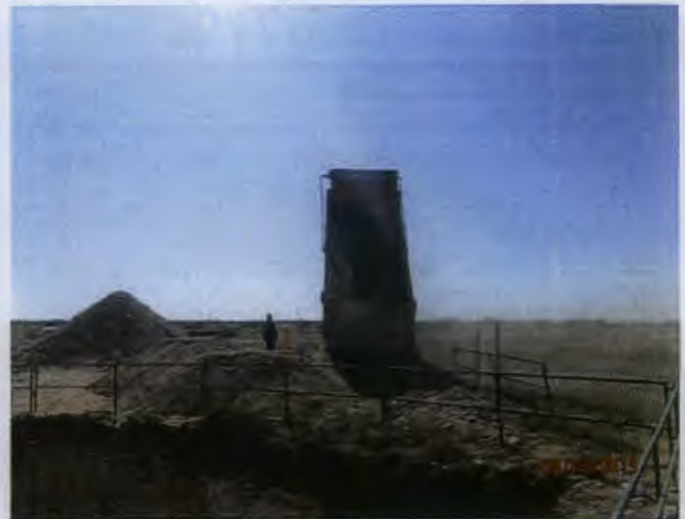
Importing soil, facing east 8.9.13

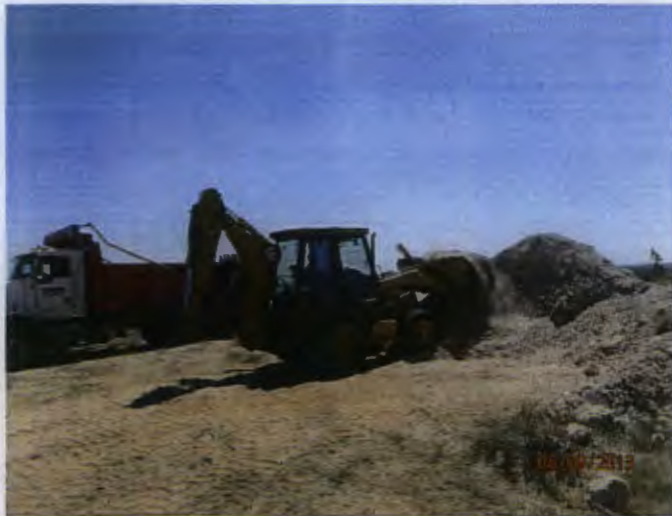
Exporting soil, facing south 8.9.13

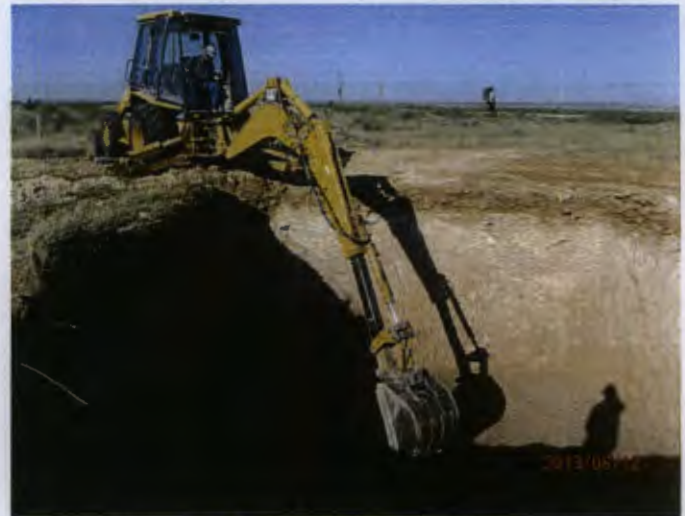
Padding bottom of excavation, facing west 8.12.13

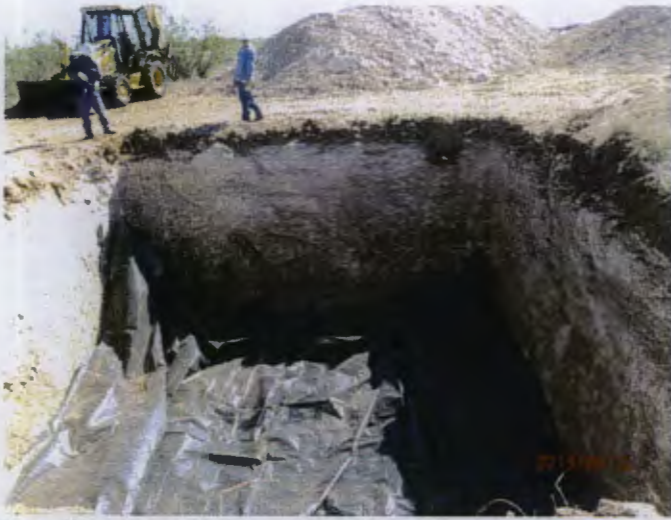
Installing 20 mil liner at 12ft bgs, facing east
8.12.13

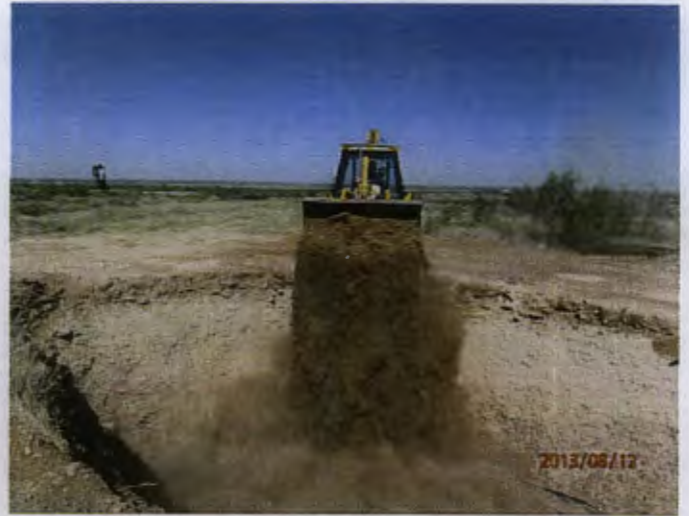
Backfilling Liner, facing west
8.12.13

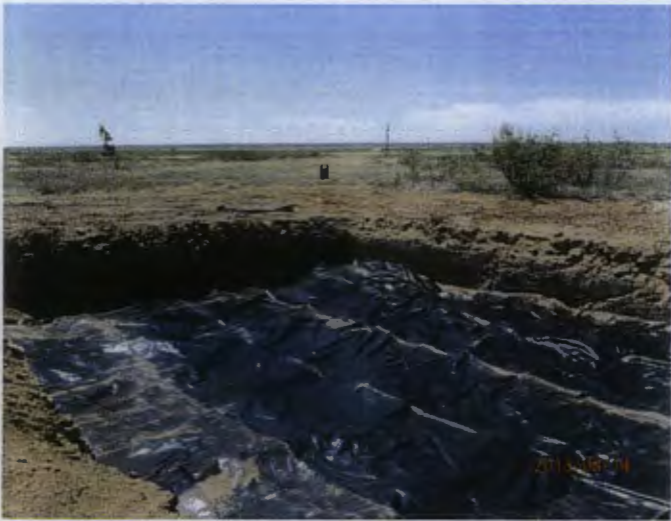
Liner installed 5'ft bgs below ground surface,
facing northwest
8.14.13

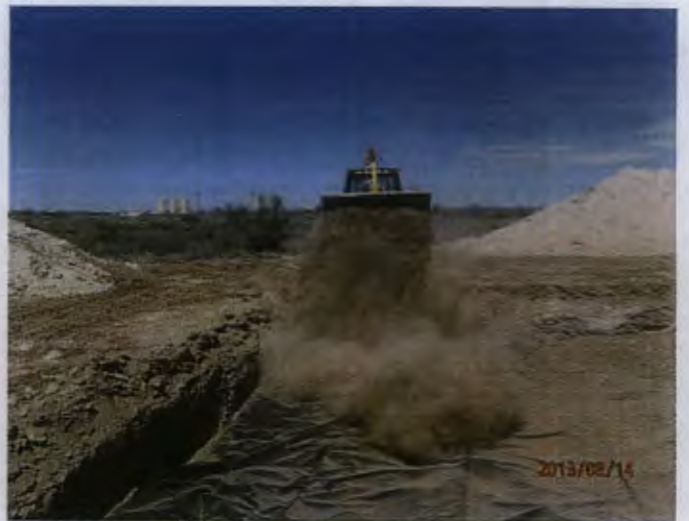
Backfilling 2nd Liner, facing east
8.14.13

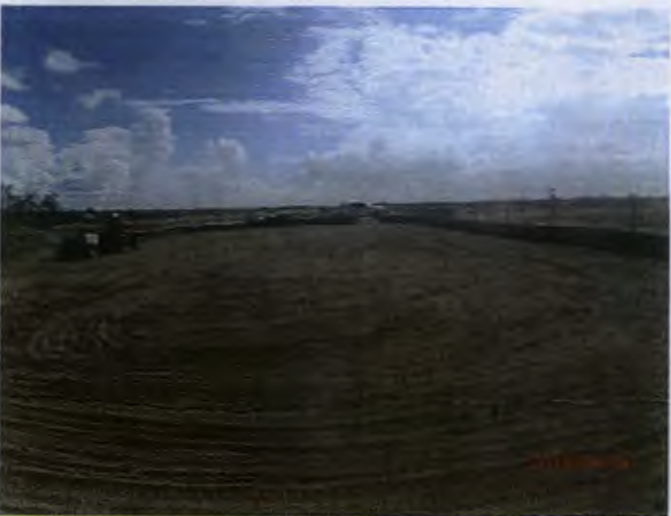
Seeding site, facing east
9.16.13

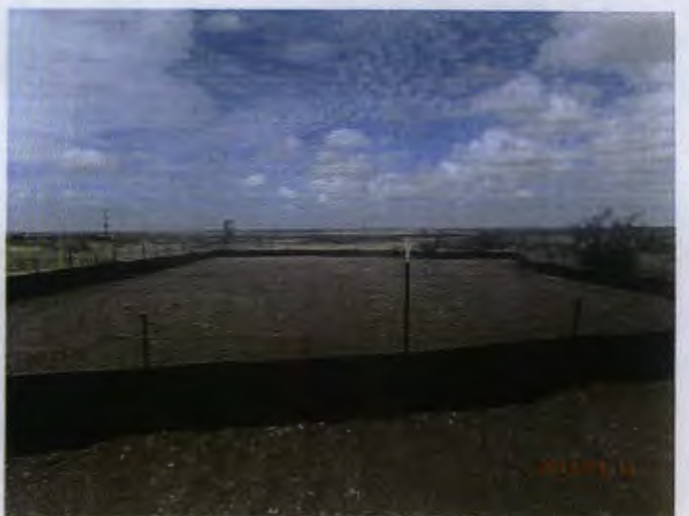
Final photo, facing west
9.16.13

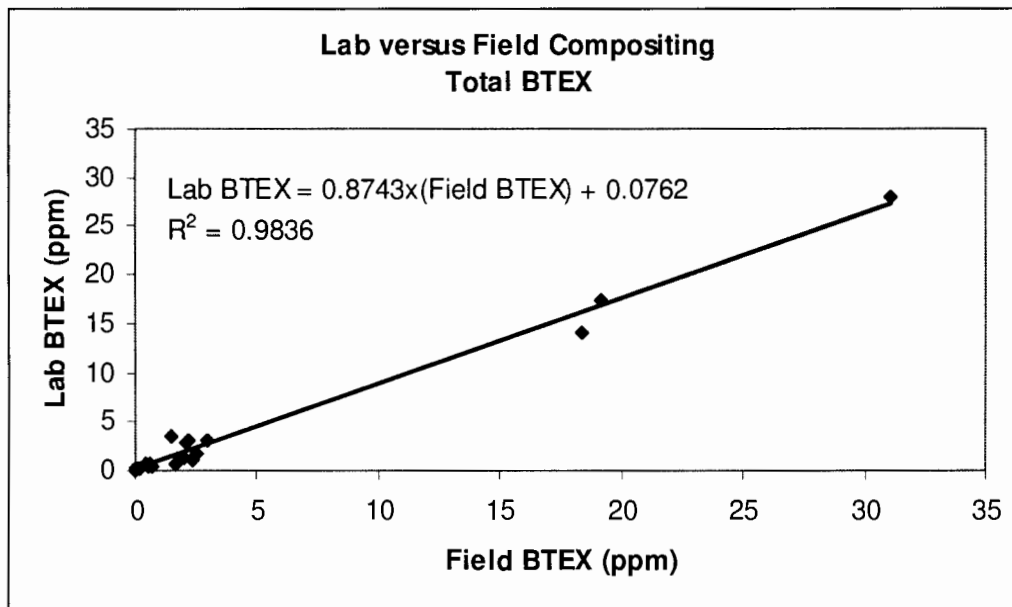
Figure 1 - Laboratory versus field-composited soil samples analyzed for BTEX.

A comparison of lab-composited soil samples versus field-composited soil samples revealed a close correspondence for total BTEX between the two methods (Figure 1).

The high R^2 value (0.9836) of the best-fit statistical regression line indicates a high degree of reliability in using the field-compositing method over the range of values observed. Below a “field-composited BTEX” value of 0.61 ppm the “lab-composited BTEX” values are slightly lower. However, above a field-composited BTEX value of 0.61 the lab-composited values run slightly lower. In other words, the field-composited values tended to produce slightly higher BTEX numbers above the point at which BTEX concentrations become significant.

There is a reason for this. BTEX is volatile and quickly biodegradable. The compositing and “packaging” of soil samples in the field minimize the handling and aeration that occur in the laboratory. Thus, field-composited soil samples lose less BTEX to evaporation and/or biodegradation prior to laboratory analysis. In other words, the field compositing and packaging of soil samples better preserves sample integrity, and for this reason would appear to represent the better method of procuring soil samples for subsequent analysis of BTEX.

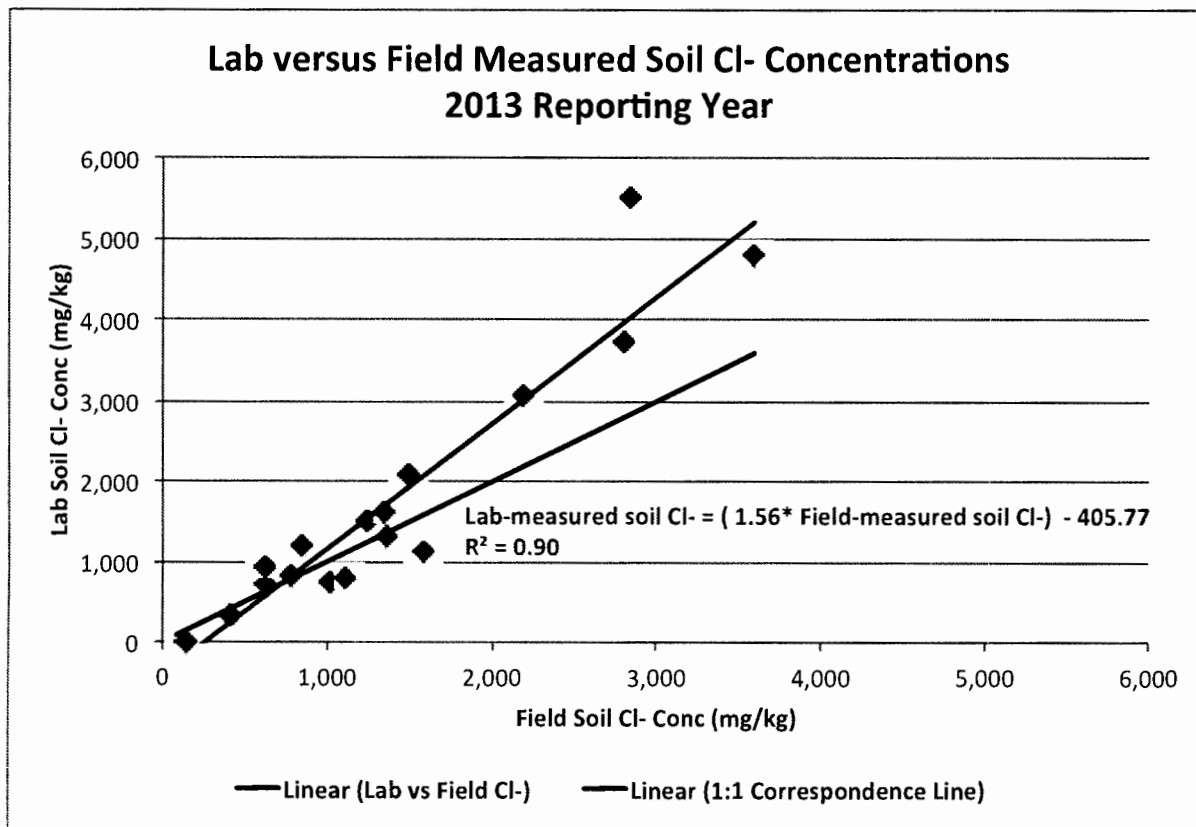
Figure 1 – Laboratory versus field measured soil chloride measurements (n = 29 paired sets).

A representative sample of 29 pairs of laboratory versus field measured soil chloride values was compared to determine how well field measurements matched laboratory measurements. It is assumed that laboratory measurements better represent the “true” values due to the controlled environment that a laboratory provides. A simple plot of the laboratory versus field measured soil chloride values is given below (Figure 1).

A straight line fit to the data confirms a general linear trend over a wide range of soil chloride concentrations, and the R^2 value (0.90) indicates that field measurements provide a reliable approximation of laboratory-measured values. Based on the best-fit line of lab vs field measured values, field measured values overestimate lab measure values below a field measured value of 723 mg/kg and above this underestimate the lab-measured values. This is indicated in the graph where the (blue) best-fit line of lab vs field measured chlorides crosses the (black) line which would indicate a 1:1 correspondence.
