# Additional Information

Re: Centerpoint SWD - Application for Authorization to Inject  
PO Number: UFY9G-191113-C-1080  
Admin. App. No.: pBL1932954303

Re: Closure Request  
Centerpoint SWD (API 05-045-33464)  
Maralex Disposal, LLC  
Incident Number NCS  
San Juan County, New Mexico

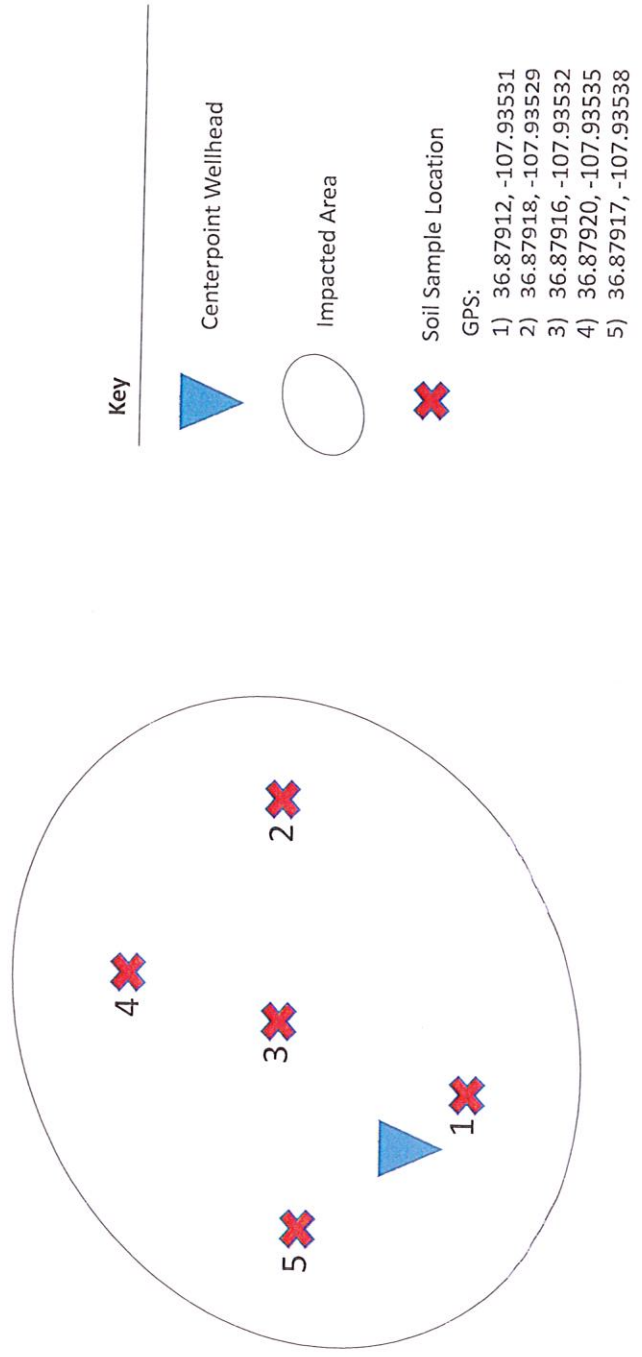
Figure 2

Sampling occurred after the workover rig had completed its operations. A five spot pattern in the impacted area of approximately 3000 square feet and a background sample was taken with NMOCD representatives present during the entire sampling activity.

**Site Map - Sampling**  
Centerpoint SWD  
05-045-33464  
P-S24-T31N-R11W NMPM  
Maralex Disposal, LLC.

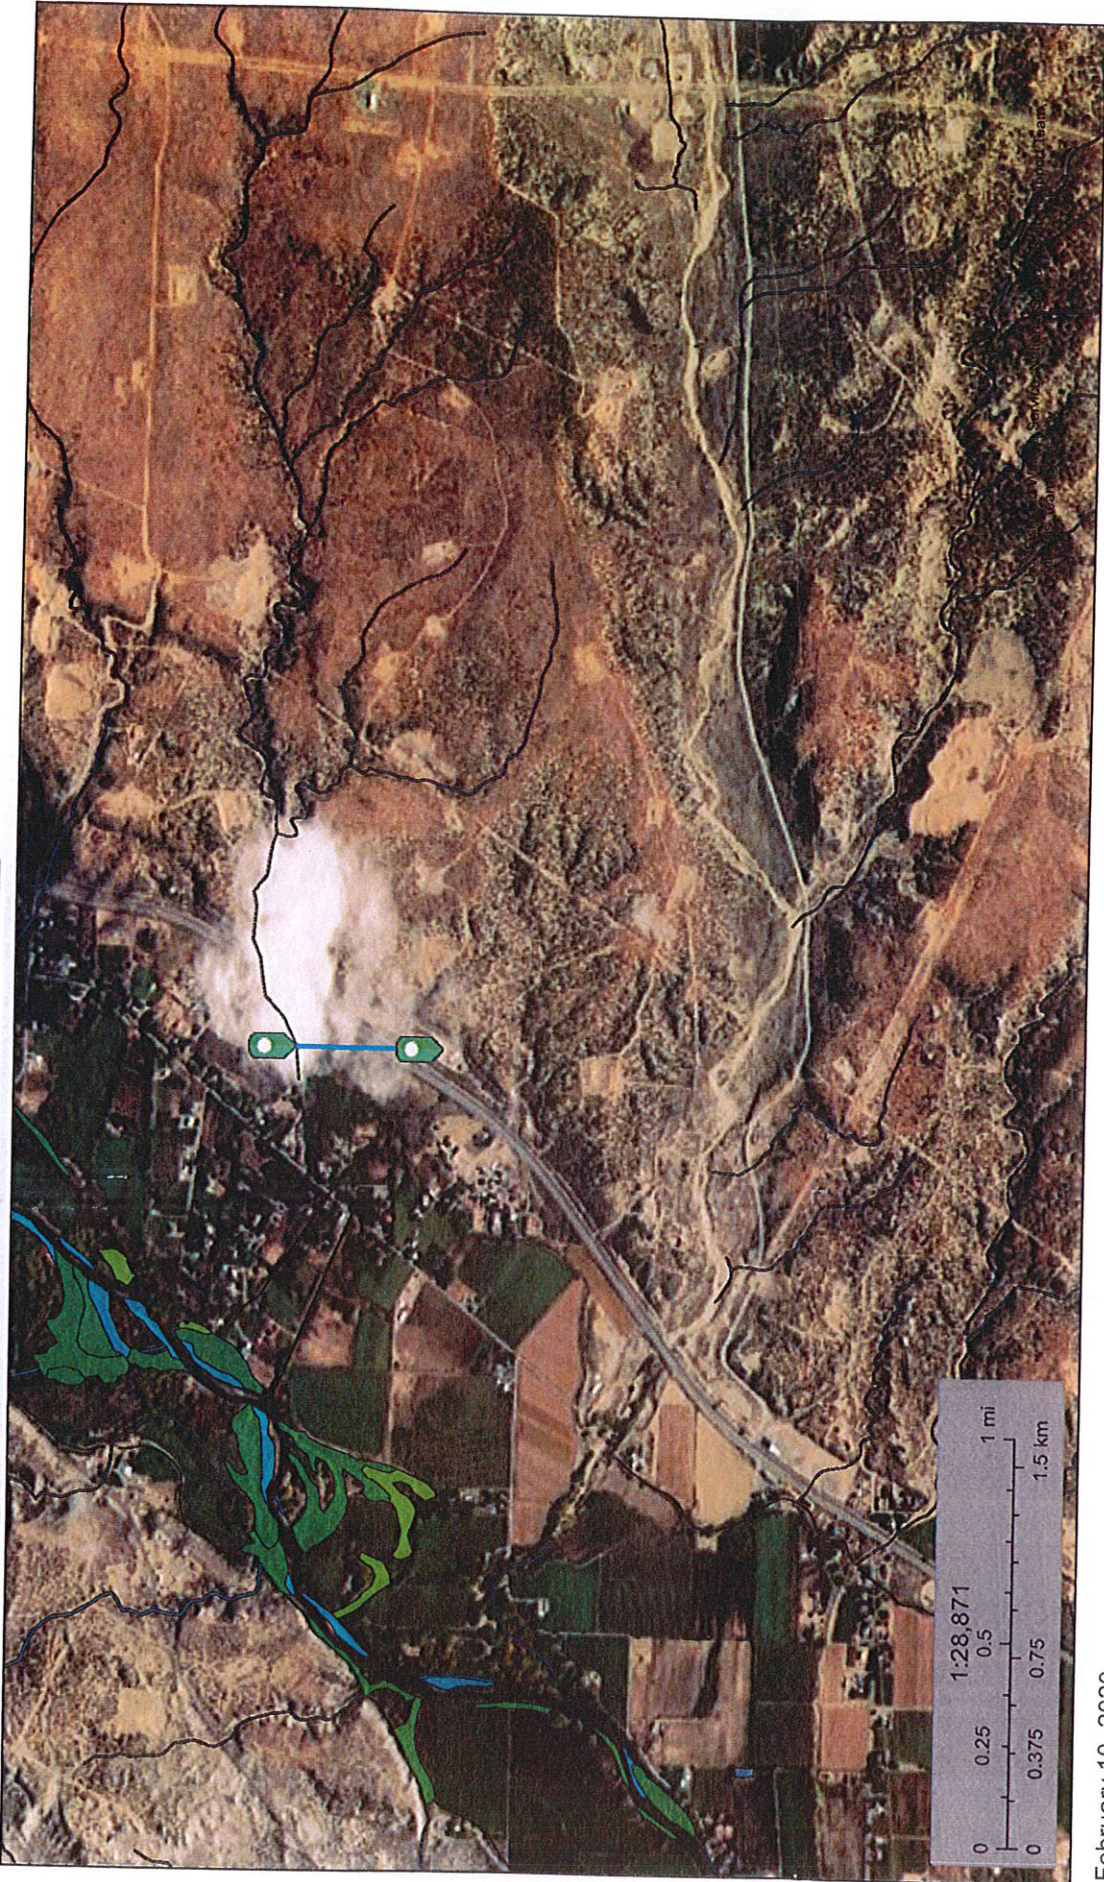
Figure 3

# Centerpoint 1/2 mile Water Sources

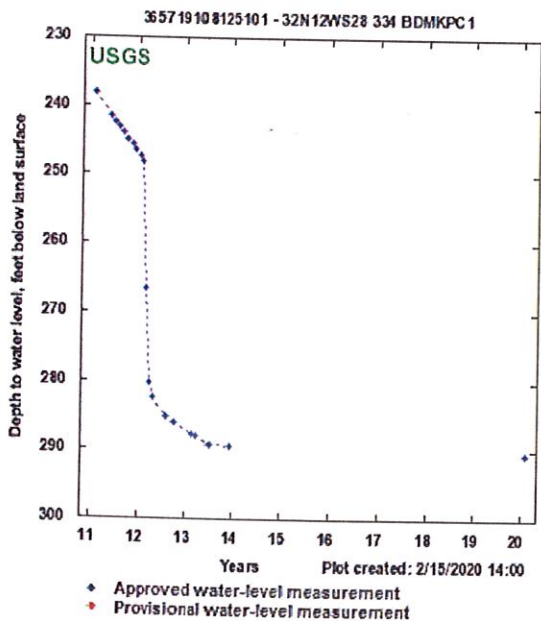
Periodic Groundwater Data

**Summary for Period of Record Periodic Water Levels**

Depth to water level, feet below land surface

Begin Date	End Date	Number of Values	
01/26/11	01/29/20	20	
Highest WL	Date of Highest WL	Lowest WL	Date of Lowest WL
238.04	01/26/11	290.5	01/29/20
