## Empire Abo Unit C49 SWD

### Closure Report

2RP-722

**RE: TERMINATION REQUEST**

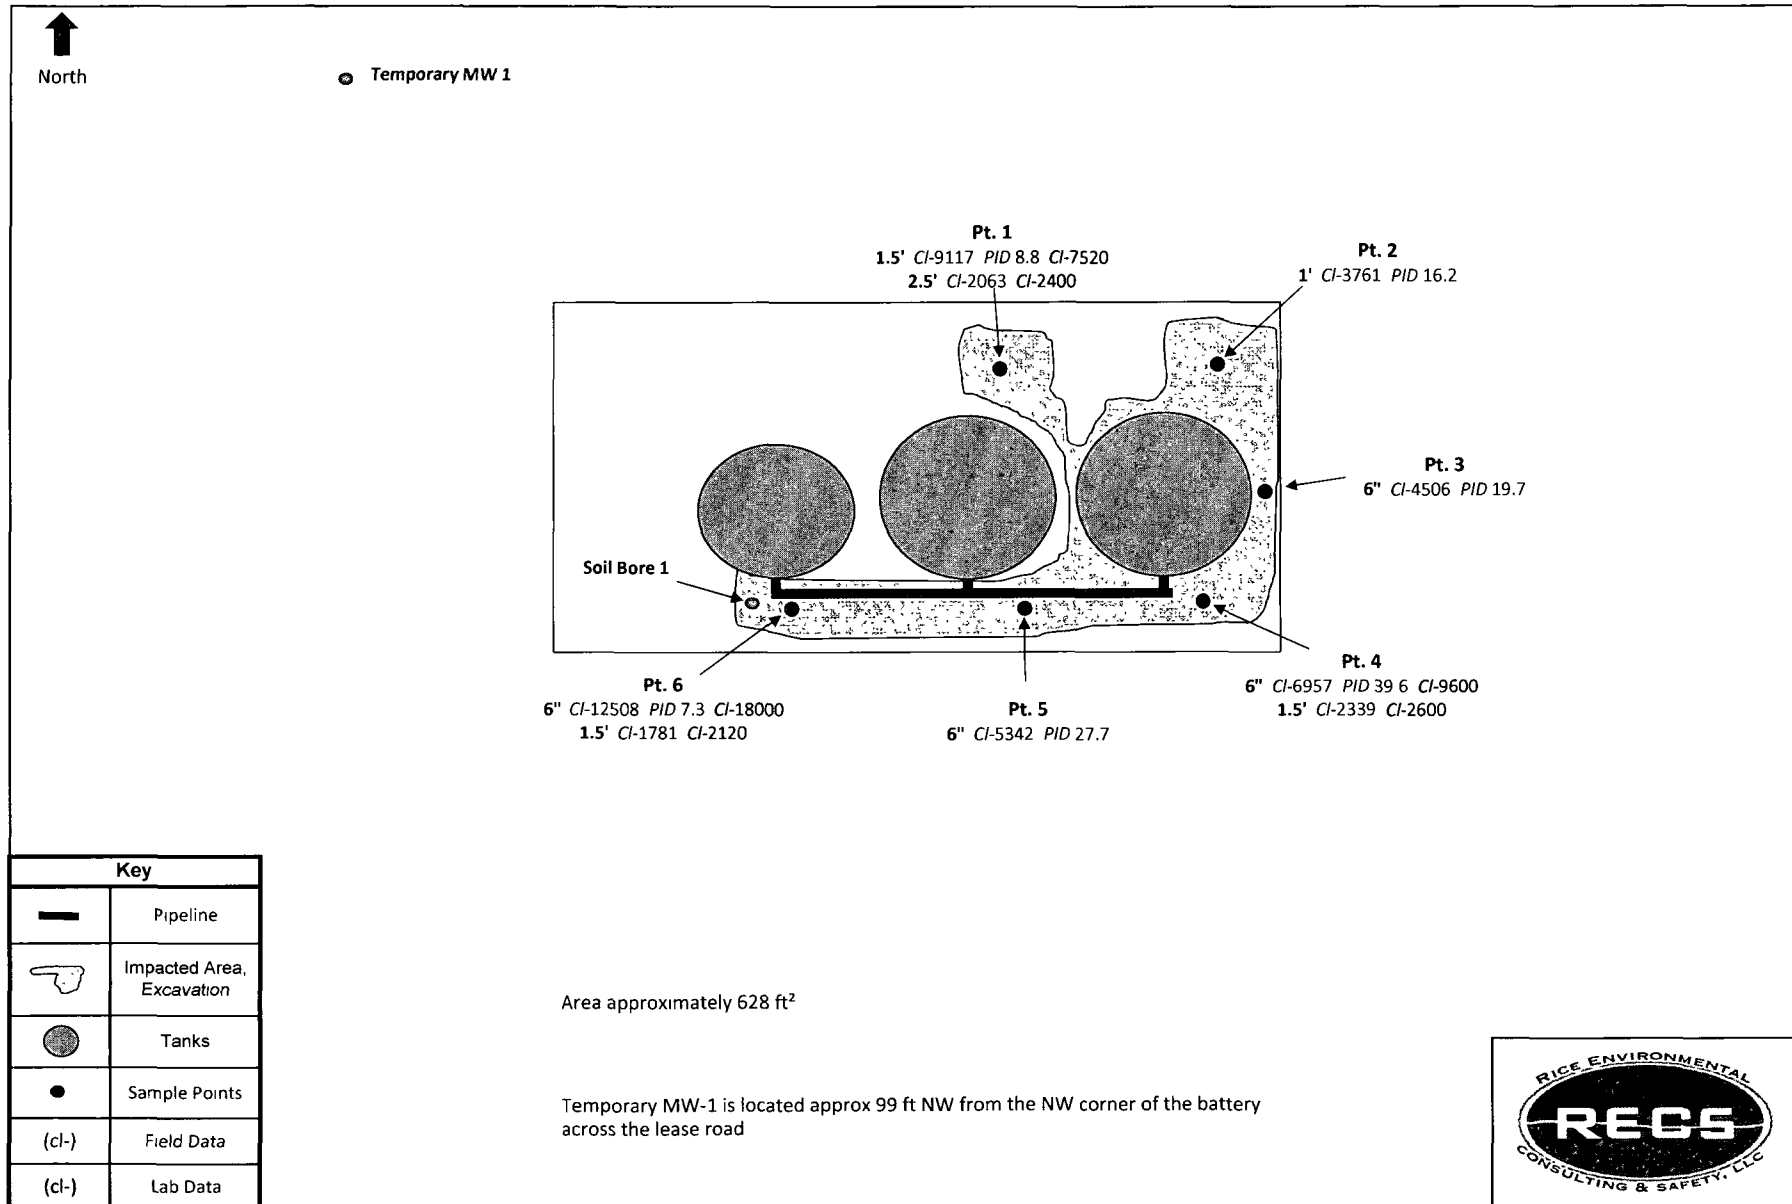
**Figure: Site Diagram with Sample Summary**  
**Apache Empire Abo C-49 SWD**

On April 11, 2011, RECS personnel initiated work on the Empire Abo C-49 SWD (See Site Photographs in Appendix C). The leak affected the east, northeast, and south portions of the containment floor from which soil samples were collected. Samples were taken from near surface and at depth and were screened for chlorides. Headspace measurements were also taken in the field using a Photo Ionization Detector (PID) (Figure). Soil samples from Pt. 1, Pt. 4, and Pt. 6 were sent to a commercial laboratory for analysis of chloride.

On April 15, 2011, a soil bore was drilled at the southwest end of the leak area to delineate vertical impact near Pt. 6 which showed the highest concentrations of chloride with 18,000 ppm (parts per million or mg/kg) at 6" bgs (below ground surface) and 2,120 ppm at 1.5 ft. bgs. From the soil bore, 5 samples were sent to a commercial laboratory for analysis of chloride, BTEX, and TPH including GRO (Gasoline Range Organics) and DRO (Diesel Range Organics). All samples were non-detect for BTEX. TPH was only present in the SB1 @ 6" sample as DRO at 43.0 ppm. Chloride in the SB1 @ 6" sample was 2,800 ppm, SB1 @ 6 ft. was 288 ppm, SB1 @ 9 ft. was 208, SB1 @ 12 ft. was 160 ppm, and SB1 @ 18 ft. was 64 ppm (Appendix D).

The impacted area was excavated using a shovel crew due to proximity and array of equipment and underground utilities. The area of Pt.1 was excavated to 1.5 ft. bgs and the remaining area from 6 inches to 1 ft. bgs. A total of 72 cubic yards of impacted soil was removed from the leak area and transported to a NMOCD approved facility for disposal. The excavation was backfilled with 125 cubic yards of clean imported caliche and contoured to the battery floor.

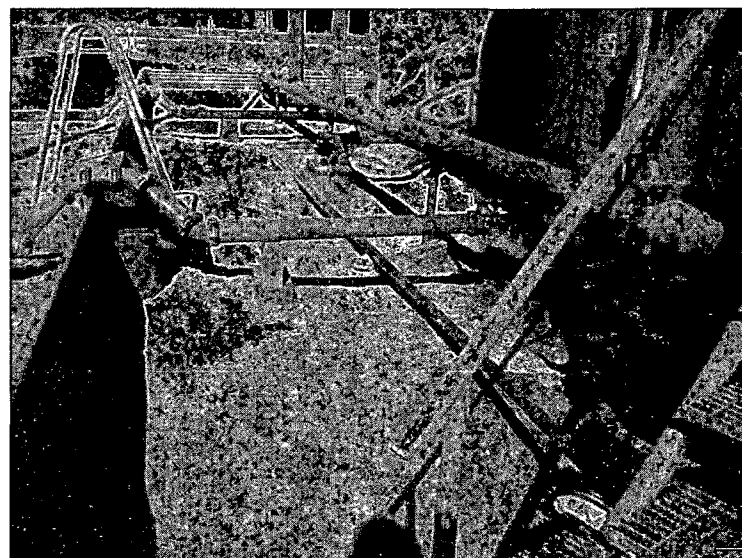
Initial Impacted Area Excavation, Facing W 4/11/2011

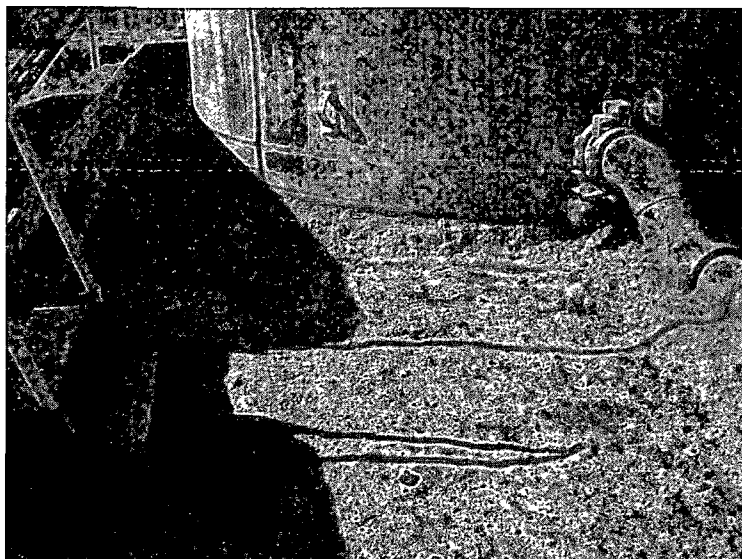
Initial Impacted Area Excavation, Facing S 4/11/2011

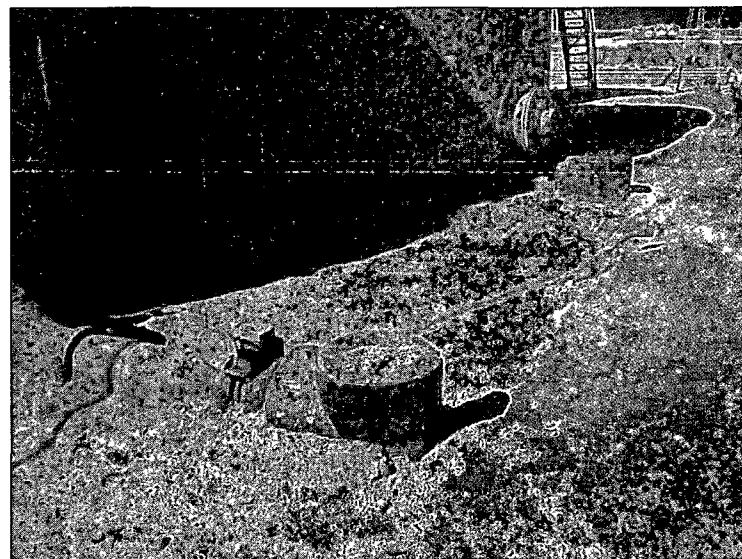
Initial Impacted Area Excavation, Facing W 4/11/2011

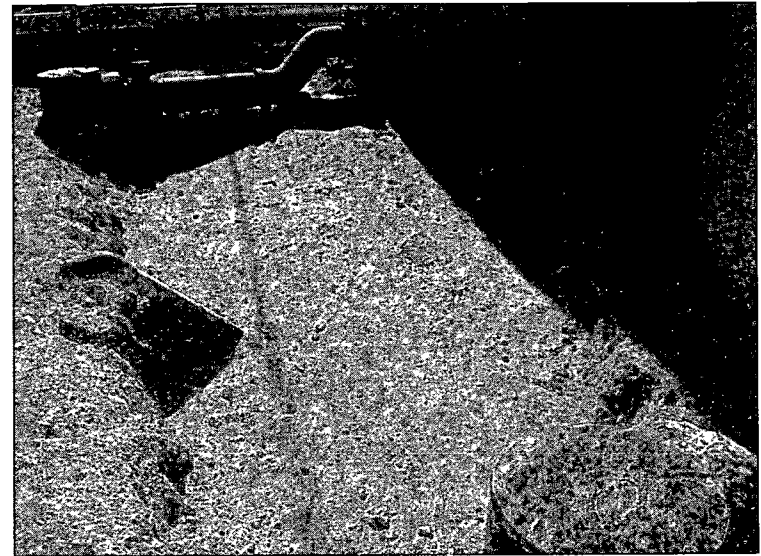
Initial Impacted Area Excavation, Facing E 4/11/2011

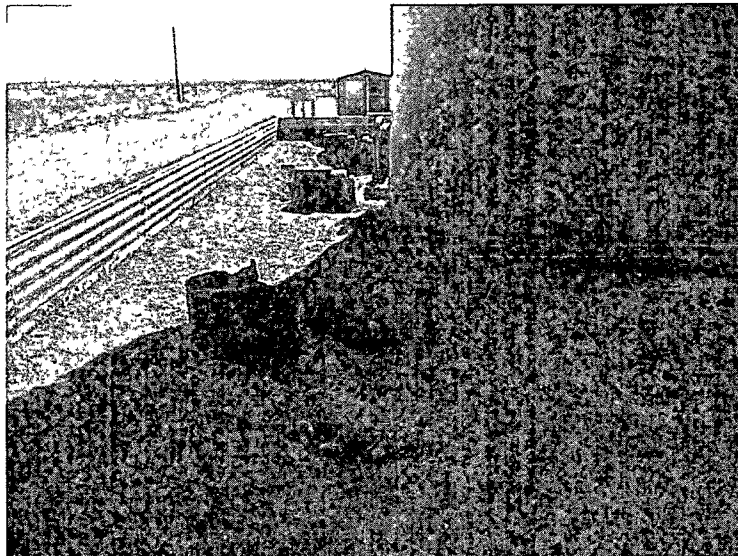
Initial Impacted Area Excavation, Facing E 4/11/2011

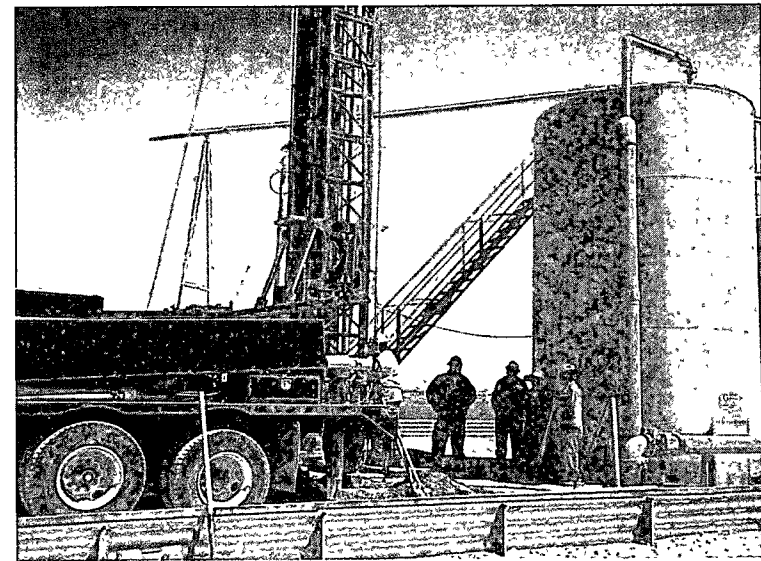
4/15/2011

Drilling Soil Bore 1, Facing N

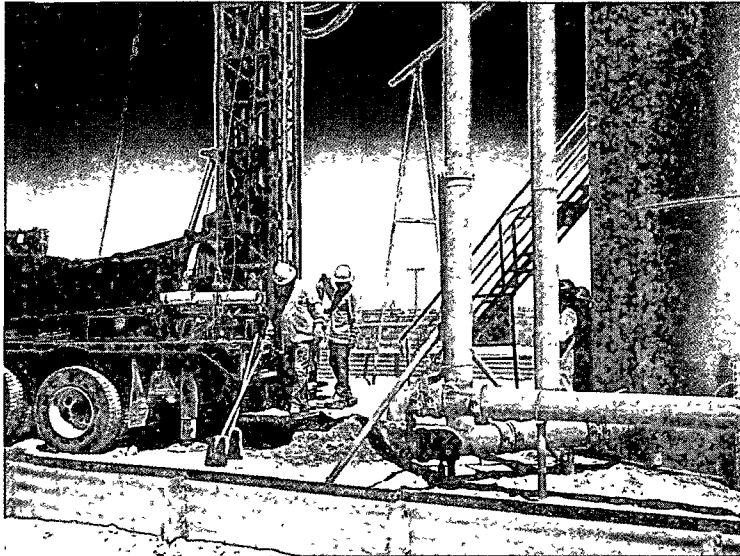
4/15/2011

Drilling Soil Bore 1, Facing NW

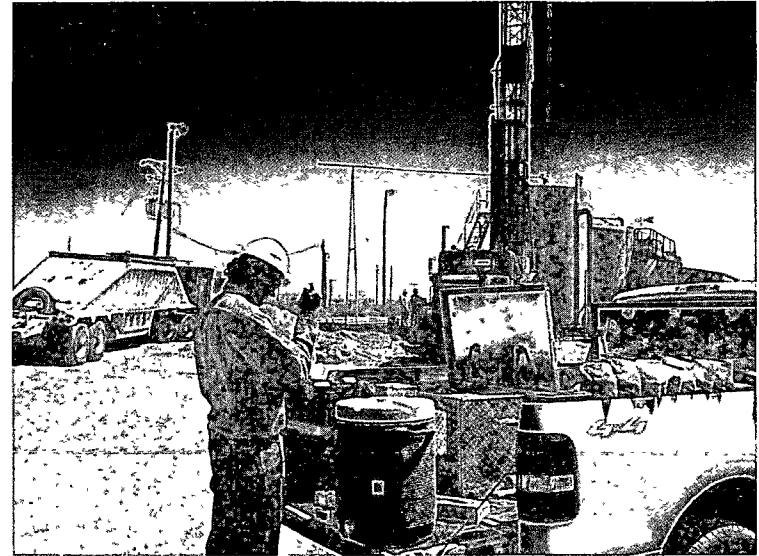
4/15/2011

Field Testing Soil Samples, Facing E

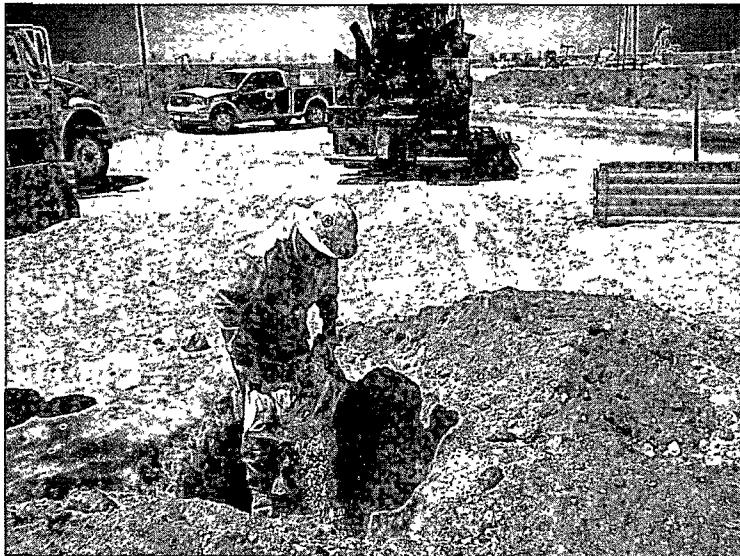
4/15/2011

Plugging Soil Bore, Facing W

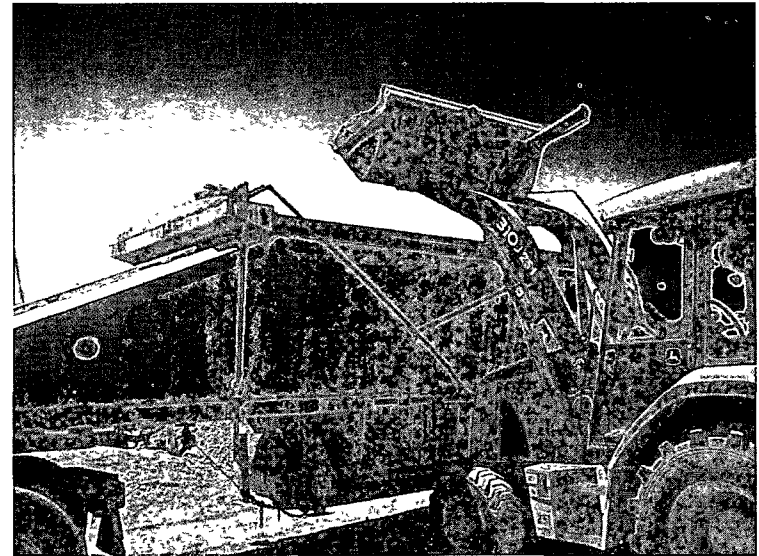
4/15/2011

Removing Soil, Facing SW

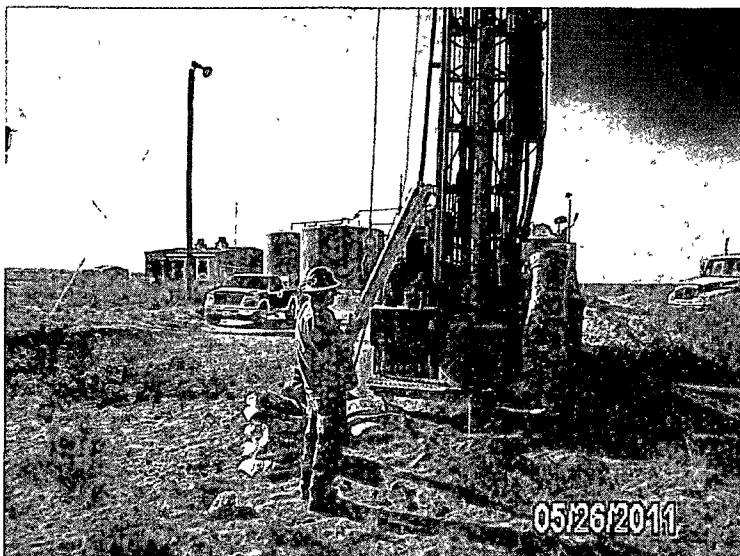
5/26/2011

On May 26, 2011, a temporary monitor well was drilled northwest of the leak site to verify the existence of groundwater (Appendix B). A red bed clay formation was encountered from 40 ft. to 55 ft. bgs and drilling ceased at 100 ft. bgs. The temporary well was set with 2 inch PVC casing and screen from 80 ft. to 100 ft. bgs to allow potential groundwater to accumulate. On June 28, 2011, RECS personnel used a Solinst Water Level Meter to verify any accumulation of groundwater. No water was detected within the borehole at the total depth of 99.12 ft. bgs. On July 7, 2011, RECS personnel removed the monitoring well casing and plugged the borehole with bentonite.

Drilling Temporary MW, Facing SE

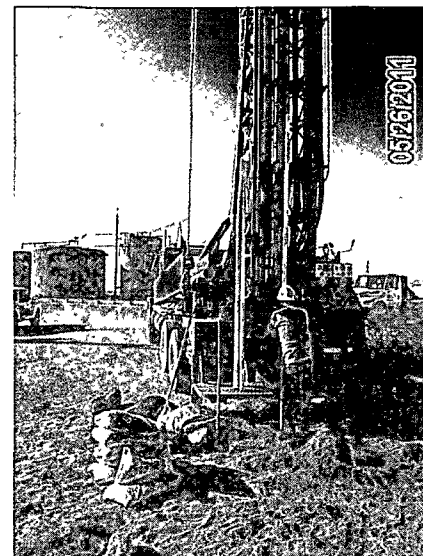
5/26/2011

Installing Casing, Facing SE

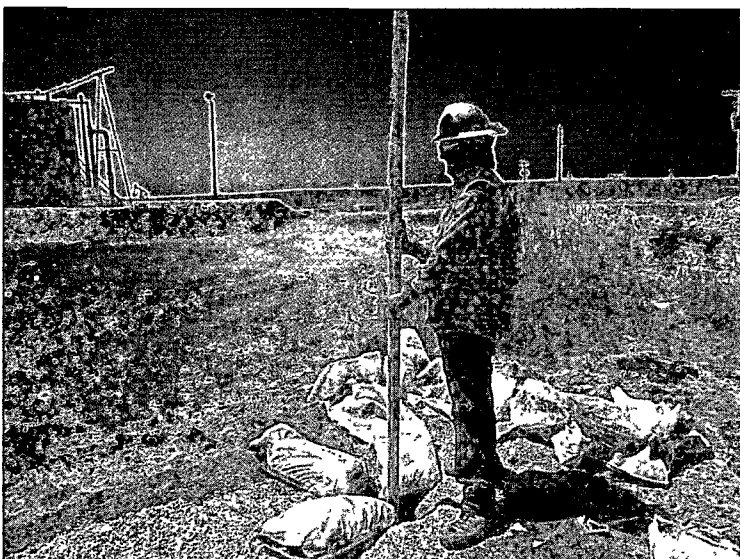
Removing Casing, Facing S

Client	Apache Corp.
Contractor	RECS
Date Completed	7/7/2011
Site	Empire Abo Unit C-49 SWD
County	Eddy
Legal Description	UL/L sec. 29 T17S R29E
Well ID	Temp. MW-1
Casing Diameter	2"
Well Depth	100'
Casing Material	PVC
Plugging Material	Bentonite

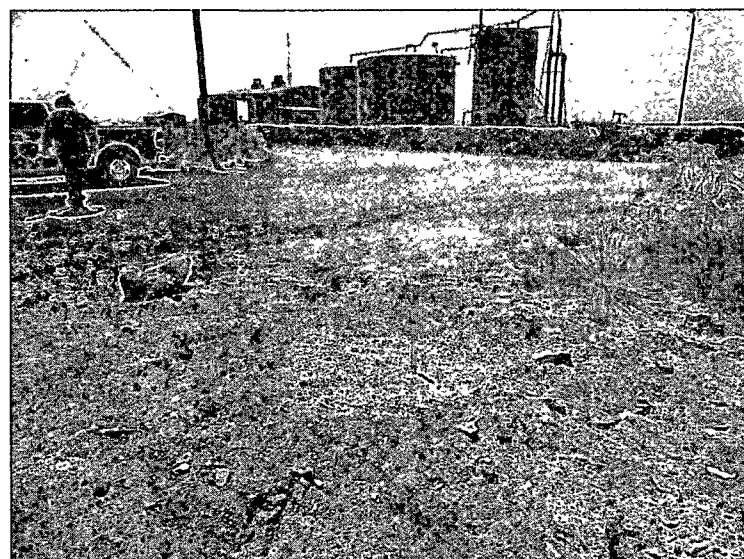
7/7/2011

Plugged and Staked, Facing SE
