**Vacuum Mobil State 'P' EOL**

RICE OPERATING COMPANY  
JUNCTION BOX CLOSURE REPORT

**RE: "Investigation and Characterization Plan Report"  
for the Rice Operating Company's  
Vacuum SWD State P EOL Site  
Unit Letter A, Section 26, T17S, R58E, Lea County, New Mexico  
Remediation Plan (1R0425-26) Termination**

**RE: Investigation and Characterization Plan Report  
Rice Operating Company – Vacuum SWD System  
State P EOL: T 17S R 35E Section 26 Unit A  
OCD Case No.: 1R425-26**

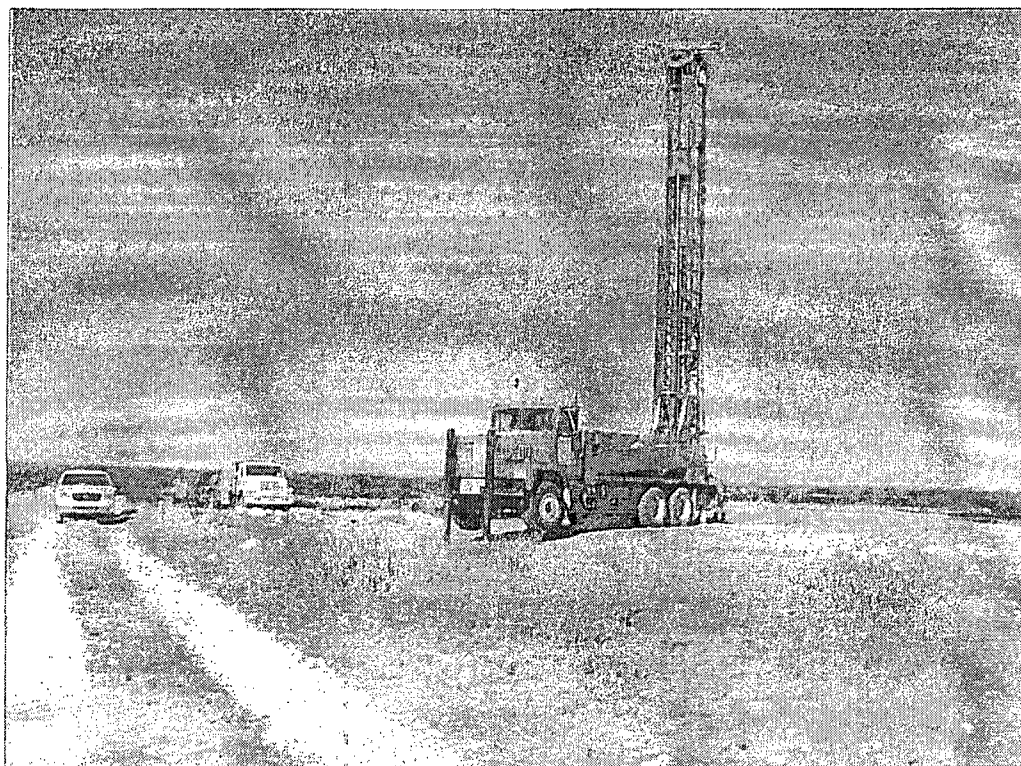
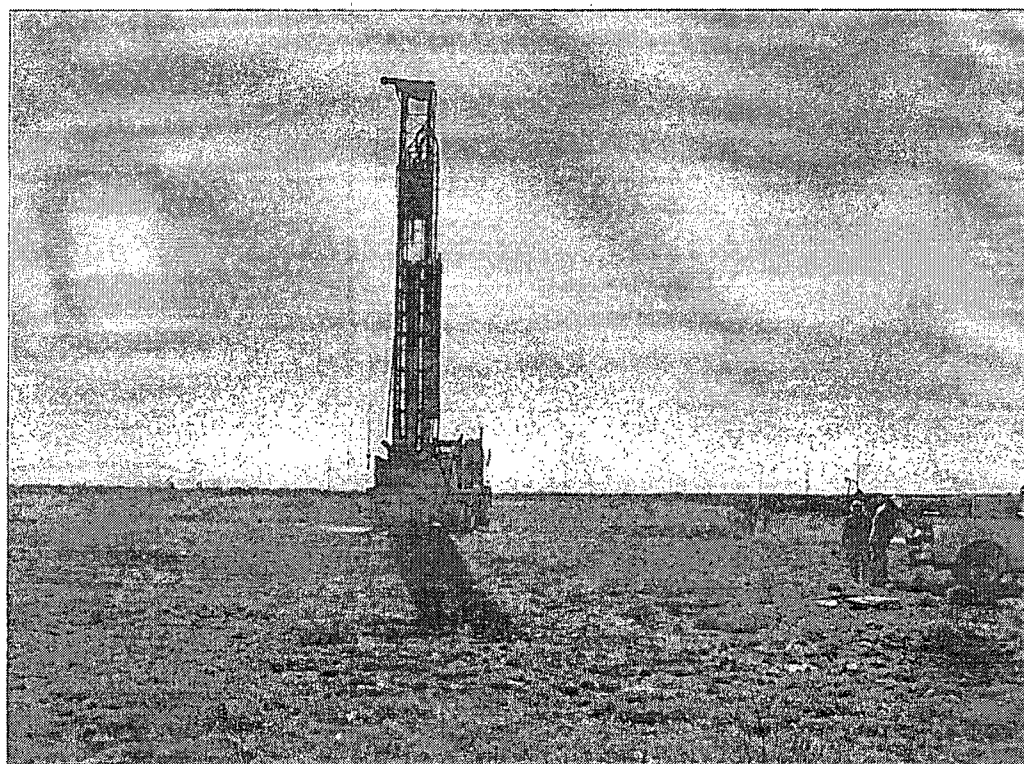
Figures 1a (above) & 1b (below) – Harrison & Cooper drill rig at VAC State P EOL on February 22<sup>nd</sup>, 2008.

A soil boring was advanced at the former junction box location using an air rotary bit on February 22nd of this year (Figure 1). Samples were analyzed at five foot increments and field titrated for chlorides (Table 1). Two sub-samples were sent to Cardinal Laboratories for a quality-check of the field results (Figures 2a & 2b). Soil chlorides concentrations dropped quickly from above 1,000 ppm (parts per million) at 20 and 25 ft bgs (below ground surface), to below 1,000 ppm at 30 ft bgs and then below 200 ppm from 40 ft bgs to the limit of drilling at 55 ft, where the capillary fringe was encountered.

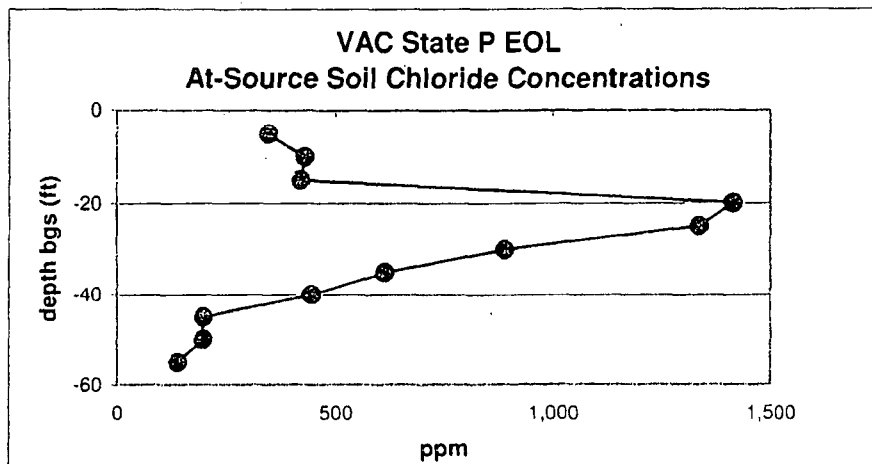
**Table 1** – Soil boring log and chemical parameters at the site of the former junction box at EME L-15-1.

<u>Depth (ft)</u>	<u>Field</u>	<u>Lab</u>				
<u>below</u>	<u>Chloride</u>	<u>Chloride</u>	<u>Field PID</u>	<u>Lab GRO</u>	<u>Lab DRO</u>	
<u>ground</u>	<u>Test (ppm)</u>	<u>Test (ppm)</u>	<u>test (ppm)</u>	<u>test (ppm)</u>	<u>test (ppm)</u>	<u>Cutting Description</u>
<u>surface)</u>						
-5	346		n/a			tan caliche backfill
-10	429		"	15	1,190	"
-15	419		"			"
-20	1,414	1,440	"			"
-25	1,336		"			light tan caliche
-30	889		"			light brown sand
-35	612		"			light brown fine gravelly sand
-40	445		"			light brown fine sand
-45	197		"	70	288	"
-50	196		"			brown loamy sand
-55	139	128	"			brown loamy sand, damp

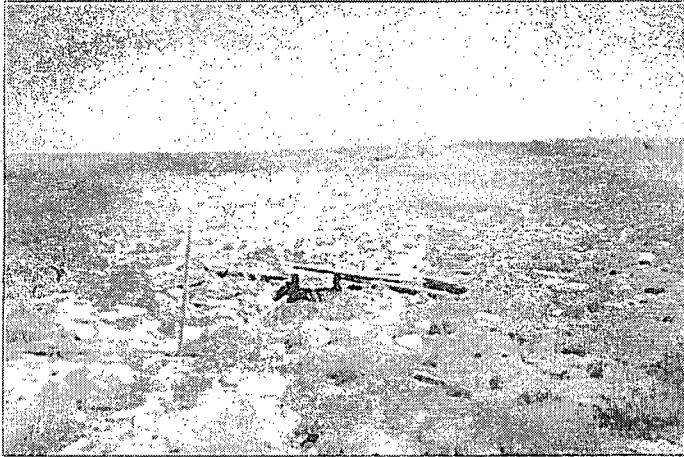
Junction box prior to excavation: 7/11/2005

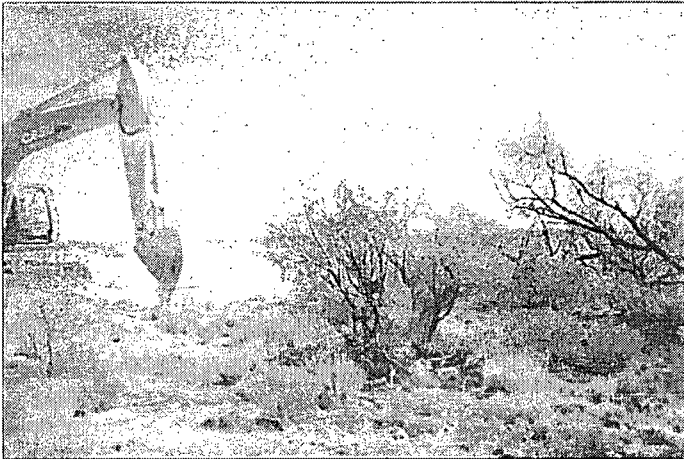
Beginning delineation with trackhoe: 8/2/2005

**General Description of Remedial Action:** This junction box was addressed as part of the abandonment of the Vacuum SWD system. After the box lumber was removed, the site was delineated using a trackhoe to collect soil samples at regular intervals, producing a 30 x 20 x 12-ft-deep excavation. Chloride and organic vapors were measured in the field for each sample. All PID readings yielded very low concentrations (<10 ppm), however, chloride concentrations increased with depth. The excavated soil was blended on site and then returned to the hole up to 6 ft BGS where a 1-ft-thick clay barrier was installed. The remaining fill was placed on top of the clay. Additional fill was needed so clean, imported fill was used to backfill the remainder of the excavation. An identification plate was placed on the surface of the site to mark the location of the former junction for future environmental consideration and the presence of the clay below. The disturbed surface was seeded with a blend of native vegetation on 4/24/2006 and is expected to return to productive capacity at a normal rate. On 4/3/2006, OCD was notified of potential groundwater impact at this site. ROC has retained the consultant, L. Peter Galusky Jr., Ph.D. to address environmental concerns at this site.

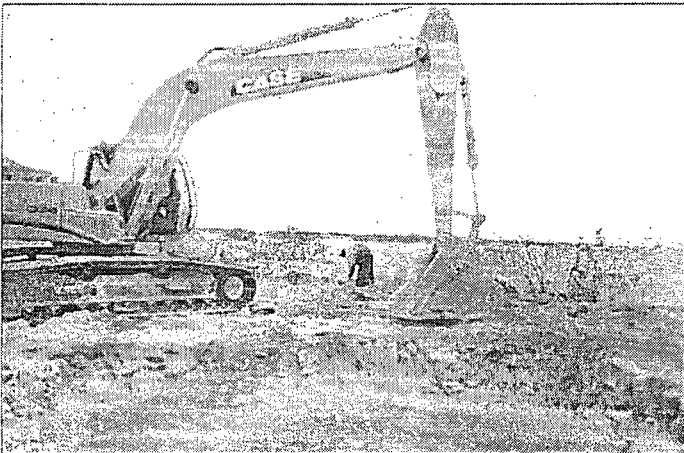
Collecting soil samples from excavation: 3/23/2006

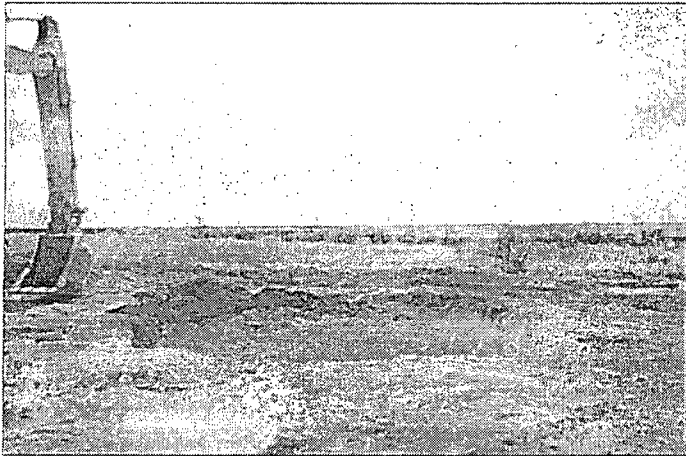
Final 30 x 20 x 12 ft deep excavation

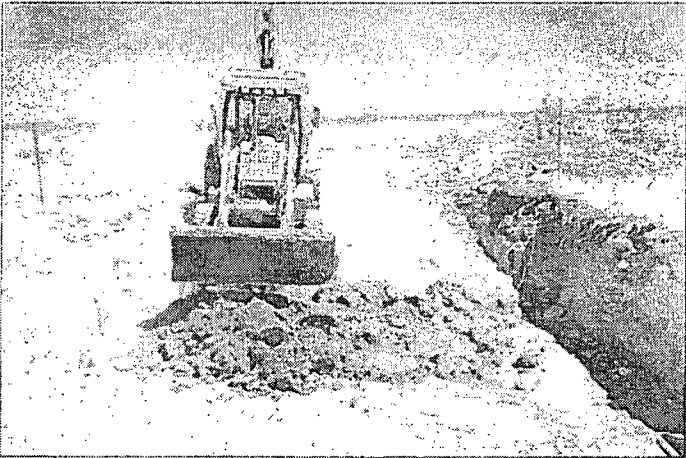
Installing clay barrier at 6 ft: 4/13/2006

The relatively low levels of chlorides found in the twenty feet of unsaturated material above the water table and the impedance against downward movement of chlorides provided by the compacted clay barrier (installed following the removal of the former junction box) indicate that the former junction box at this location does not pose a threat to groundwater; (see middle photo on page 12 and cross section on page 14). On behalf of my client, Rice Operating Company, I therefore request that this project be considered "closed" and dropped from OCD's list of potentially impacted sites.
