# WORKPLANS

**RE: ICP Report and Corrective Action Plan (CAP)  
Rice Operating Company – EME SWD System  
EME L-34 (1R427-04): UL/L sec. 34 T20S R36E**

**EME L-34**

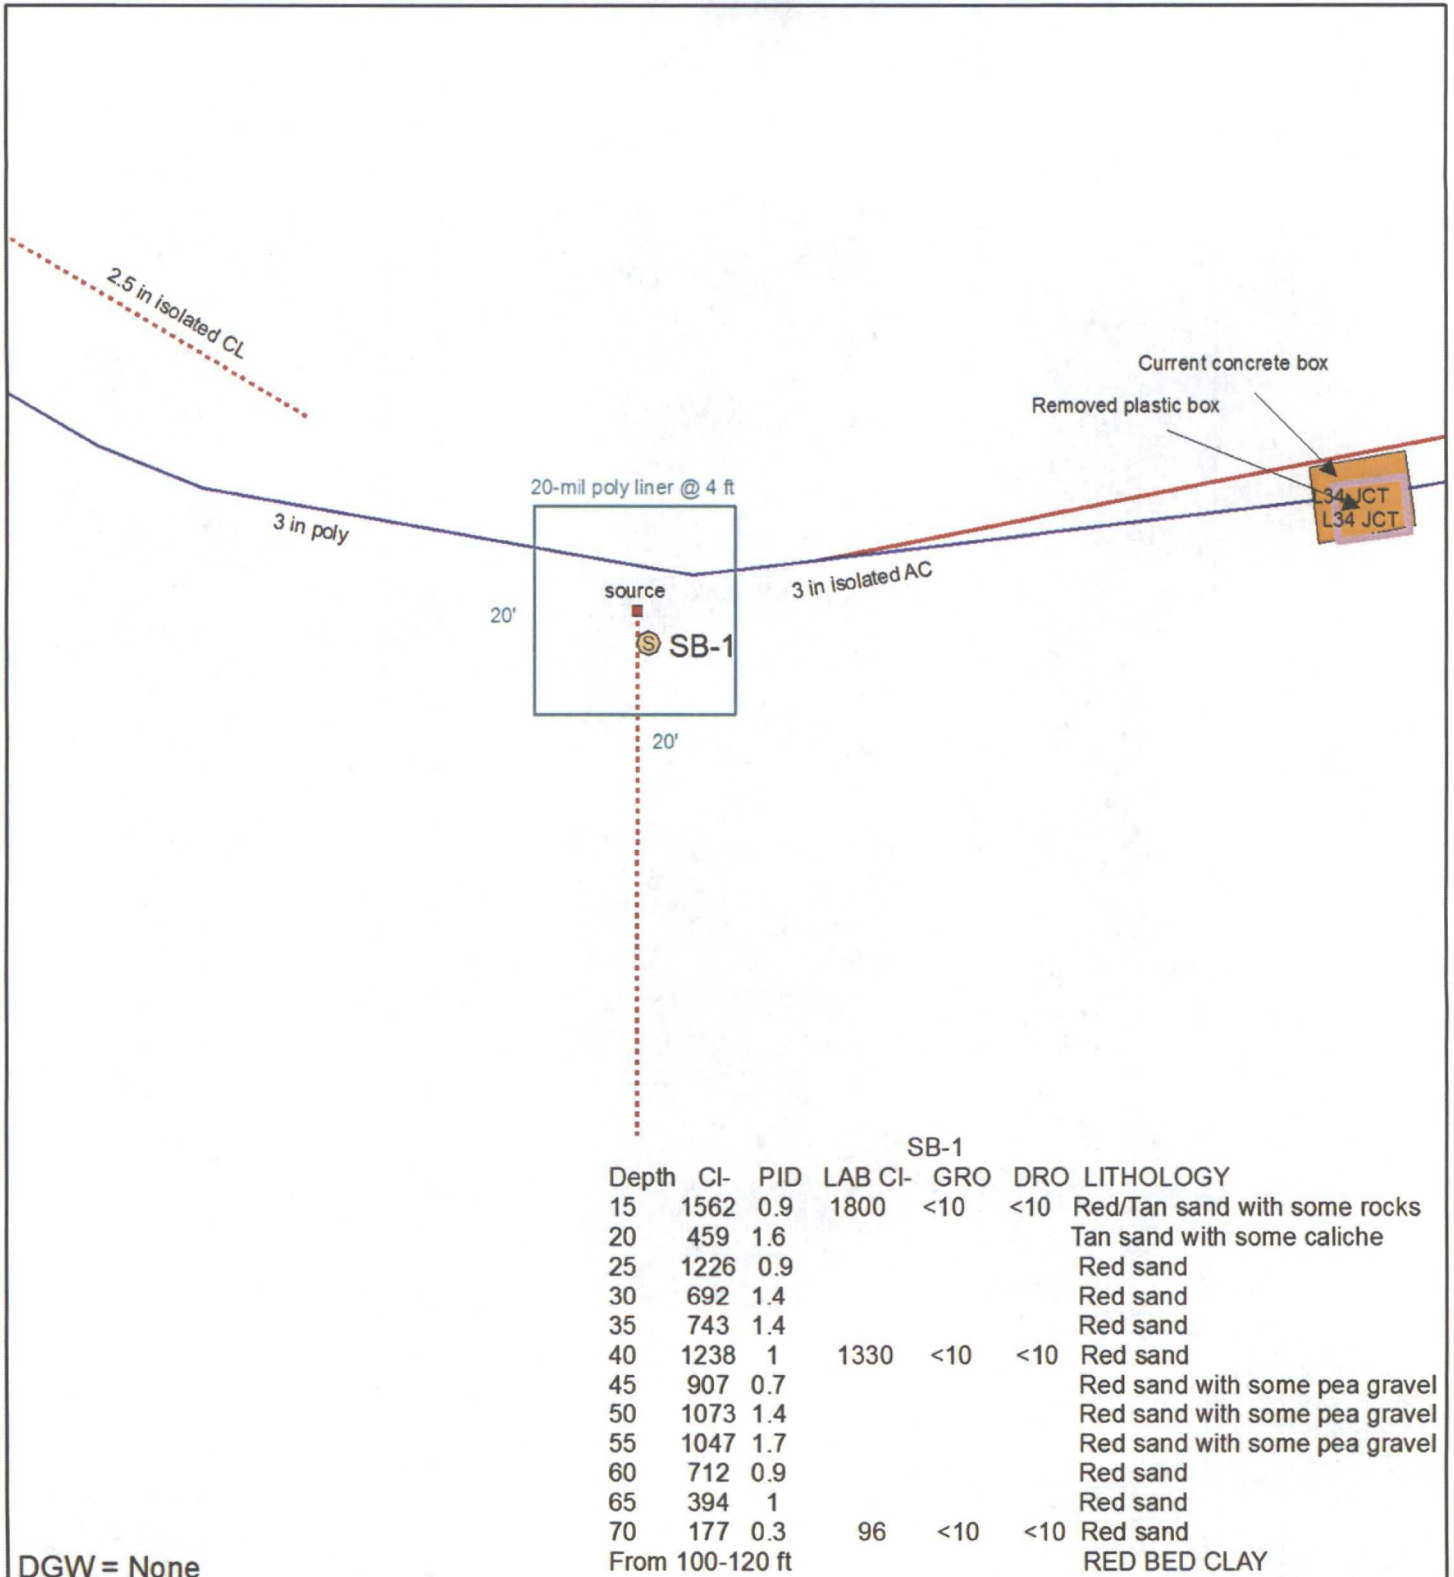
Figure 2

As part of the Investigation and Characterization Plan (ICP) approved by NMOCD on November 17<sup>th</sup>, 2011, one soil bore was advanced through the former junction box site to a depth of 120 ft bgs on December 13<sup>th</sup>, 2011 (Figure 2). RECS personnel field tested the soil at regular intervals to a depth of 70 ft bgs for chlorides and screened in the field with a photo-ionization detector for hydrocarbons. Representative samples from the bore were taken to a commercial laboratory for confirmation of chloride and hydrocarbon field numbers (Appendix A). Laboratory chloride numbers peaked at 15 ft bgs with a reading of 1,800 mg/kg and declined to 96 mg/kg at 70 ft bgs. GRO and DRO laboratory readings were non-detect throughout the bore. Even though the bore attained appropriate chloride levels at 70 ft bgs, the bore was advanced to 120 ft to determine depth to groundwater. Red bed clay was encountered at approximately 100 ft bgs which indicated the bottom of the aquifer. Since no groundwater was encountered, the bore was advanced to approximately 120 ft bgs and packed open for 48 hours to allow any possible groundwater to accumulate. On December 15<sup>th</sup>, 2011, Harrison & Cooper Drilling, Inc. were on site to gauge the bore for groundwater accumulation. They found no water in the bore (Appendix B).
