**RE: CAP Report and Termination Request  
Rice Operating Company – EME SWD System  
EME B-7 (1R427-164): UL/B sec. 7 T20S R37E**

- Figure 1 – Site Location Map
- Figure 2 – NMOCD Approved Liner
- Appendix A – CAP Liner Installation Documentation
- Appendix B – Plug and Abandon of MW-1 and MW-3

CAP Liner Installation Documentation

Plug and Abandon of MW-1 and MW-3

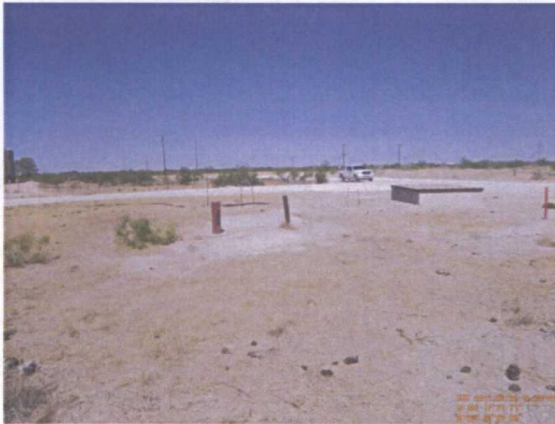
site prior to excavation, facing west

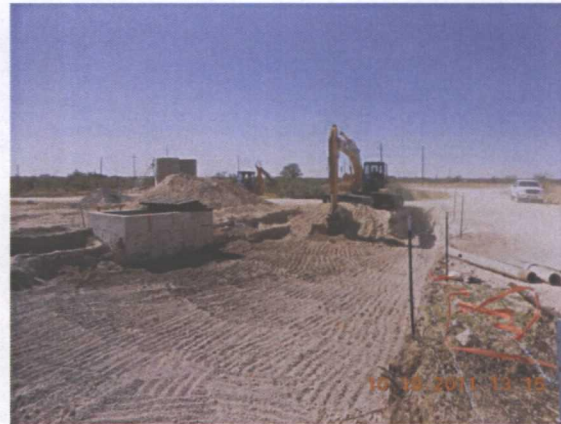
excavating the site, facing east

On October 13<sup>th</sup>, 2011, RECS personnel were on site to begin the liner excavation and installation. The site was excavated to 73 ft x 98 ft x 5 ft bgs. A total of 412 yards of the excavated soil was taken to a NMOCD approved facility for disposal. The remaining excavated soil was blended on site to use as backfill. A sample of this blended backfill was screened in the field for hydrocarbons with a result of 3.3 ppm. The sample was then taken to a commercial laboratory for analysis of chloride which returned a result of 304 mg/kg. A total of 668 yards of clean sand was imported to the site for use to pad the liner and as the remaining backfill. A sample of this imported sand was screened in the field for hydrocarbons with a result of 0.2 ppm. The sample was then taken to a commercial

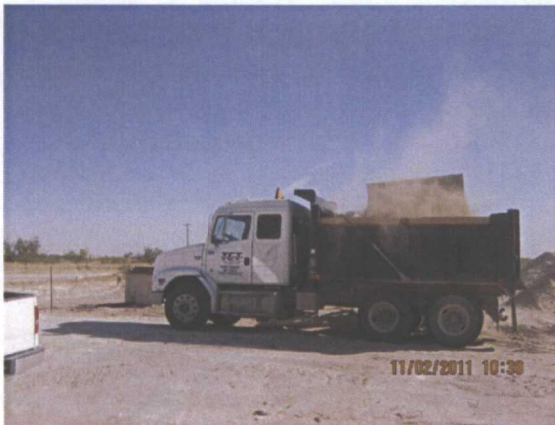
exporting excavated soil, facing east

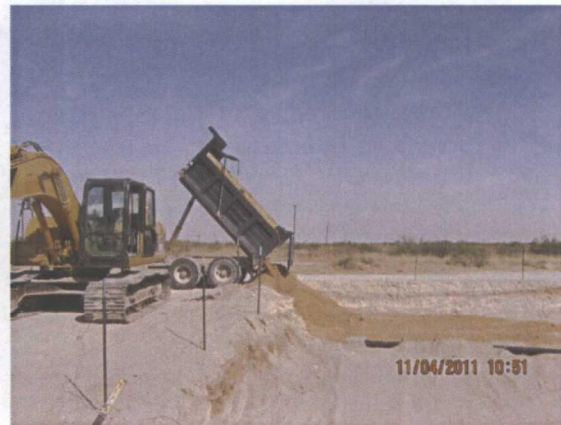
importing blow sand to pad the excavation,  
facing north

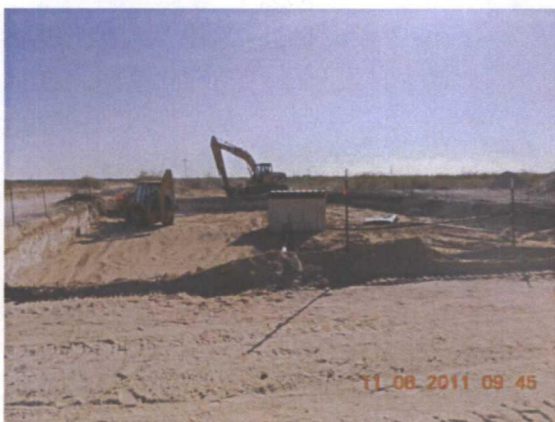
73x98 ft excavation complete with a 6 inch blow  
sand pad, facing east

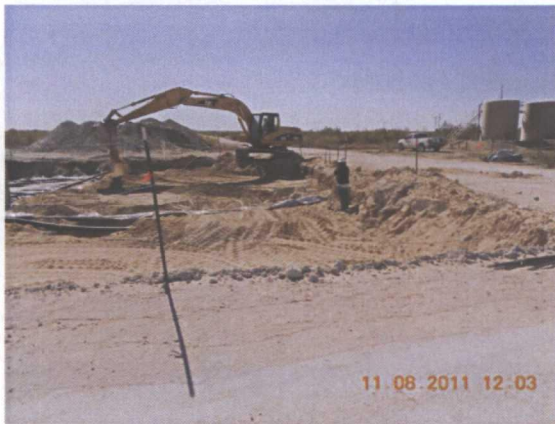
padding the south liner with 6 inches of blow sand, facing south

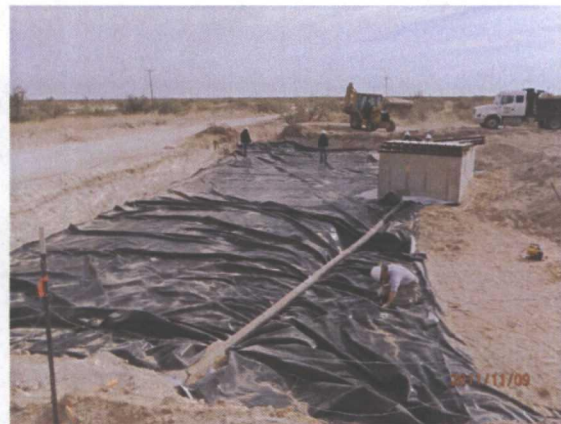
installing the north half of the 20-mil reinforced liner, facing east

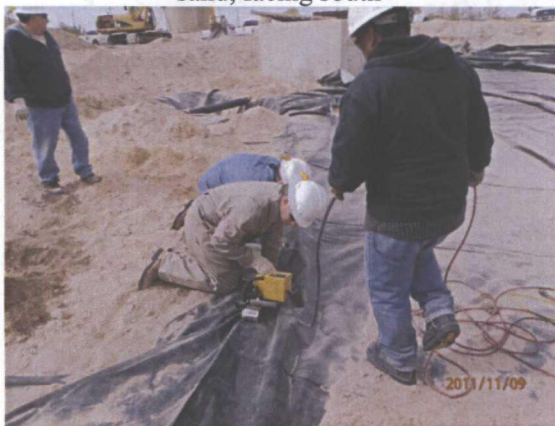
fusing the north and the south liners, facing west

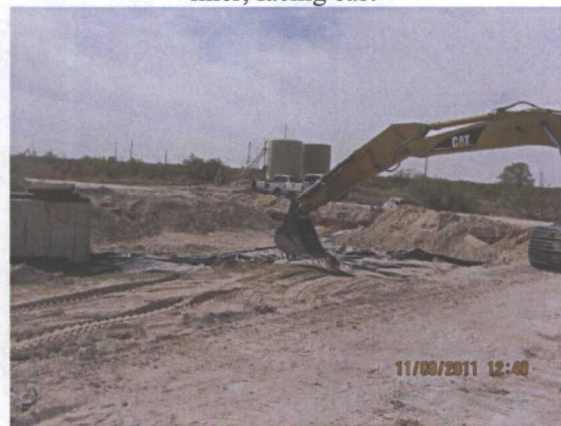
padding the north liner with 6 inches of blow sand, facing southwest

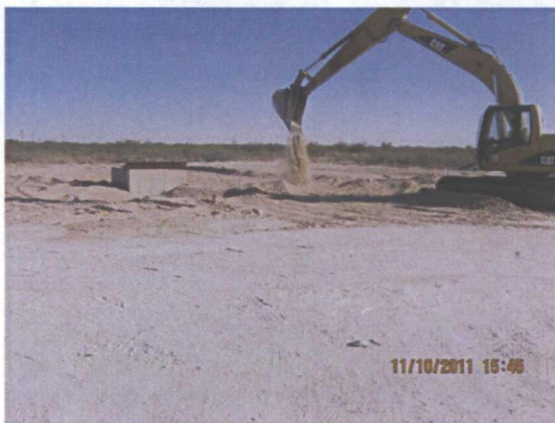
backfilling the excavation, facing east

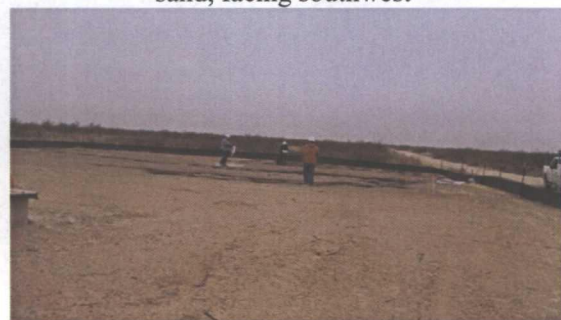
adding soil amendments to the backfilled site, facing west 12/2/2012

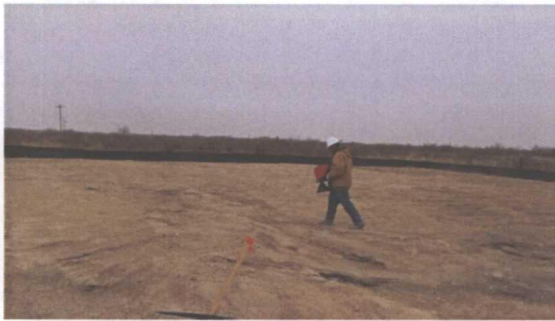
seeding the backfilled site with winter wheat,  
facing southeast 12/2/2011

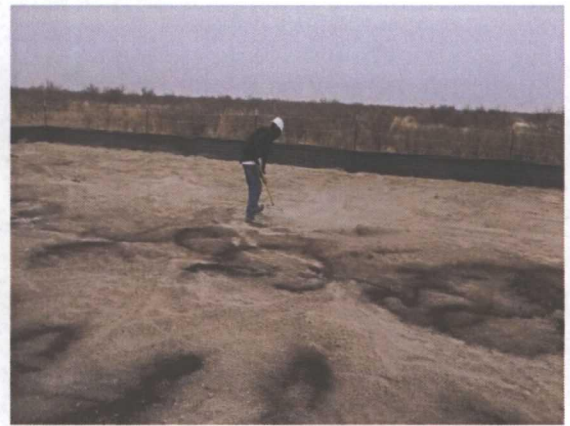
raking in seed and soil amendments, facing south  
12/2/2012

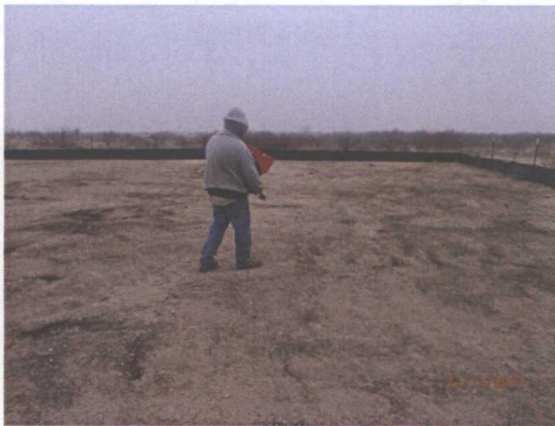
seeding the backfilled site with blue grama,  
facing east

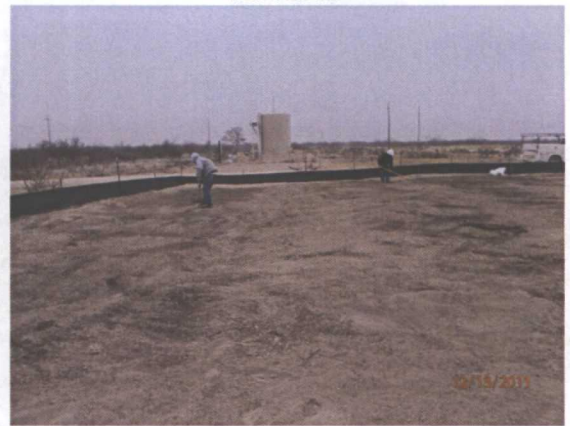
raking in seed, facing west

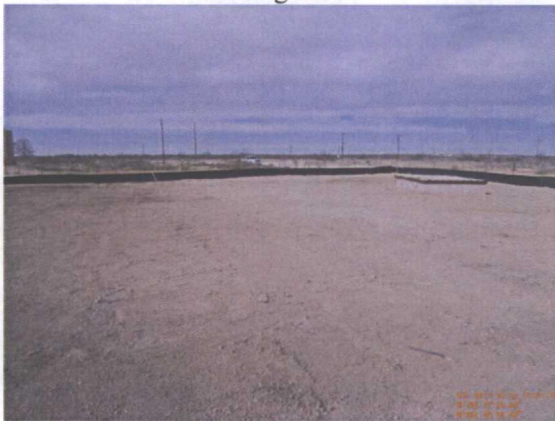
site complete, facing west

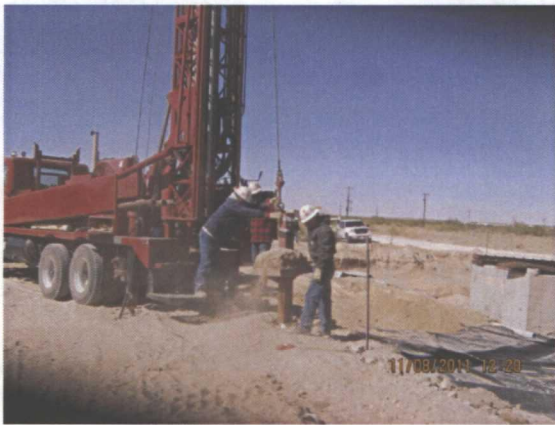
Pulling MW-1, facing northwest 11/8/11

On November 8<sup>th</sup>, 2011, MW-1 and MW-3 were plugged and abandoned with a concrete grout with 1-3% bentonite and a 3 foot cement cap. Documentation of this can be found in Appendix B. The up-gradient well, MW-2, will remain open and will be used to monitor regional groundwater impact in the area.

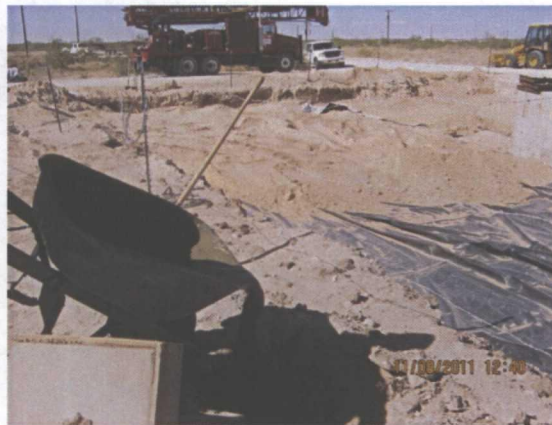
Plugging MW-1 with a 1 – 3% bentonite/concrete slurry, facing northwest 11/8/11

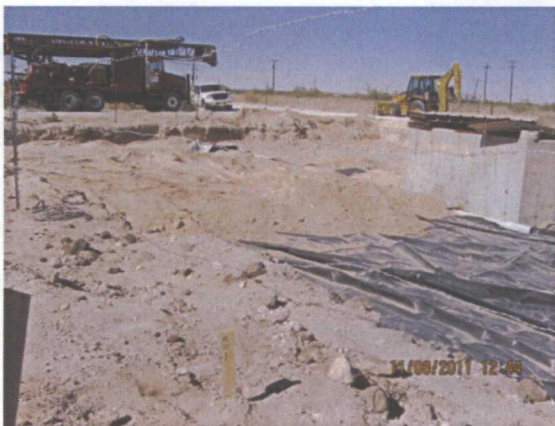
MW-1 plugged, facing northwest 11/8/11

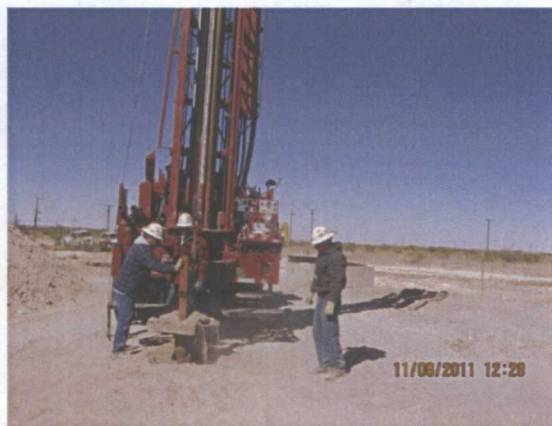
Pulling MW-3, facing northwest 11/8/11

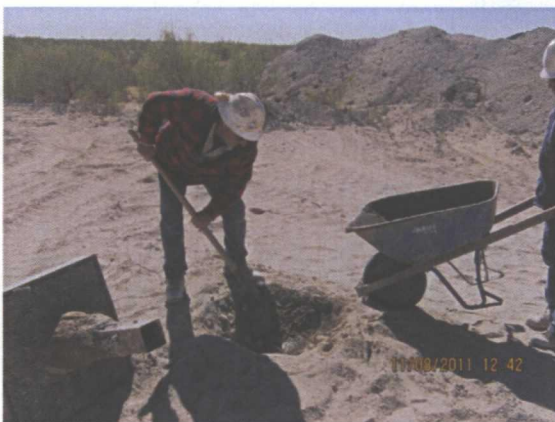
Plugging MW-3 with a 1 – 3% bentonite/concrete slurry, facing south 11/8/11

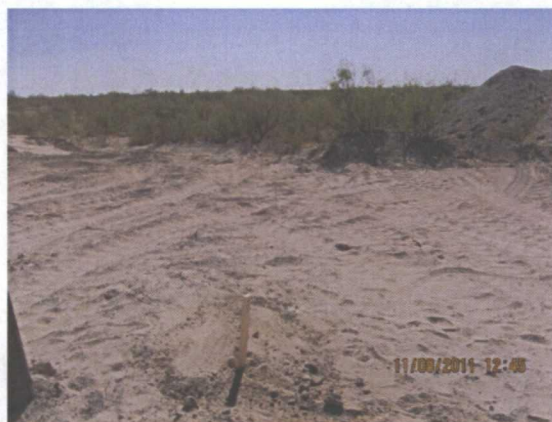
MW-3 plugged, facing south 11/8/11
