Koonunga Hill BGX Federal #1
Water Line
30-015-26914

Section 13, T22S-R25E
Eddy County, NM

SAMPLE DIAGRAM (Not to Scale)

Analytical Report 434596

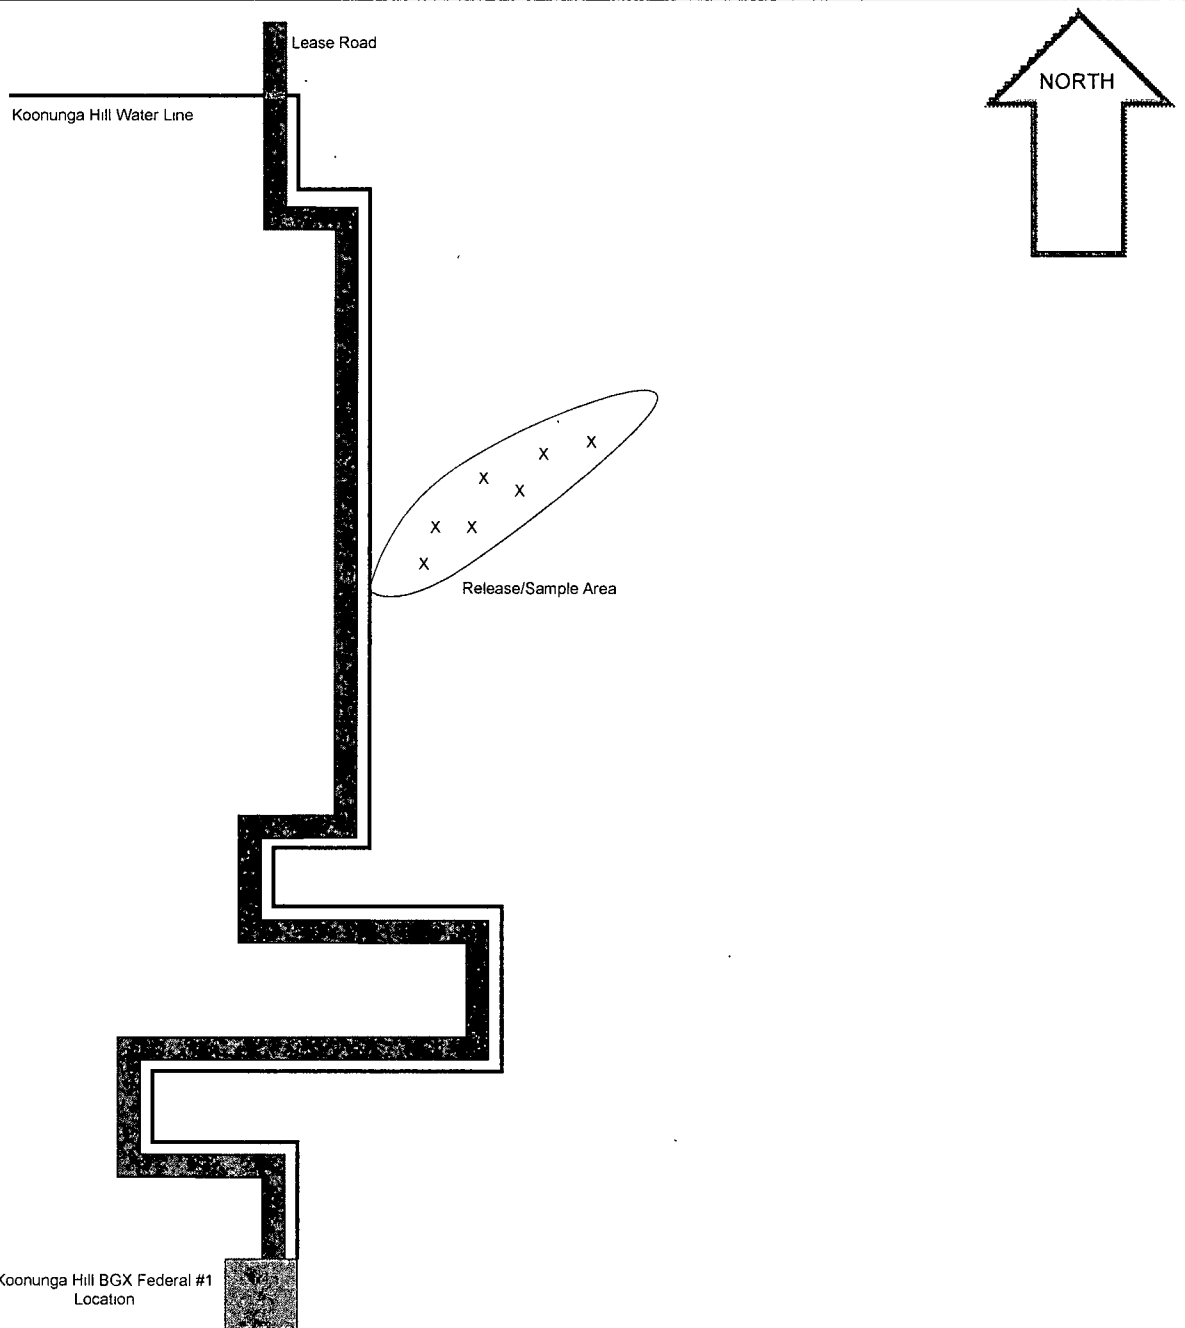
Analytical Report 434596 & 434597	Sample Area	Sample Date	Sample Type	Depth	BTEX	GRO	DRO	TOTAL	Chlorides
Comp-00.5	Release Area	1/5/2012	Comp/Shovel	6"	ND	ND	ND	ND	123

Site Ranking is Zero (0). Depth to Ground Water >100' (approx. 213', Section 24, T22S-R23E).

All results are ppm. Chlorides for documentation. **X - Sample Points**

Released: 30 B/PW; Recovered: 15 B/PW. Release Date: 12/7/2011
