# WORKPLANS

**RE: ICP Report and Corrective Action Plan (CAP)  
Rice Operating Company – BD SWD System  
BD G-16 vent (1R426-29): UL/G sec. 16 T22S R37E**

## *BD G-16 vent*

Legals: UL/G sec. 16  
T22S R37E  
NMOCD Case #: 1R426-29

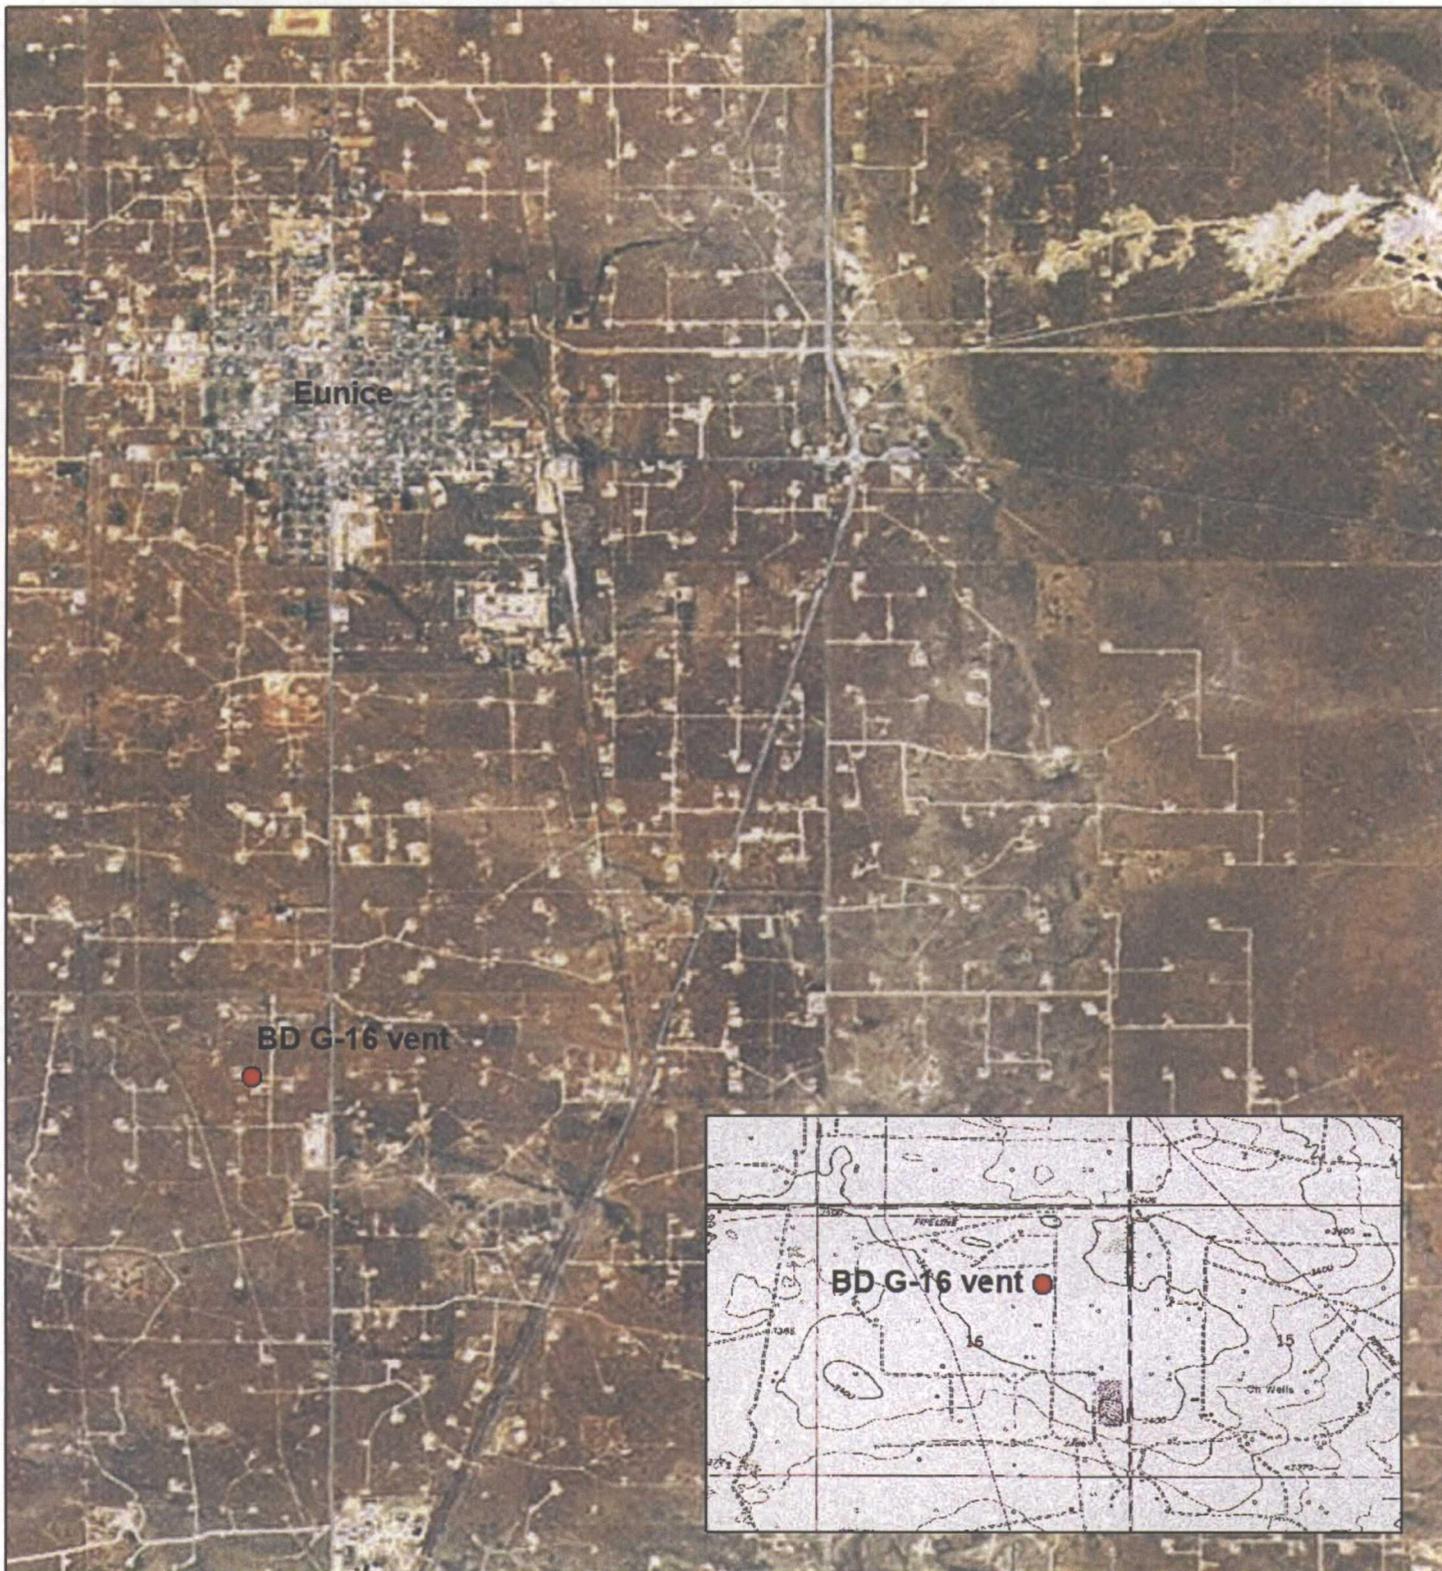
# Site Location

The site is located approximately 3 miles south of Eunice, New Mexico at UL/G sec. 16 T22S R37E as shown on the Site Location Map (Figure 1). Groundwater at this site is located approximately 96 +/- feet below ground surface (bgs).

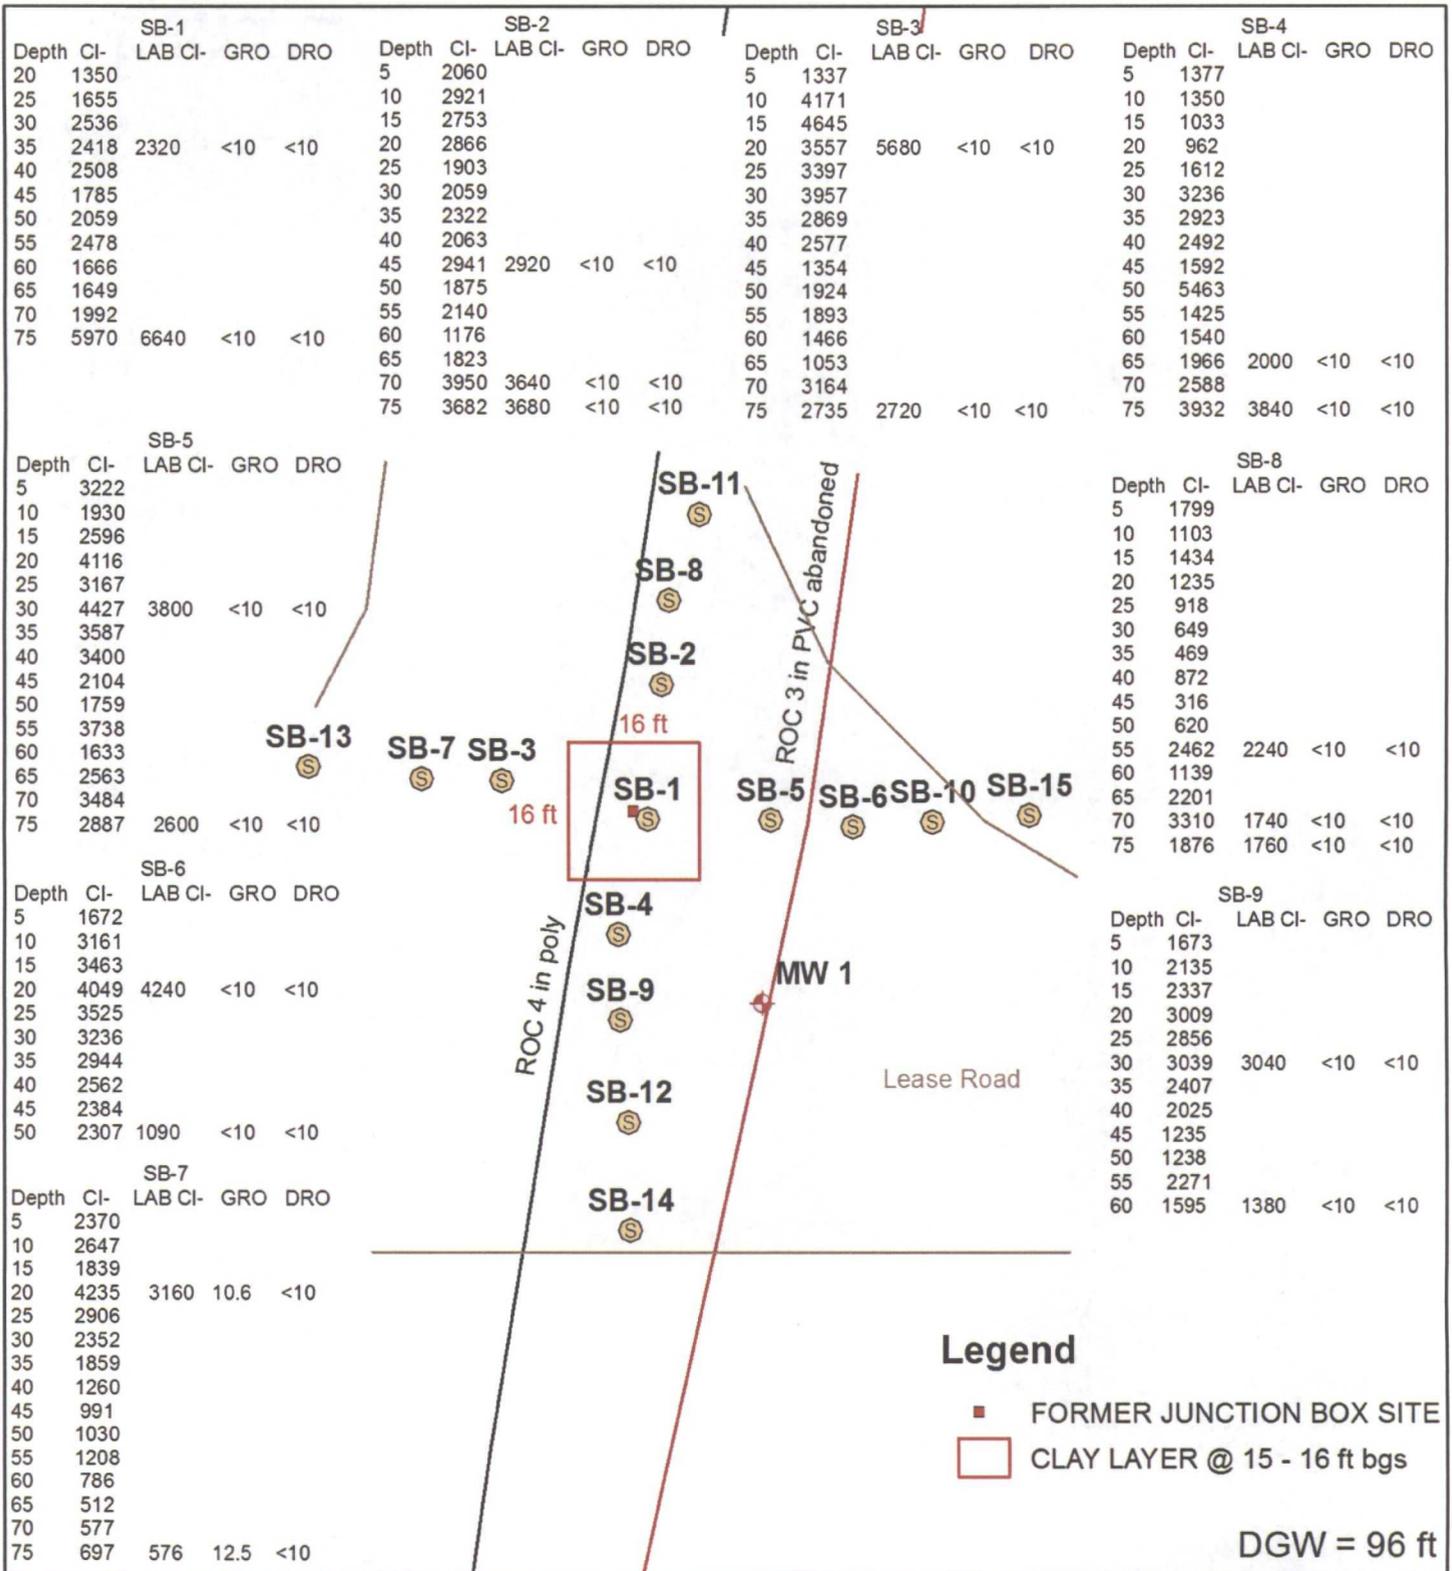
### Figure 2

Per the ICP, nine soil bores were advanced through the former junction box site on September 13<sup>th</sup> and 14<sup>th</sup>, 2010 (Figure 2). ROC personnel field tested the soil for chlorides and screened in the field with a photo-ionization detector (PID). Representative samples from the bore were taken to a commercial laboratory for confirmation of chloride and hydrocarbon field numbers (Appendix A). Laboratory readings in SB-3, SB-5, SB-6, SB-7, SB-8, and SB-9 exhibited chloride concentrations that decreased with depth. SB-3 decreased from 5,680 mg/kg at 20 ft to 2,720 mg/kg at 75 ft, SB-5 decreased from 3,800 mg/kg at 30 ft to 2,600 mg/kg at 75 ft, SB-6 decreased from 4,240 mg/kg at 20 ft to 1,090 mg/kg at 50 ft, SB-7 decreased from 3,160 mg/kg at 20 ft to 576 mg/kg at 75 ft, SB-8 decreased from 2,240 mg/kg at 55 ft to 1,760 mg/kg at 75 ft, and SB-9 decreased from 3,040 mg/kg at 30 ft to 1,380 mg/kg at 60 ft. SB-1 increased with depth from 2,320 mg/kg at 35 ft to 6,640 mg/kg at 75 ft, SB-2 increased with depth from 2,920 mg/kg at 45 ft to 3,680 mg/kg at 75 ft, and SB-4 increased with depth from 2,000 mg/kg at 65 ft to 3,840 mg/kg at 75 ft. Laboratory readings for GRO, DRO, and BTEX showed non-detect throughout all bores, except SB-7 where the GRO was 10.6 mg/kg at 20 ft and 12.5 mg/kg at 75 ft.

# Soil Bore Installation

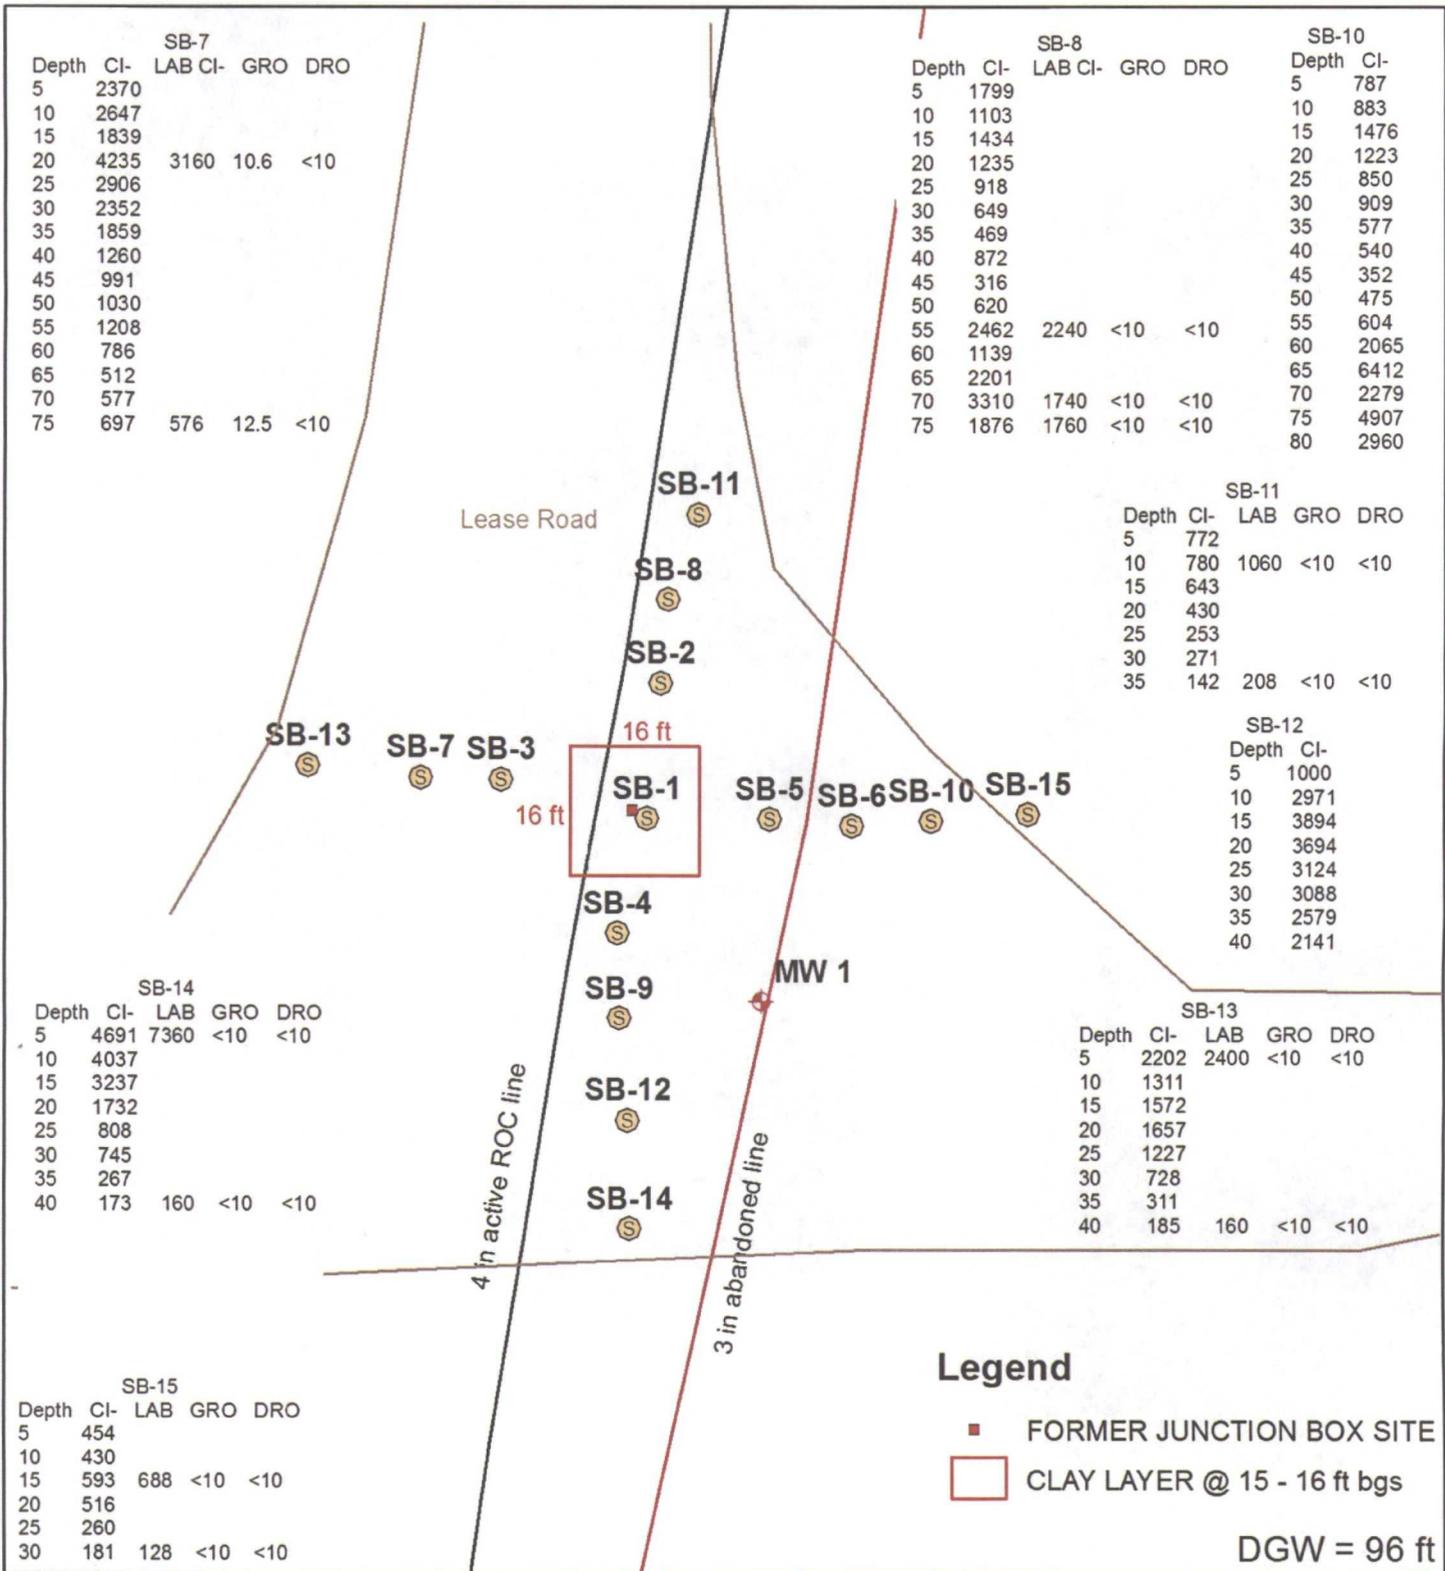
### Figure 3

On March 21<sup>st</sup>, 2011, an additional five soil bores (SB-10 through SB-15) were installed at the site (Figure 3). ROC personnel field tested the soil for chlorides and screened in the field with a photo-ionization detector (PID). Representative samples from SB-11, SB-13, SB-14, and SB-15 were taken to a commercial laboratory for confirmation of chloride and hydrocarbon field numbers (Appendix A). Laboratory chloride readings significantly decreased with depth. SB-11 decreased from 1,060 mg/kg at 10 ft to 208 mg/kg at 35 ft, SB-13 decreased from 2,400 mg/kg at 5 ft to 160 mg/kg at 40 ft, SB-14 decreased from 7,360 mg/kg at 5 ft to 160 mg/kg at 40 ft, and SB-15 decreased from 688 mg/kg at 15 ft to 128 mg/kg at 30 ft. GRO and DRO readings for all laboratory samples showed non-detect.

# Soil Bore Information

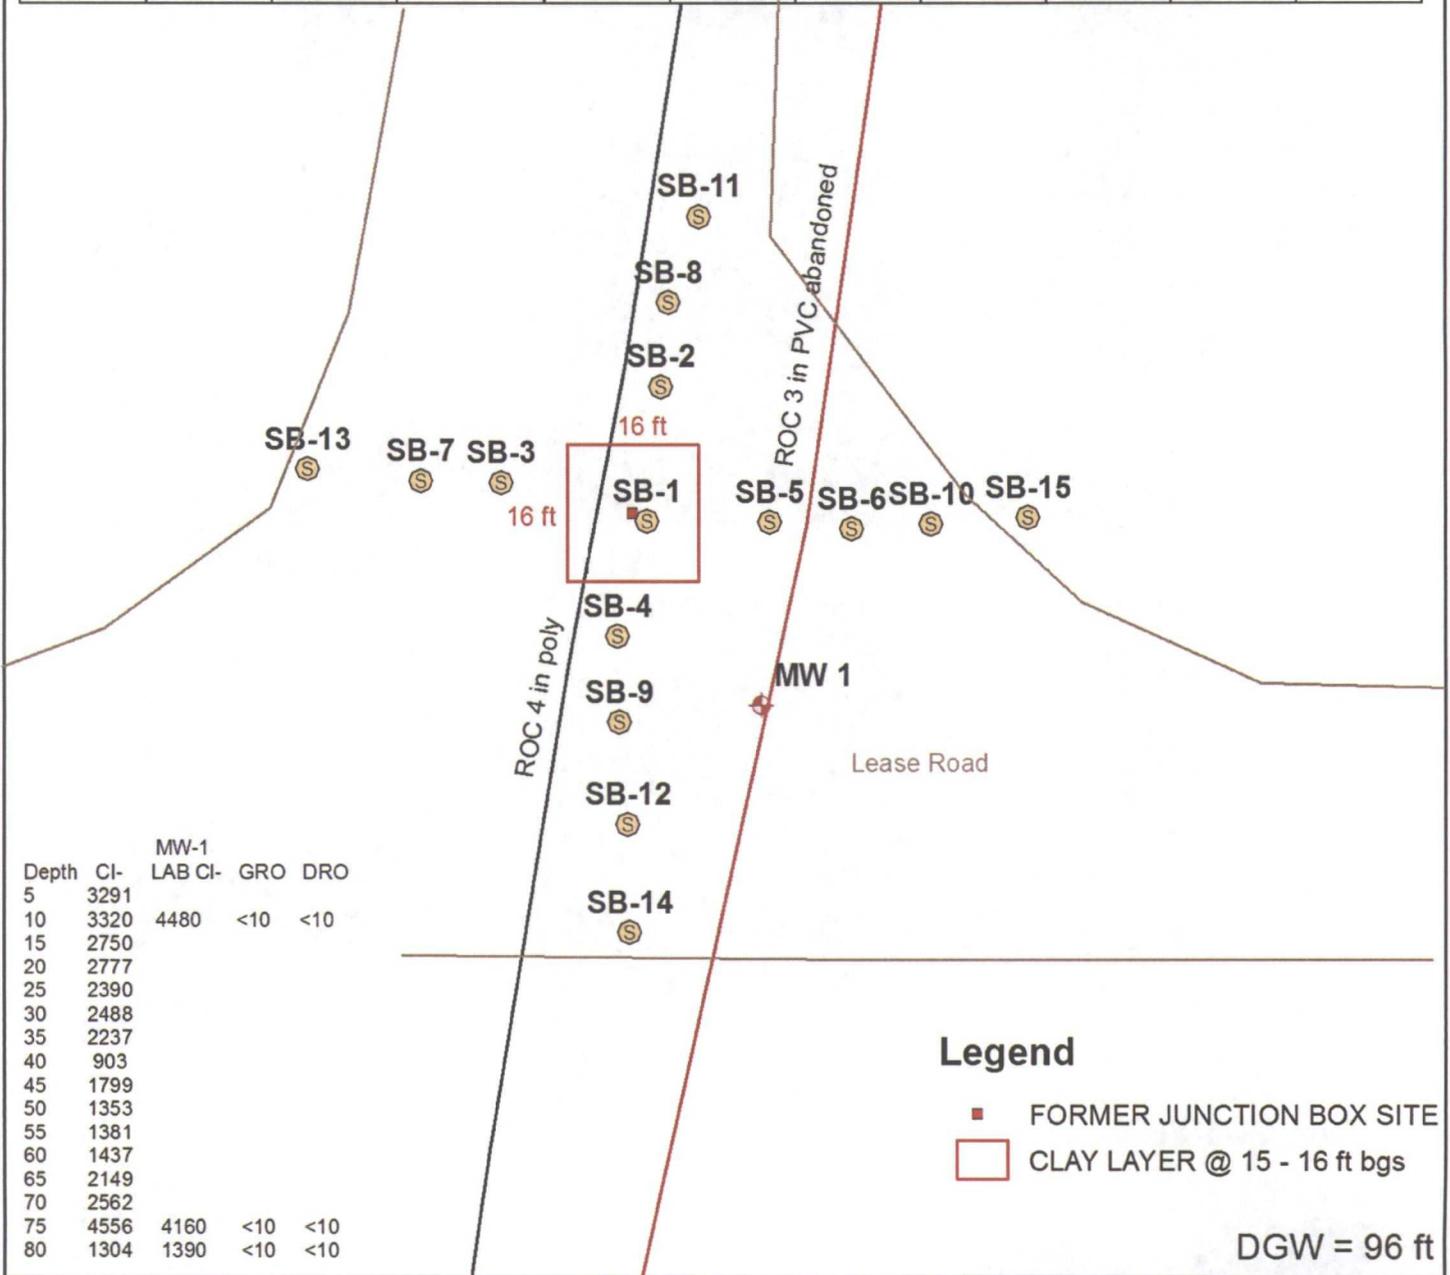
**Figure 4**

On January 13<sup>th</sup>, 2011, a monitor well was installed 26 ft southeast of the former junction box site (Figure 4). As the well was being installed, ROC personnel field tested the soil for chlorides and screened in the field with a photo-ionization detector (PID). Representative samples from the well were taken to a commercial laboratory for confirmation of chloride and hydrocarbon field numbers (Appendix A). Laboratory readings showed chloride numbers of 4,480 mg/kg at 10 ft bgs, 4,160 mg/kg at 75 ft bgs, and 1,390 mg/kg at 80 ft bgs. GRO and DRO readings were non-detect in all three samples.

The monitor well has been sampled quarterly since its installation (Figure 4). The most recent (October 21, 2011) groundwater samples tested 64 mg/L in the near-source well (MW-1) (Appendix B). Five quarters of monitoring well sampling data have been collected, and each sampled constituent has remained below WQCC standards.

# MW Installation and Sampling

MW	Depth to Water	Total Depth	Sample Date	Cl	TDS	Benzene	Toluene	Ethyl Benzene	Total Xylenes	Sulfate
MW-1	96.48	100.51	2/8/2011	160	674	<0.001	<0.001	<0.001	<0.003	86.5
	96.47	100.51	4/20/2011	60	501	<0.001	<0.001	<0.001	<0.003	85.6
	96.47	100.51	4/20/2011	60	501	<0.001	<0.001	<0.001	<0.003	85.6
	96.7	100.51	7/27/2011	172	652	<0.050	<0.050	<0.050	<0.150	102
	96.86	100.51	10/21/2011	64	410	<0.001	<0.001	<0.001	<0.003	87.3

Five quarters of monitoring well sampling show no impact to groundwater above WQCC standards; as such ROC proposes to plug and abandon the near-source well (MW-1) with a 1-3% bentonite/concrete slurry with a 3 ft concrete cap.
